PILATUS AIRCRAFT LTD. CH-6371 STANS, SWITZERLAND

SERVICE BULLETIN

SERVICE BULLETIN NO: 1005 REF NO:

FUSELAGE - GENERAL CONTROL COLUMN SUPPORT ON FRAME 2 - INSPECTION

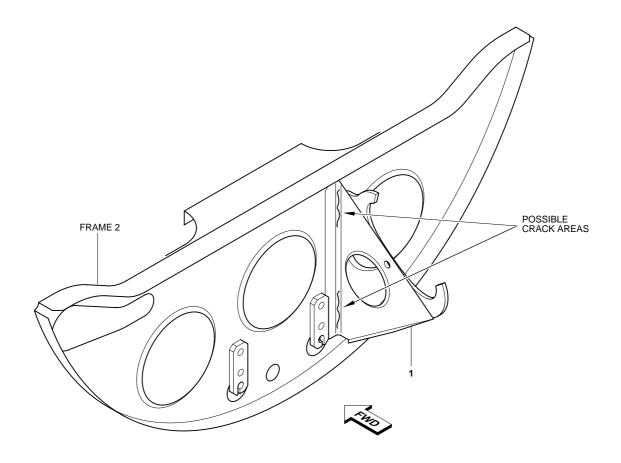
Support Frame 2 - Inspection Figure 1

Cracks can occur in the support to which the control-column is attached.

- (1) Get access to the aft face of Frame 2 lower.
- B. Inspection of the Support (Ref. Fig. 1)
 - (1) Use a source of bright light and X10 magnifier and examine support (1) for cracks. Do this specially in the areas of the upper and lower bend angles where the support (1) is attached to Frame 2.
 - (2) Cracks are not permitted in the support (1). Replace the support (1) if you find cracks.
 - (3) Do the inspection again at each annual servicing.

Examine the support and replace it if cracked.
