# SERVICE BULLETIN

Service Bulletin Number:		nber:	SB05147	
Revision:	В	2 and 3. B: Replac 2. Revise	ase reference "note" to instructions. Added figures ced photos figure 2 and 3 with illustration figure ed A(6) and B(6) to refer to figure 2. Deleted B(7) requiring DASC completion form	Page: 1

## TITLE: LEG REPLACEMENT

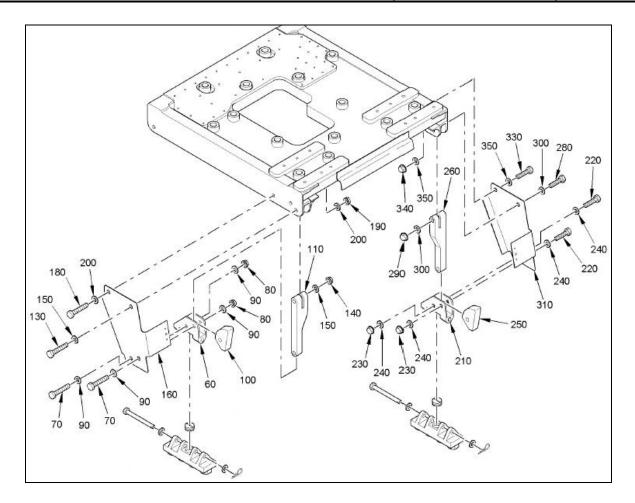
Fig 1 Leg Replacement

The lot of material used to manufacture the forward pedestal legs are suspect. Replacement ensures the seat meets the approved data package.

- 1. Remove bolts (70), (130), (180), washers (90), (150), (200), nuts (80), (140), (190) and remove gusset (160).
- 2. Remove and discard leg (110) and install leg 431005-17.

- 3. Reinstall hardware removed in steps 1 & 2 in reverse order of removal.
- 4. Remove bolts (220), (280), (330), washers (240), (300), (350), nuts (230), (290), (340) and gusset (310).

- 5. Remove and discard leg (260) and install leg 431005-18.
- 6. \*Reinstall hardware removed in steps 4 & 5 in reverse order of removal.
  - **\*NOTE**: See Figure 2. Remove the pedestal shroud. Examine the two solid aluminum legs that are in the forward position relative to the aircraft. The legs are installed CORRECTLY if the length of the slot on the top of the leg is *shorter on the forward side* as compared to the length of the slot on the aft side of the leg. The legs are installed INCORRECTLY if the length of the slot on the top of the leg is *longer on the forward side* as compared to the length of the slot on the slot on the slot on the slot on the top of the leg is *longer on the forward side* as compared to the length of the slot on the slot

- 1. Remove bolts (70), (130), (180), washers (90), (150), (200), nuts (80), (140), (190) and remove gusset (160).
- 2. Remove and discard leg (110) and install leg 431005-18.
- 3. Reinstall hardware removed in steps 1 & 2 in reverse order of removal.
- 4. Remove bolts (220), (280), (330), washers (240), (300), (350), nuts (230), (290), (340) and gusset (310).
- 5. Remove and discard leg (260) and install leg 431005-17.
- 6. \*Reinstall hardware removed in steps 4 & 5 in reverse order of removal.

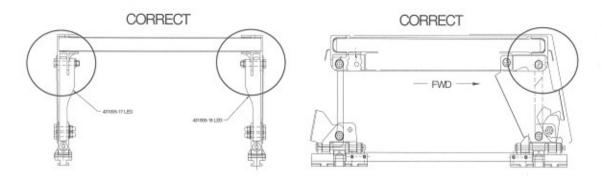
Fig 2 Leg Orientation

The upper pictures show the correct leg installation. The lower pictures show the incorrect installation which can be identified by the long side of the slot facing away from the seat.

**\*NOTE**: See Figure 2. Remove the pedestal shroud. Examine the two solid aluminum legs that are in the forward position relative to the aircraft. The legs are installed CORRECTLY if the length of the slot on the top of the leg is *shorter on the forward side* as compared to the length of the slot on the slot on the top of the leg. The legs are installed INCORRECTLY if the length of the slot on the top of the leg is *longer on the forward side* as compared to the length of the slot on the slot on the slot on the top of the leg is *longer on the forward side* as compared to the length of the slot on t
