Lufttüchtigkeitsanweisung (LTA) Consigne de Navigabilité (CN) Direttive sulla Navigabilità (DN) Airworthiness Directive (AD)		FOCA AD HB-2016-007
Inkraftsetzung Mise en vigueur Entrata in vigore Effective Date	03 October 2016	Pilatus – P3 FOCA TC/TCDS No: None

Subject: **Fuselage – Main Frame 3 – Wing to Fuselage Attachment Bolts – Inspection**

Applicability: Model P3-03 and P3-05 aircraft, all Serial Numbers (S/N).

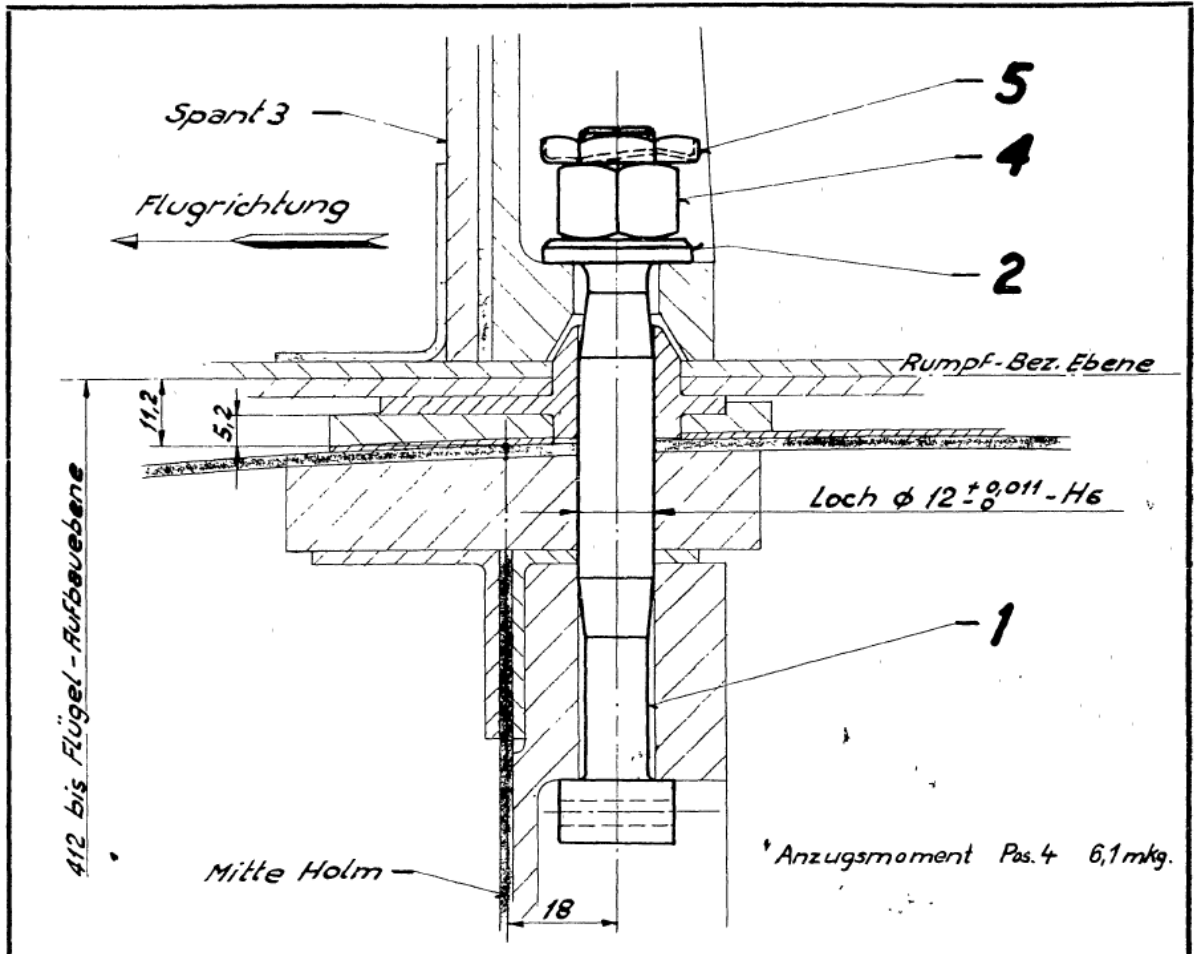
Appendix 1

Reason: This Airworthiness Directive (AD) is prompted due to a report of corrosion of a wing to fuselage attachment bolt. The corrosion was detected during an inspection of the fleet leader aircraft. The corrosion of the wing to fuselage attachment bolt can occur when water is entering into the aircraft structure, for example with an open canopy in raining conditions.

Such a condition, if left uncorrected, could lead to stress corrosion cracking in the affected bolts and will prejudice the structural integrity of the aircraft.

- (1) Within the next 50 Flight Hours (FH) or at the next annual inspection, whichever occurs first after the effective date of this AD, remove the wing to fuselage attachment bolts as described in "Technisches Reglement der Fliegertruppe 56.199d" (the technical description and operating instructions of the Swiss Air Force) and perform a visual inspection for corrosion and a dye penetrant inspection for cracks. No corrosion and/or cracks are permitted.

- (2) If during the inspection by paragraph (1) of this AD any wing to fuselage attachment bolts with corrosion and/or cracks are found, before next flight, replace the wing to fuselage attachment bolts as described in "Technisches Reglement der Fliegertruppe 56.199d" with new bolts. The tightening torque of the new installed or reinstalled bolts is: 60 Nm (6.1 mkg).
