FOCA AD
HB-2020-001

Pilatus – P3

Subject: **Fuselage – Fuselage to Horizontal Tail Fittings – Identification, Repetitive Inspections**

Applicability: Model P3-03 and P3-05 aircraft, all Serial Numbers (S/N).

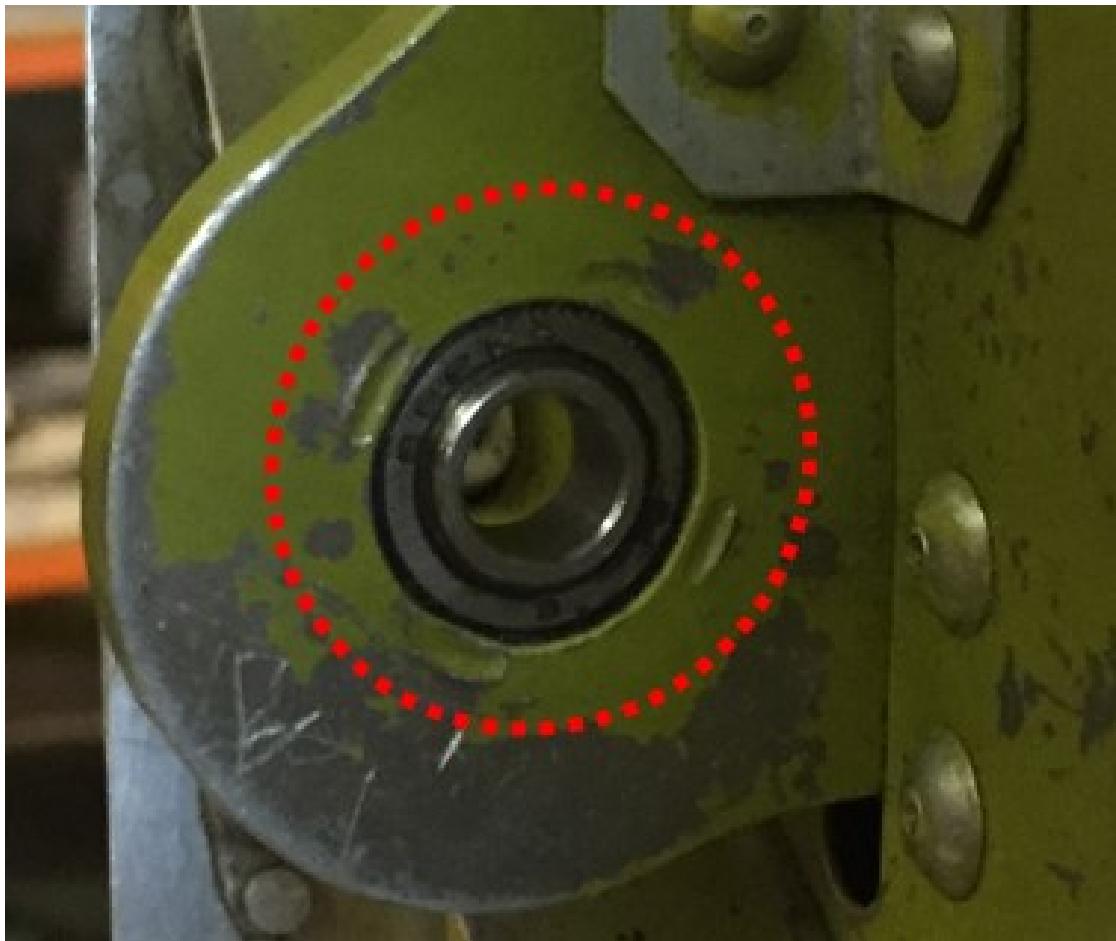
Fuselage to horizontal tail fitting: original manufactured by Pilatus Flugzeugwerke AG

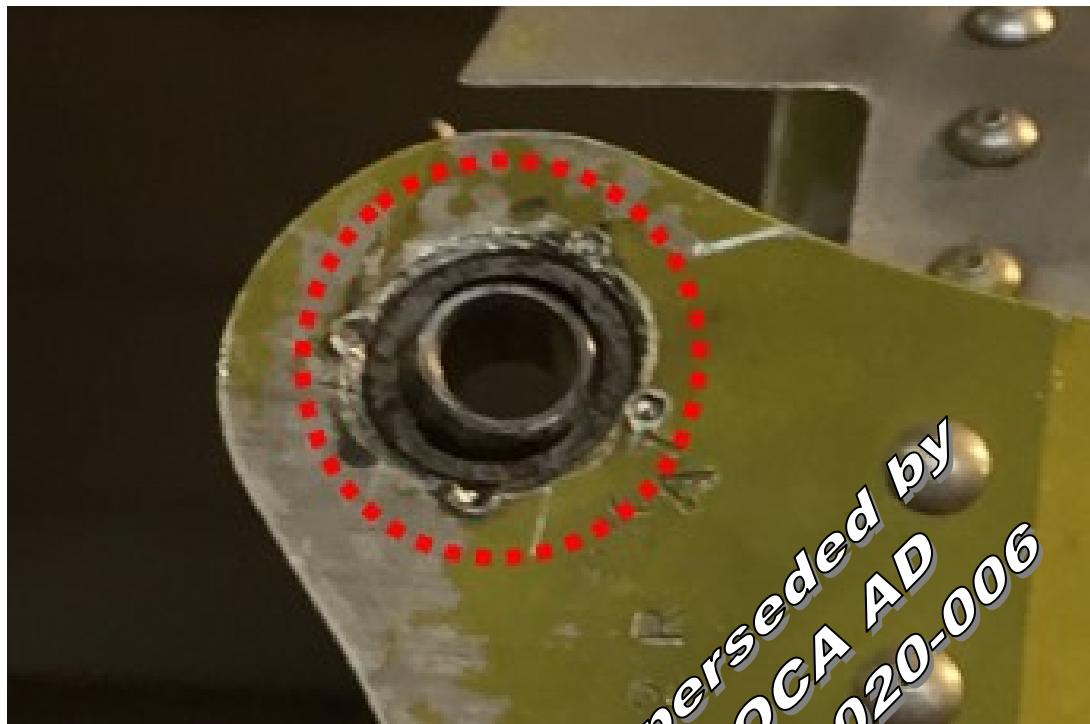
Reason: This Airworthiness Directive (AD) is prompted due to a report of a damaged fuselage to horizontal tail fitting. It's assumed that the signs of damage of the fuselage to horizontal tail fitting was occurred during maintenance work by using a centre punch tool.

Such a condition, if left uncorrected, could lead to stress corrosion cracking on the affected fuselage to horizontal tail fittings and will prejudice the structural integrity of the aircraft.

Fuselage to horizontal tail fitting: damage caused by using a centre punch tool during maintenance

- (1) Perform a visual inspection for damage caused by using a centre punch tool. No signs of damage caused by using a centre punch tool are permitted.
- (2) If during the inspection required by paragraph (1) of this AD any fuselage to horizontal tail fittings with no signs of damage caused by using a centre punch tool are found, no further action is necessary.

- (3) If during the inspection required by paragraph (1) of this AD any fuselage to horizontal tail fittings with signs of damage caused by using a centre punch tool are found, before next flight, perform an eddy current inspection of the fuselage to horizontal tail fittings for cracks.
- (4) If during the eddy current inspection required by paragraph (3) of this AD any fuselage to horizontal tail fittings with cracks are found, replace the fitting in accordance with an approved repair solution.
- (5) If during the eddy current inspection required by paragraph (3) of this AD any fuselage to horizontal tail fittings with no cracks are found, within the next 200 FH repeat the eddy current inspection for signs of cracks.
