Lufttüchtigkeitsanweisung (LTA) Consigne de Navigabilité (CN) Direttive sulla Navigabilità (DN) Airworthiness Directive (AD)		FOCA AD <b>HB-2020-006</b>
Inkraftsetzung Mise en vigueur Entrata in vigore Effective Date	<b>04 August 2020</b>	<b>Pilatus – P3</b> FOCA TC/TCDS No: None

**Subject:** **Fuselage – Fuselage to Horizontal Tail Fittings – Inspection, Replacement**

**Applicability:** Model P3-03 and P3-05 aeroplanes, all Serial Numbers (S/N).

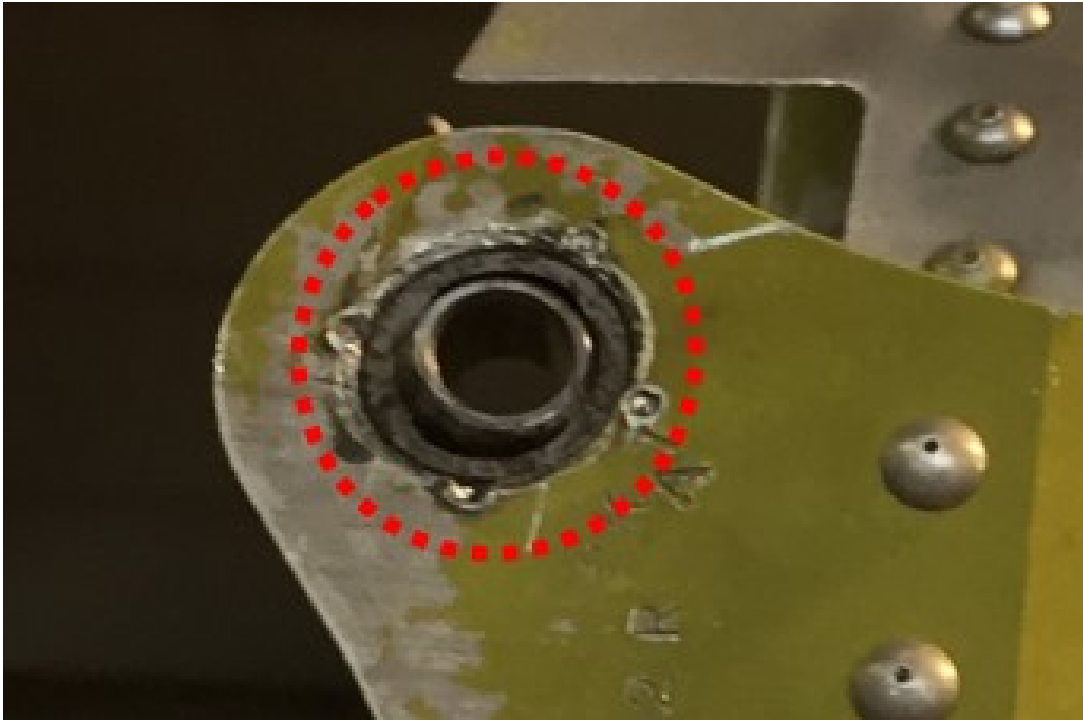
**Reason:** A case was reported where, during an overhaul of a Pilatus P3 aeroplane, a damaged fuselage to horizontal tail fitting was found. It's assumed that the signs of damage of the fuselage to horizontal tail fitting was occurred during maintenance work by using a centre punch tool.

Such a condition, if left uncorrected, could lead to stress corrosion cracking on the affected fuselage to horizontal tail fittings and will prejudice the structural integrity of the aeroplane.

Fuselage to horizontal tail fitting: damage caused by using a centre punch tool during maintenance

- (3) If during the inspection required by paragraph (1) of this AD any fuselage to horizontal tail fittings with signs of damage caused by using a centre punch tool are found, before next flight, replace the fitting with a serviceable part or repair the fitting in accordance with an approved repair solution.
