SERVICE BULLETIN

SERVICE BULLETIN NO: 25-031

EQUIPMENT/FURNISHINGS - FLIGHT COMPARTMENT CREW SEATS - INSPECTION OF THE BUCKET ASSEMBLY TUBES

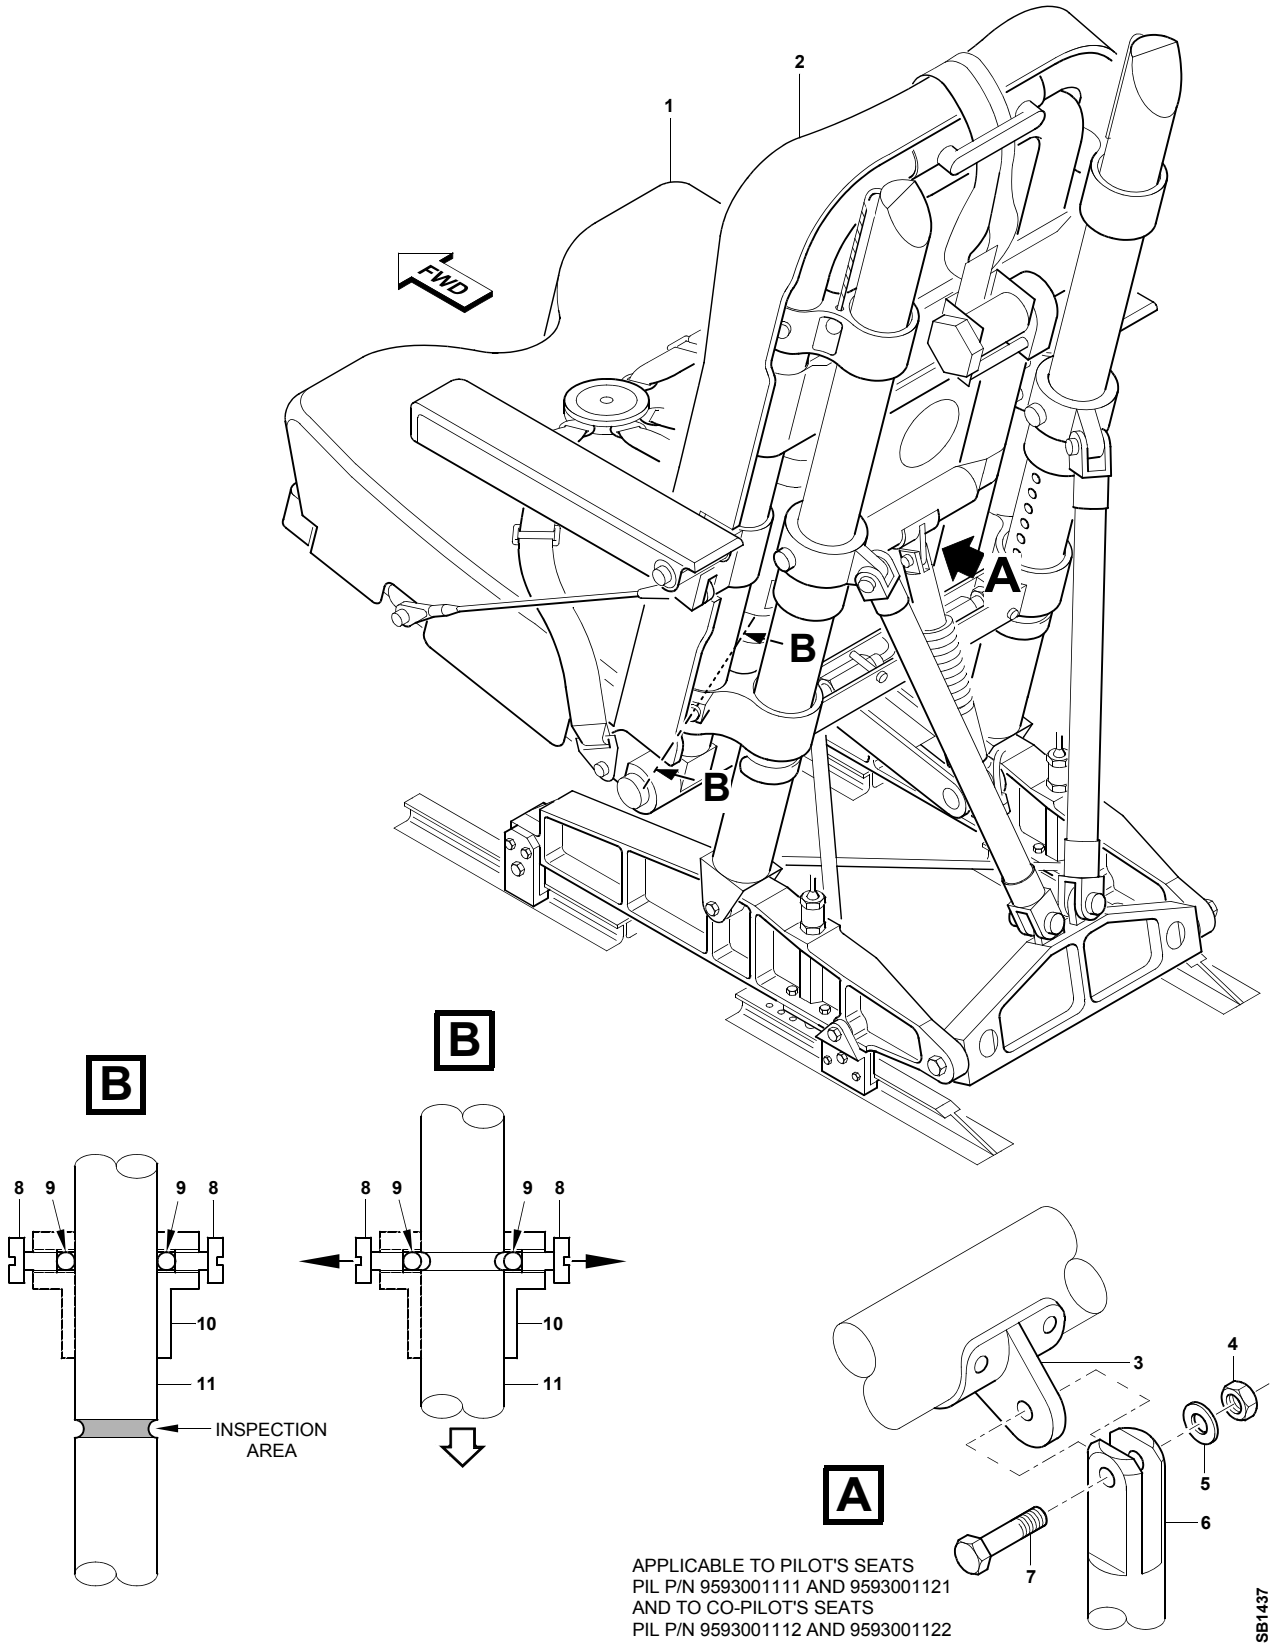
Inspection of the Bucket Assembly Tubes Adjacent to the Energy Devices
 Figure 1

The bucket assembly tubes failed at the location of the energy device pins. The lower tubes remained attached but the upper parts were completely disconnected.

- (7) Do a fluorescent dye-penetrant inspection of the grooved area of the bucket assembly tubes (11). Crack(s) are not permitted.

- (5) Push down on the bucket assembly tubes (11) until the circular groove is visible below the supports (10).

- Contact PILATUS for a repair procedure to replace the bucket assembly. Give the aircraft Serial Number (S/N) and the seat S/N and flying hours
- Continue with this procedure.

- (13) Permit the bucket assembly to move up the bucket assembly tubes (11) until you can feel the ball bearings (9) go into the groove of the bucket assembly tubes (11).
- (14) Keep the bucket assembly in this position and torque the four energy device pins (8) to between 5,42 and 5,65 Nm (48 and 50 lb in).
- (15) Secure each pair of the energy device pins (8) with the lockwire (Mat. No. P02-001).
