SERVICE BULLETIN

SERVICE BULLETIN NO: 28-009

ENGINE FUEL AND CONTROL - DISTRIBUTION ENGINE-DRIVEN FUEL PUMP - TORQUE CHECK OF RELIEF-VALVE-BODY SCREWS

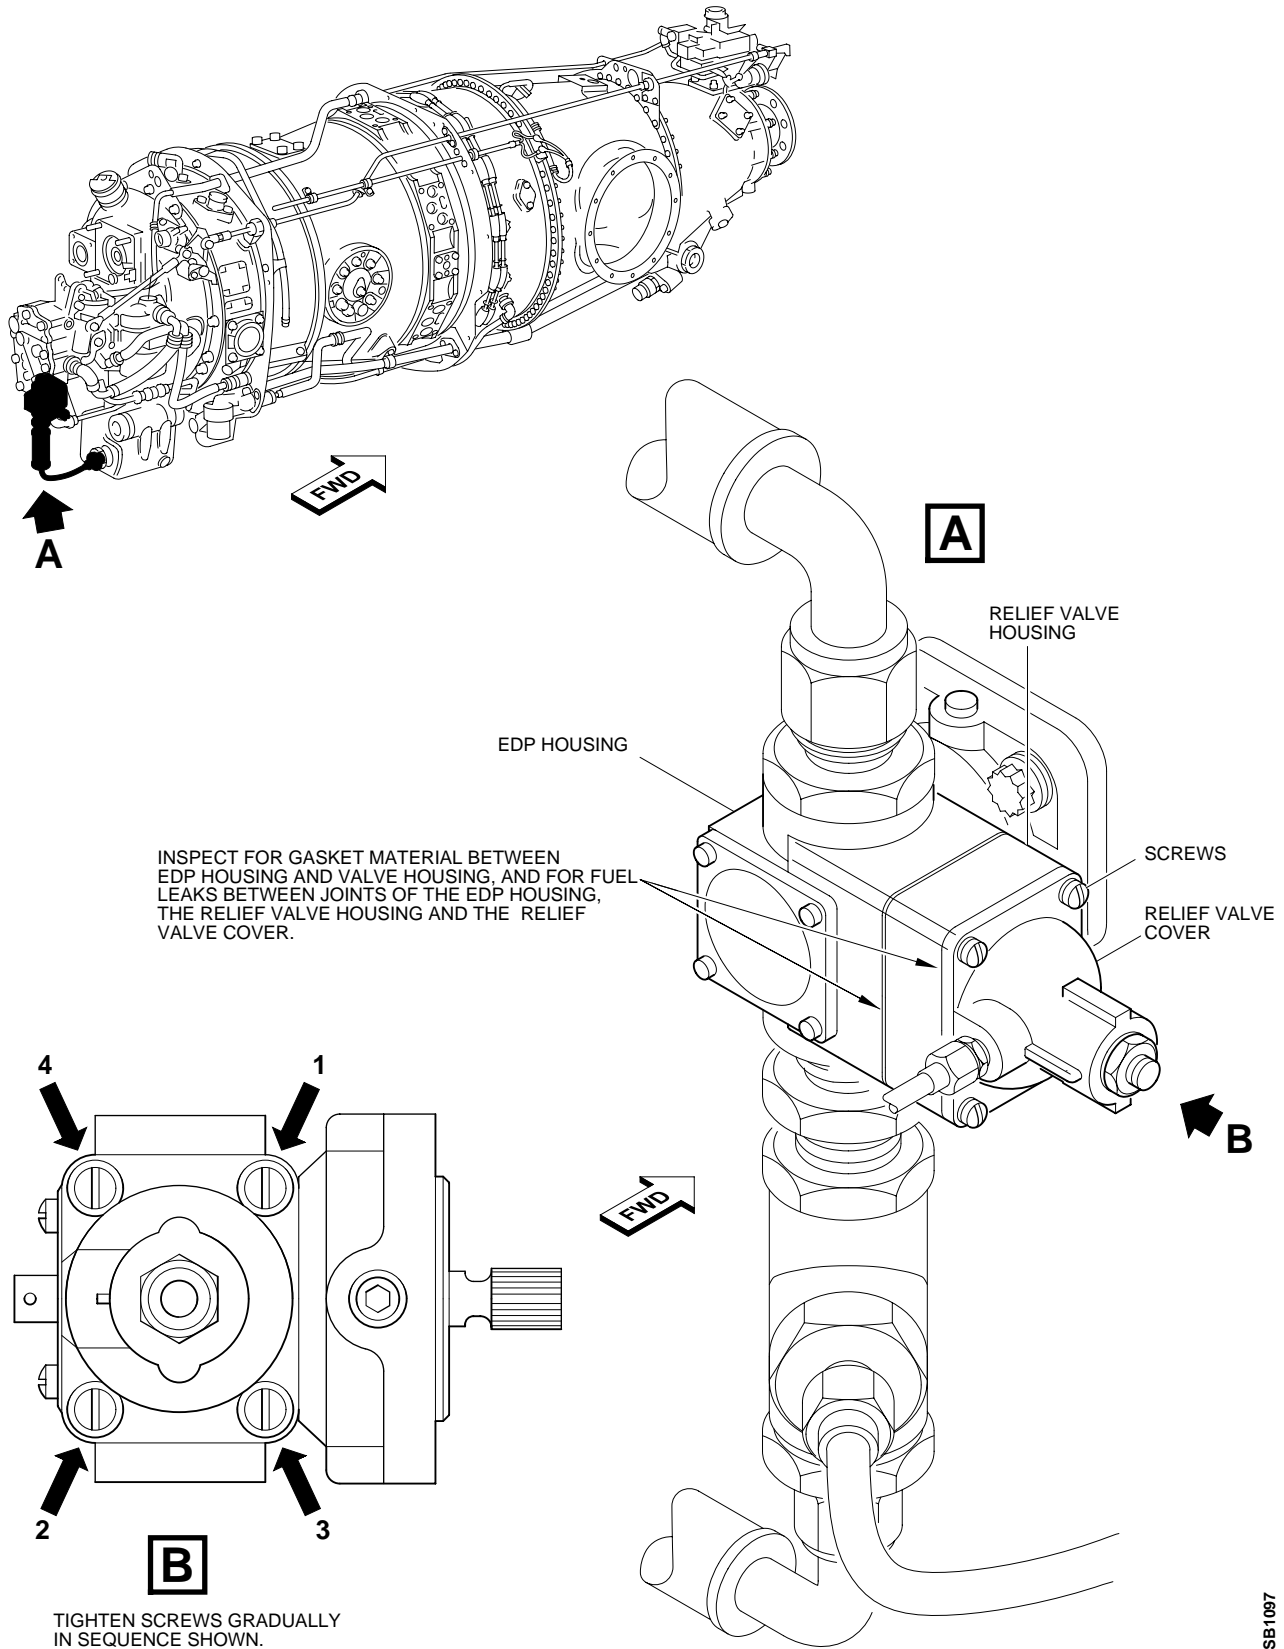
Torque Check and Fuel Leak Inspection of the EDP
Figure 1

Fuel leakage through the gasket of the EDP relief valve.

It is possible the torque of the screws that attach the EDP relief-valve cover to the relief valve housing is not correct. It is also possible that the gasket between the EDP relief-valve housing and the EDP housing has been pushed out.

- (1) Do an inspection of the joints between the EDP housing, relief valve housing and the relief valve cover for:

- Fuel leakage
- Gasket material pushed out

- (3) Use a torque screwdriver to do a check of the torque value of the relief-valve-cover screws. Do the check clockwise only. The minimum torque value must be 23 lbf in. (2,6 Nm).

- (5) If the relief-valve-cover screws are loose, or the torque found at Step (3) is less than 23 lbf in. (2,6 Nm), do as follows:

- (a) Cut, remove and discard the lockwire that safeties the relief-valve-cover screws.
- (b) Torque the screws gradually to between 23 and 25 lbf in. (2,6 and 2,83 Nm). Do this in the sequence shown in Figure 1, Detail B.

(c) Safety the screws with lockwire (Material Item P02-001).
