# SERVICE BULLETIN

SERVICE BULLETIN NO: 28-011

## FUEL - DISTRIBUTION FUEL BOOSTER PUMP - DAMAGE TO WIRES DURING INSTALLATION

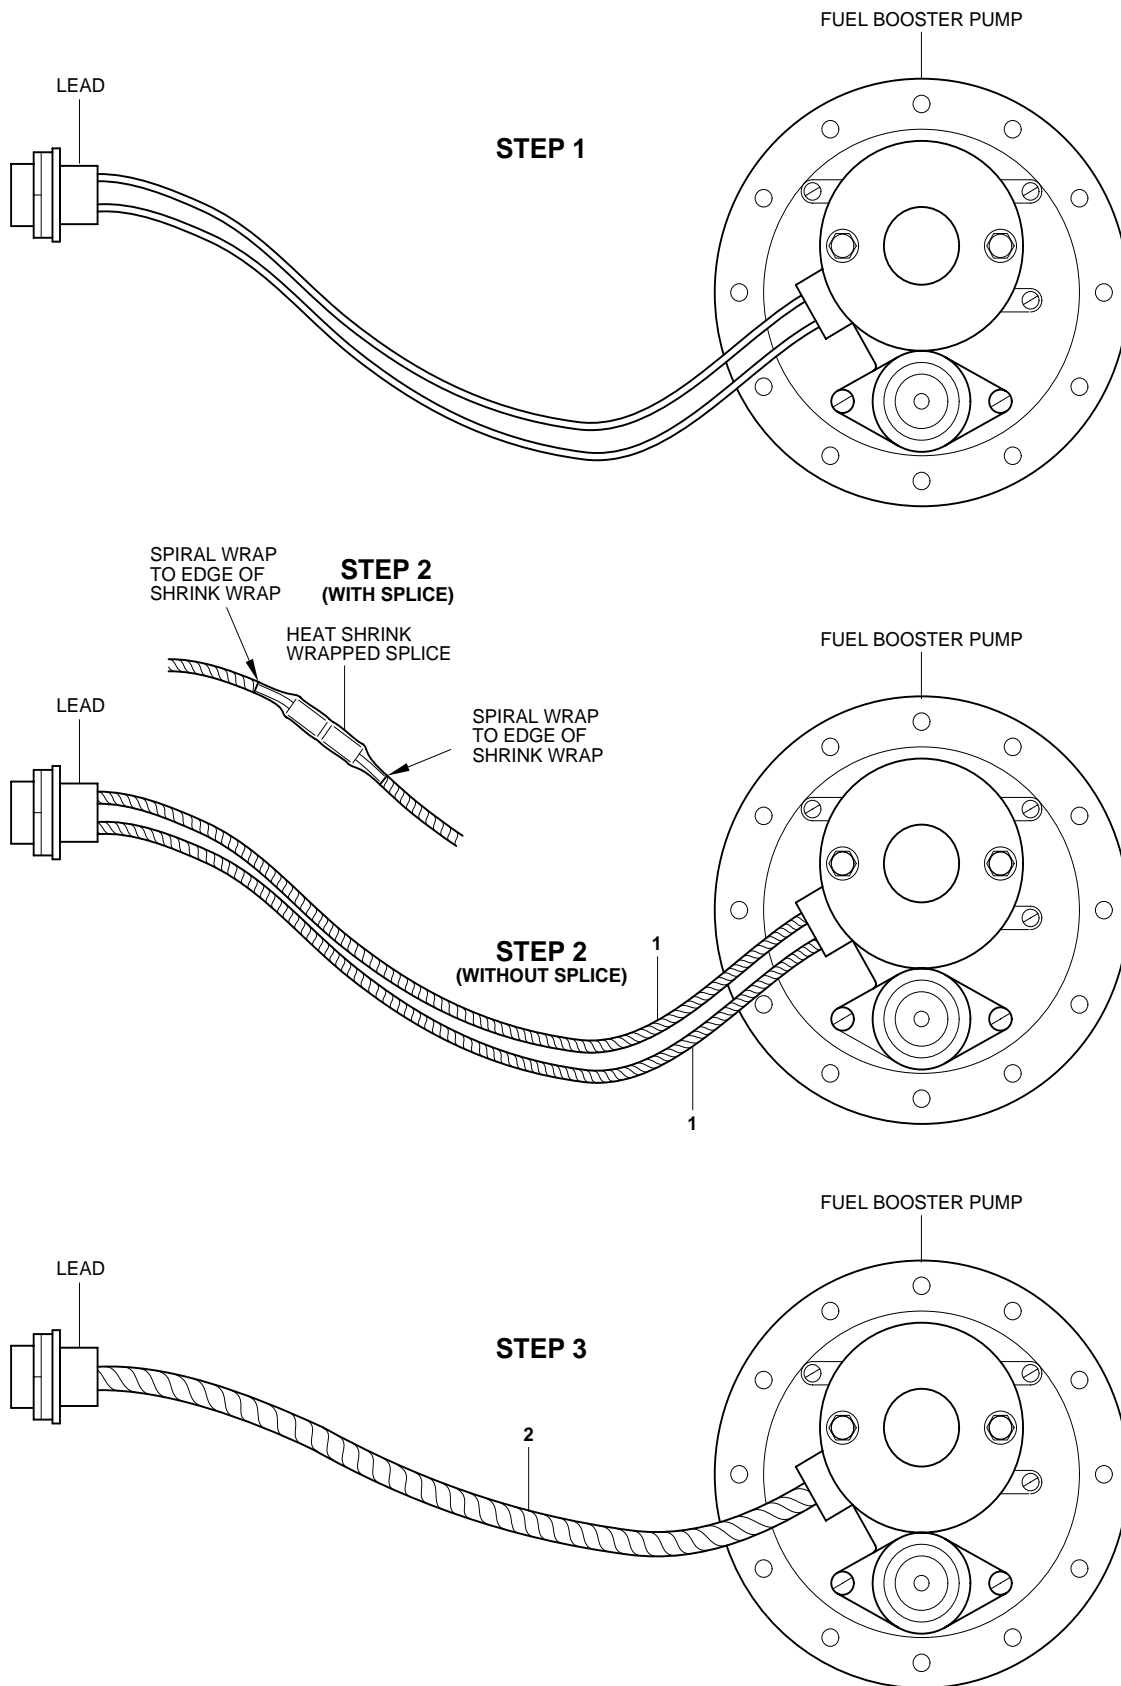
Lead Protection - Installation  
Figure 1

It is possible the electrical power wires (leads) to the left and right fuel pumps are damaged. This could possibly cause electric arcs from the leads in an air/fuel mixture which could result in an unsafe condition.

Damage can occur to the leads during the installation of the pump. It is also possible that during aircraft operation the leads can rub.

- (2) Install the spiral wrap on each wire:
  - (a) For a wire with no splice. Wind spiral wrap (1) around the full length of the wire. Twist the spiral wrap (1) to make sure there are no gaps and cut the spiral wrap (1).
  - (b) For a wire with a splice. Wind spiral wrap (1) around the wire between the edge of the shrink wrap and the end of the wire. Twist the spiral wrap (1) to make sure there are no gaps and cut the spiral wrap (1). Do this for each side of the splice.

- (3) Release the black wire and the white wire.
- (4) Wind the spiral wrap (2) around the full length of the black wire and the white wire. Twist the spiral wrap (2) to make sure there are no gaps and cut the spiral wrap (2).
- (5) Reidentify the Fuel Booster Pump, Part No. 968.84.11.403 or 968.84.11.404 when this Service Bulletin is done. Use a stamp or vibropen to put the letter B immediately after the Serial Number on the fuel pump Identification plate.
