SERVICE BULLETIN NO: 30-009

ICE AND RAIN PROTECTION - WINDSHIELD DEICE SYSTEM WINDSHIELD DEICE SYSTEM WIRING - INSPECTION

PC-12 and PC-12/45 aircraft MSN 322 thru MSN 400.

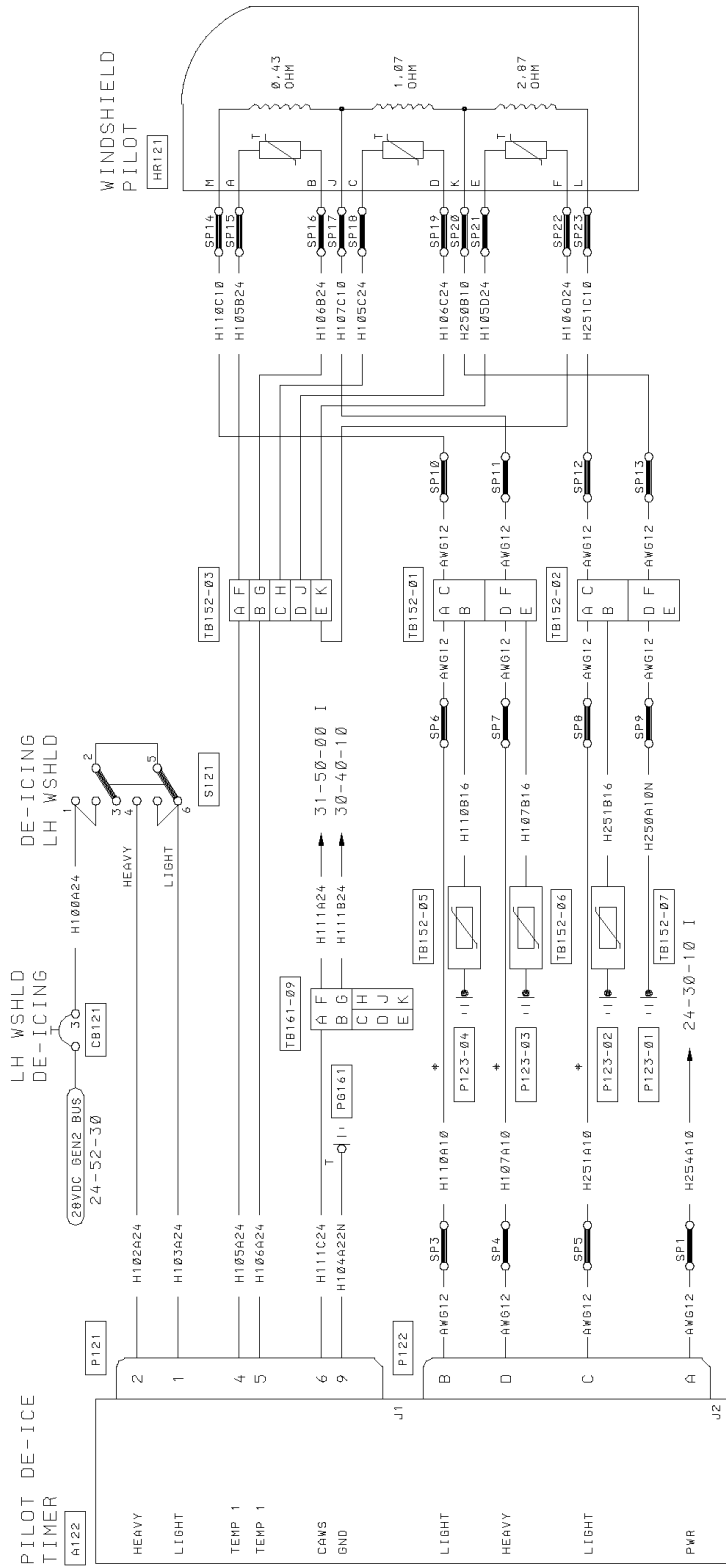
Wiring Diagram - Left Windshield Deice System
Figure 1

It is possible for heat damage to occur in given wires in the deice systems of the left and/or right windshields in some PC-12 and PC-12/45 aircraft.

This problem has only occurred in a windshield deice system in which wires of incorrect gage were used.

- (1) Do an inspection of the wires, splices and related link wires in the area of terminal block (TB152) for signs of heat damage (Ref. Table - Wire, Splice and Link Wire Assemblies - Inspection). Heat damage is not permitted. Replace all damaged wires and link wires (Ref. Para C).
- (2) Do a check of the wires and related link wires to make sure that they are correct as specified (Ref. Table - Wire, Splice and Link Wire Assemblies - Inspection and WM, 30-40-00 and 30-40-10).

- (1) Fully remove the flight-compartment overhead panel for access to terminal block TB152 (Ref. AMM, 25-10-03, Page Block 401).
- (2) Replace damaged or incorrect wires as necessary (Ref. WM, 30-40-00 and 30-40-10).
