# SERVICE BULLETIN

SERVICE BULLETIN NO: 32-015

**LANDING GEAR - MAIN LANDING GEAR  
INSPECTION OF THE LANDING GEAR ASSEMBLIES AND REPLACEMENT OF THE SHOCK  
ABSORBER ATTACHMENT BOLTS**

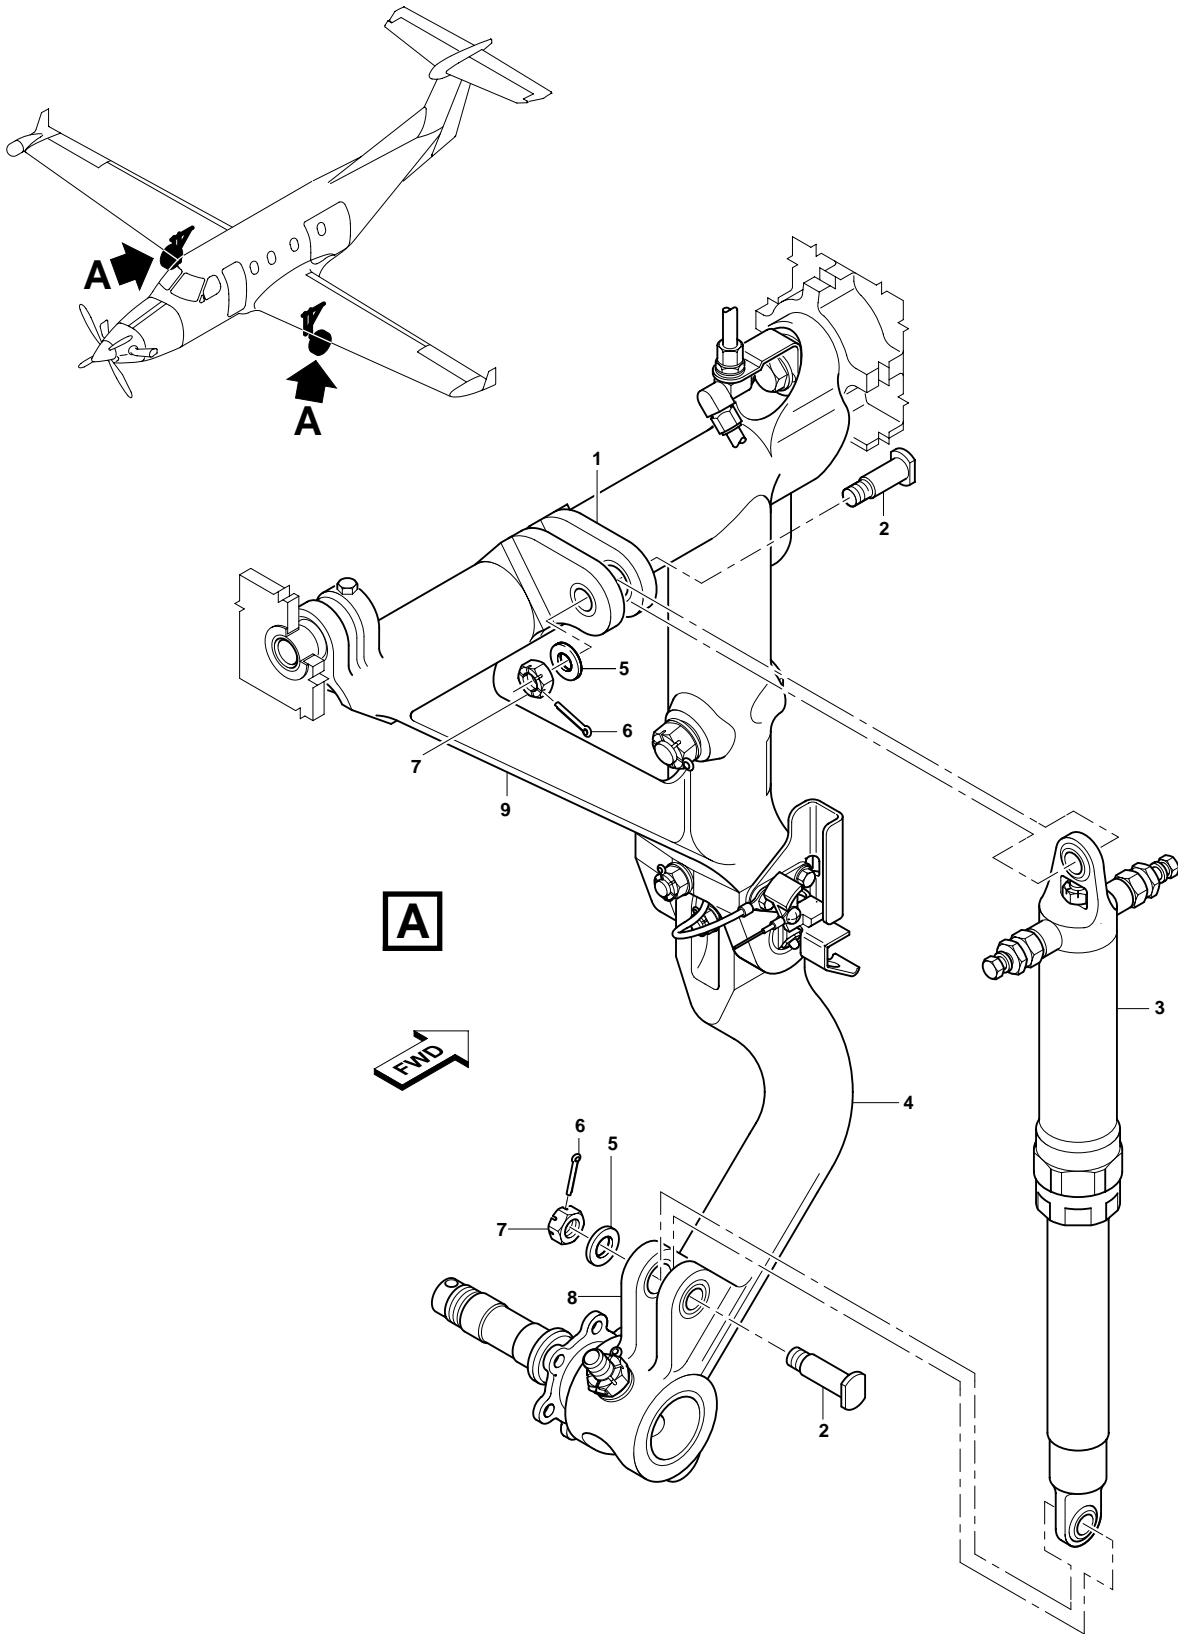
MLG - Replacement of Components  
Figure 1

It is possible for the shock-absorber attachment bolts (special bolts) in some MLG assemblies to be defective. The problem is only applicable to MLG assemblies with serial numbers that start with the letters AM.

It is now known that it is possible for hydrogen embrittlement to occur during the manufacture of the special bolts.

Replace the special bolts (2, Fig 1) in all assemblies with serial numbers that start with the letters AM (Ref. Part B). It is not necessary to replace the special bolts in assemblies with serial numbers that do not start with the letters AM.

- (1) Remove the shock absorber.
  - (a) Remove the cotter pins (6), nuts (7) washers (5) and special bolts (2). Discard the cotter pins.
  - (b) Remove the shock absorber (3) from the trunnions (8) on the trailing link (4) and the trunnions (1) on the yoke fitting (9).
- (2) Send the special bolts (2) to PILATUS.
- (3) Install the shock absorber.
  - (a) Put the shock absorber (3) in position between the trunnions (1) and (8).
  - (b) Put the new special bolts (2) in position and install the washers (5), nuts (7) and cotter pins (6) (Ref. AMM, 20-20-00, Page Block 1).
