SERVICE BULLETIN NO: 32-018

MODIFICATION NO: ECN 04-0333

LANDING GEAR - MAIN LANDING GEAR SPECIAL BOLT ASSEMBLY - INSPECTION AND REPLACEMENT

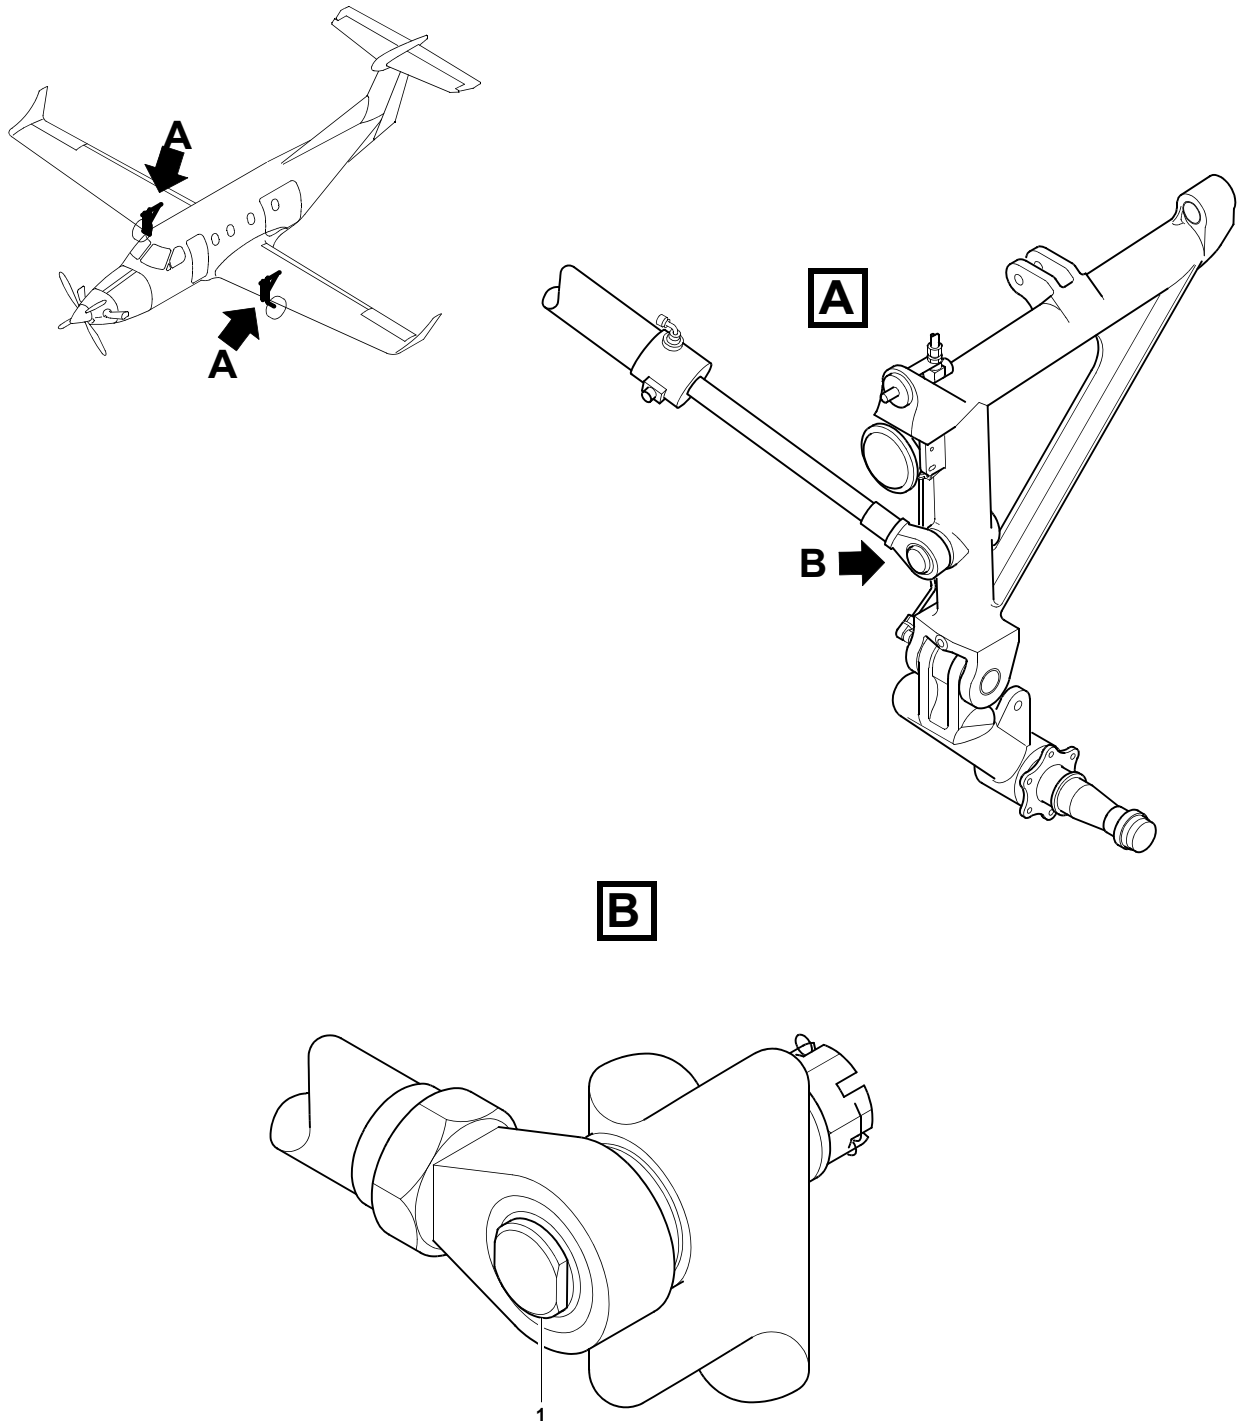
Special Bolt - Inspection
Figure 1

It is possible for the heads to break from the shanks of the bolts (532.10.12.077). These bolts attach the hydraulic actuators to the left and right MLG assemblies. The separation of a bolt head has only occurred in a MLG assembly of a specified manufacturer.

Corrosion has occurred in the area of the bolt head radius of a bolt (532.10.12.077) in a MLG assembly. This has caused the bolt to break with subsequent separation of the bolt head. The corrosion occurred in the damaged bolt because the bolt head was not primed and painted.

- (1) Do an inspection of the left and right MLG assemblies to find bolts (1) that do not have white primed and painted heads.
- (2) Replace all bolts that do not have white primed and painted heads (Ref. Part D). Send removed bolts to PILATUS
