SERVICE BULLETIN

SERVICE BULLETIN NO: 35-004

OXYGEN - PASSENGER OXYGEN OXYGEN PIPES - CHANGE THE ROUTING POSITIONS

PILATUS
PC12
SERVICE BULLETIN

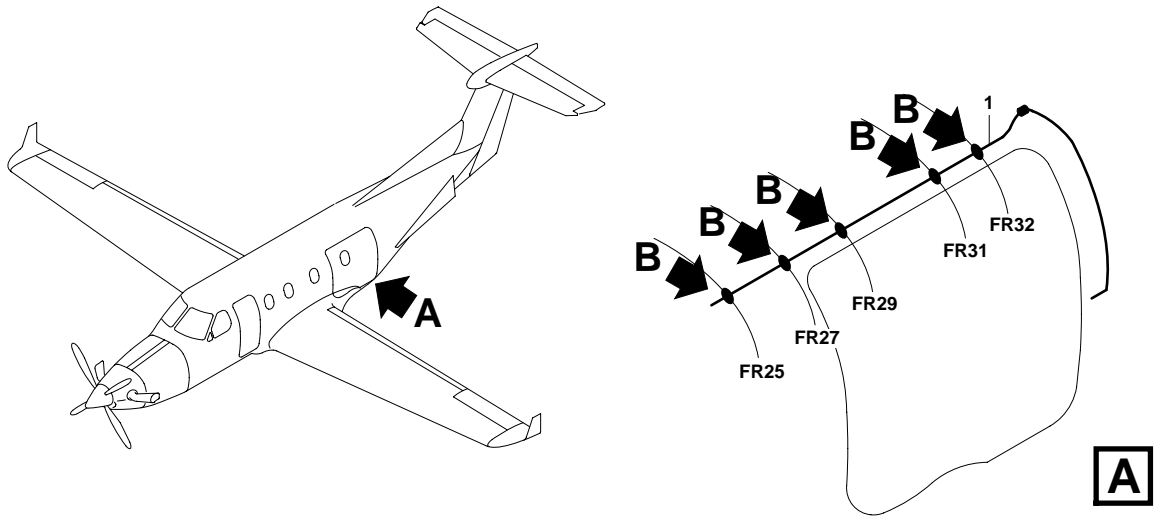
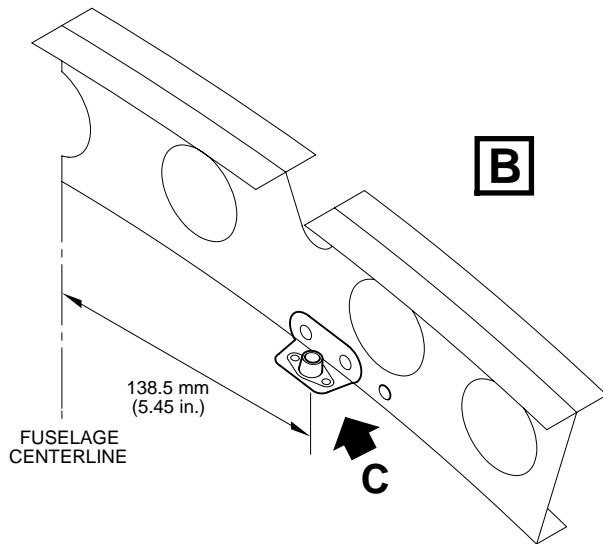
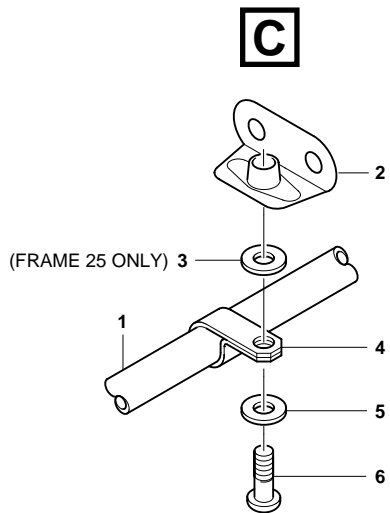
Modification of the Aft Pipe Routing
 Figure 1

It is possible for chaff damage to occur in the passenger oxygen pipe-assemblies (pipes) (535.21.12.076) and (535.21.12.054) in aircraft with executive interiors. These pipes are installed on the fuselage structure above the cabin headliner. The oxygen pipes are not pressurized at all times. The pipes are pressurized only on crew selection or automatically if the cabin pressurization fails above 13500 ft (4117 m).

The chaff damage occurs because the clearance distances are not sufficient between the pipes and some of the cabin lighting components in the headliner.

Increase the clearance distances between the pipes and the applicable lighting components to prevent the damage. To do this the pipe routing must be changed and the forward pipe (535.21.12.076) replaced.

F. Modification of the Attachment of the Aft Oxygen Pipe (Fig. 1)

This procedure is applicable only to the eight-seat oxygen system.

- (1) Obey the safety precautions given in AMM, 35-00-00, Page Block 201.
- (2) Disconnect the pipe (1) (535.21.12.054).
- (3) Remove the screws (6), washers (5), the clamps (4) and the pipe (1). On Frame 25 remove washer (3) also.

- (4) Install blanks in the open ends of all disconnected aircraft oxygen pipes.
- (5) Remove the two rivets that attach the five oxygen-pipe angle brackets (angle) (2) to Frames 25, 27, 29, 31 and 32 (Ref. SRM 51-40-01, Page Block 1). Remove the angles (2).

- (6) Move one of the angles (2) inboard and align the outer hole of the angle with the inner hole in the Frame (where you removed the rivets in Step (5)).

- (7) Install a grip pin or similar to hold the angle (2) in this location.
- (8) Use the other hole in the angle as a guide and make a mark for the new hole in the frame.

- (9) Remove the grip pin and the angle (2).
- (10) Use a 0.13 in. (3,3 mm) diameter drill to make a new hole where you made the mark at Step (8).
- (11) Do Steps (6) thru (10) for the other four Frames.

- (12) Deburr the new rivet holes you made at Step (10).
- (13) Obey the manufacturers instructions and apply a layer of Alodine 1200S (Item No. P07-001) to the bare metal of the holes in the Frames and the angles (2).

- (14) Put one of the angles (2) in position and install the two rivets (P/N: 939.17.81.018) to attach the angle to the Fame (Ref. SRM 51-40-01, Page Block 1).

- (15) Do Step (14) for the other four angles (2).

- (16) Install a rivet (P/N: 939.17.81.018) in the remaining rivet hole in Frames 25, 27, 29, 31 and 32 (Ref. SRM 51-40-01, Page Block 1).
- (17) Remove the blanks from the oxygen pipes and connectors.
- (18) Put the pipe (1) in position, turned approximately 90 degrees from the initial position and loosely connect it at each end.
- (19) Put the clamps (4) in position on the pipe (1) and install the washers (5) and the screws (6). On Frame 25, install also washer (3).
- (20) Tighten the connections of the pipe (1).
