# SERVICE BULLETIN

SERVICE BULLETIN NO: 53-004

## FUSELAGE - CENTER FUSELAGE FR21, IN THE AREA OF THE WING UPPER-ATTACHMENT LUGS - INSPECTION

(1) All PC-12 and PC-12/45 up to, and including, MSN 617.

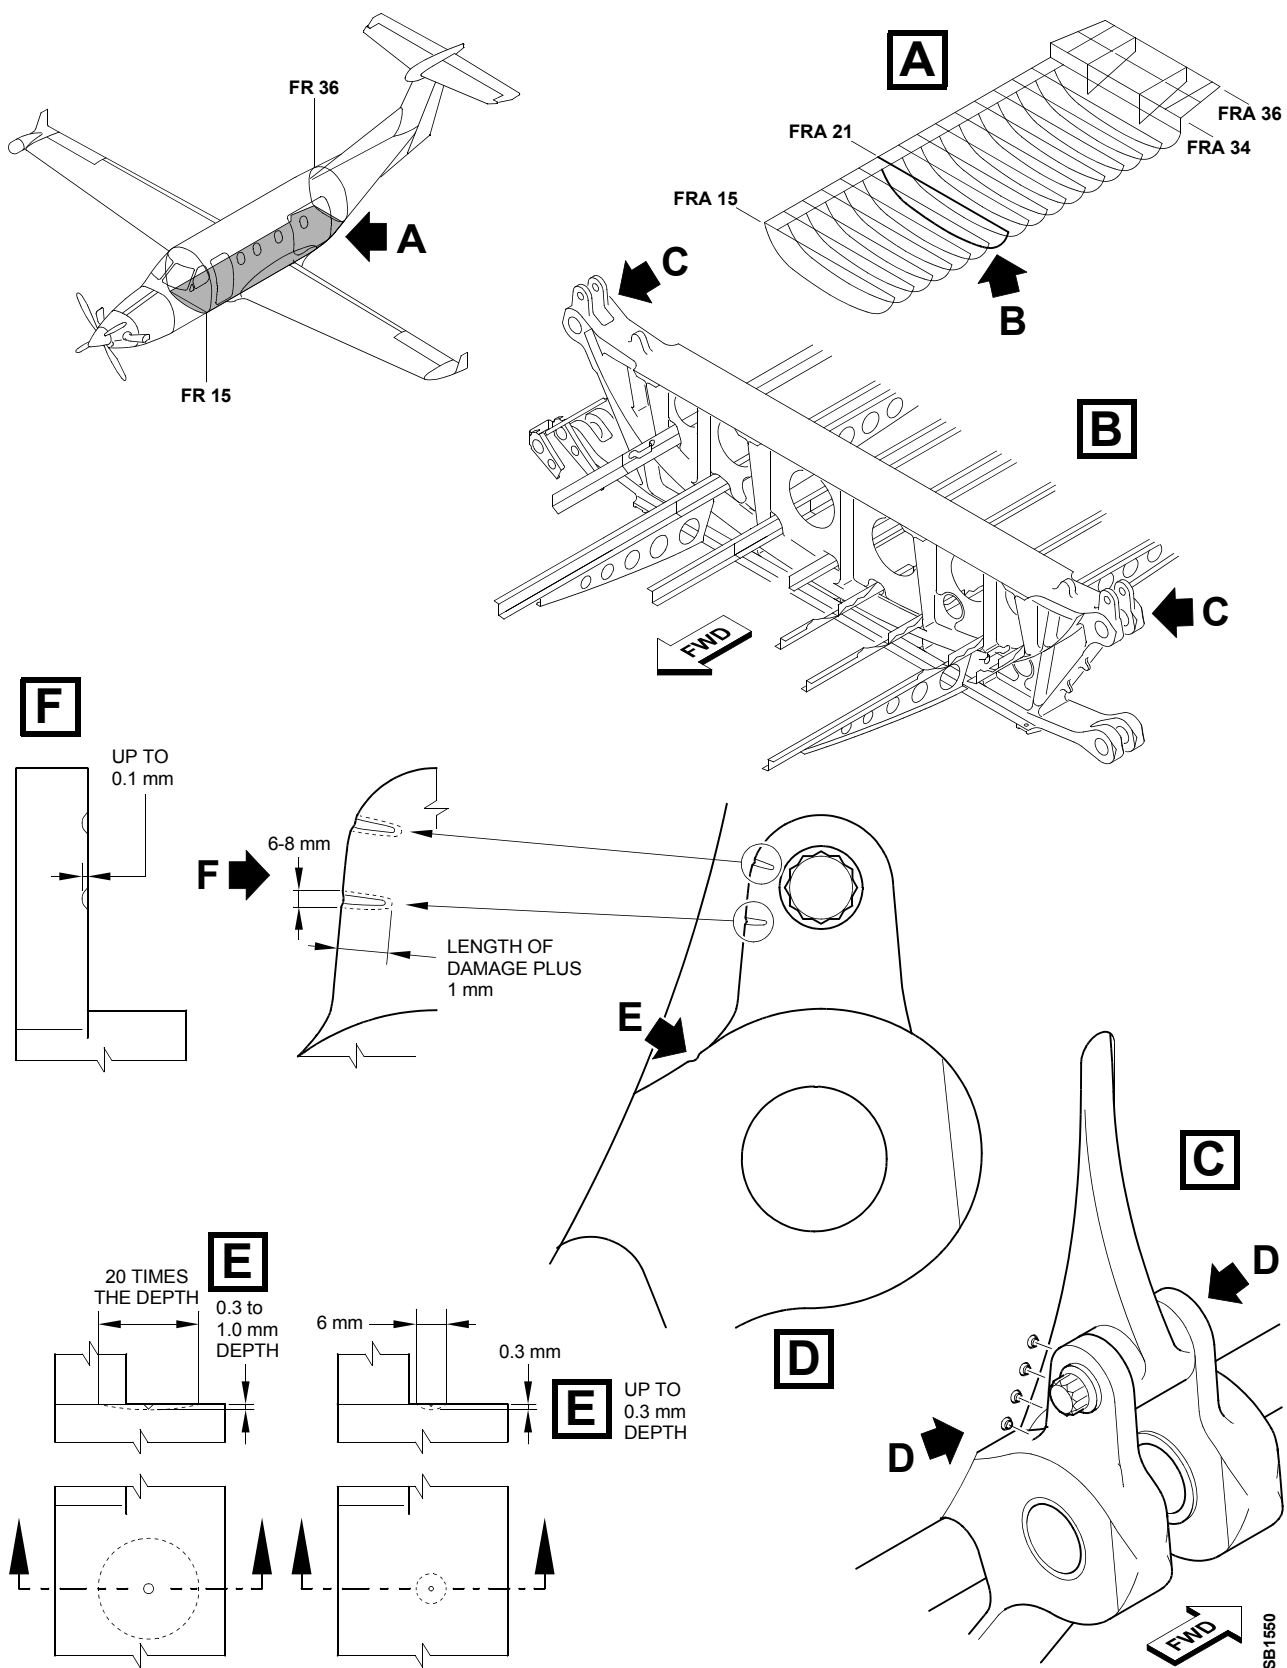
Damage Location and Repair  
Figure 1

Operators have reported that damage has been found on FR21 in the area adjacent to the wing upper-attachment lugs, left and right.

It is thought the damage occurred during assembly of the aircraft.

- (5) On the frame outer attachment-lug (Ref. Fig. 1, Detail F):
- For damage less than 0.1 mm (0.004 in.) deep, refer to Para. 3.C.(1)
  - For damage more than 0.1 mm (0.004 in.) deep refer to Para.3.C.(3).

- (6) On the top-surface of the upper-wing attachment-lug (Ref. Fig. 1, Detail E):
- For damage less than 1 mm (0.040 in.) deep (Ref. Para. 3.C.(2))
  - For damage more than 1 mm (0.040 in.), refer to Para.3.C.(3).

- (1) Repair No. 1 (On the frame outer attachment-lug, less than 0.1 mm (0.004 in.) deep)  
Ref. Fig. 1, Detail F.
- (a) Use the silicon carbide paper (Material No. P02-009), silicon carbide paper (Material No. P02-010), silicon carbide paper (Material No. P02-011), silicon carbide paper (Material No. P02-012), silicon carbide paper (Material No. P02-013), silicon carbide paper (Material No. P02-014) and the aluminum wool (Material No. P02-002) to polish the damage and make it smooth with the adjacent area.
- (b) Clean the repair area with cleaning cloth (Material No. P02-003) made moist with solvent (Material No. P01-010).
- (c) Use a brush to apply a layer of the alodine (Material No. P07-001). Let the alodine dry.
- (d) Apply a layer of the epoxy primer (Material No. 07-007).

- (2) Repair No. 2 (On the top-surface of the upper-wing attachment-lug, less than 1 mm (0.040 in.) deep)

- (a) Measure the depth of the damage.
- (b) If the damage is:
- Less than 0.3 mm (0.012 in.) deep, the polished area must be a minimum of 6 mm (0.236 in.) in diameter

- Between than 0.3 mm (0.012 in.) and 1 mm (0.040 in.) deep, the polished area must be approximately 20 times the depth of the damage, up to a maximum of 20 mm (0.787 in.) in diameter.

- (c) Use silicon carbide paper (Material No. P02-009), silicon carbide paper (Material No. P02-010), silicon carbide paper (Material No. P02-011), silicon carbide paper (Material No. P02-012), silicon carbide paper (Material No. P02-013), silicon carbide paper (Material No. P02-014) and the aluminum wool (Material No. P02-002) to polish the damage and make it smooth with the adjacent area.

- (f) Apply a layer of the epoxy primer (Material No. 07-007).
- (3) If the damage:
- On the frame outer attachment-lug is more than 0.1 mm (0.004 in.) deep (Ref. Fig. 1, Detail F)

- On the upper wing attachment-lug is more than 1.0 mm (0.040 in.) deep (Ref. Fig. 1, Detail E)
  - Is not covered by this Service Bulletin,

Contact Pilatus Aircraft. Give as much detail as you can, including photographs and sketches, to show the damage location and the size and depth of the damage.
