Service Bulletin No: 57-007

ATA Chapter: 57

**WINGS - WING-TO-FUSELAGE ATTACHMENTS
CORRECT INSTALLATION OF TORLON PLATES****1. Planning Information****A. Effectivity**

All PC-12, PC-12/45, PC-12/47 and PC-12/47E aircraft which have had a wing removed between June 2007 and May 2014.

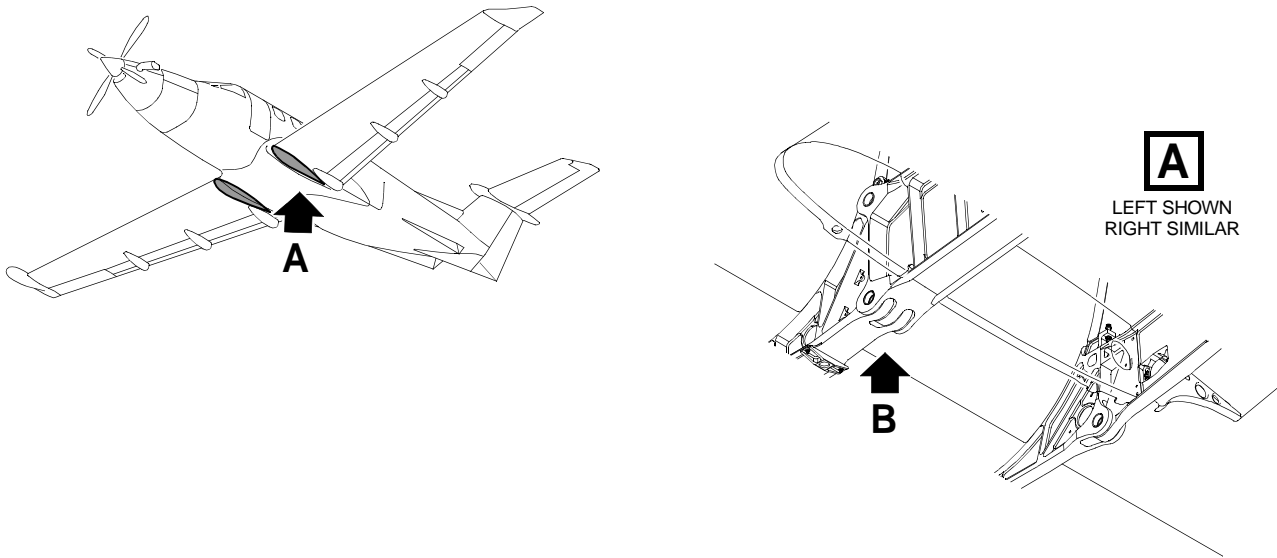
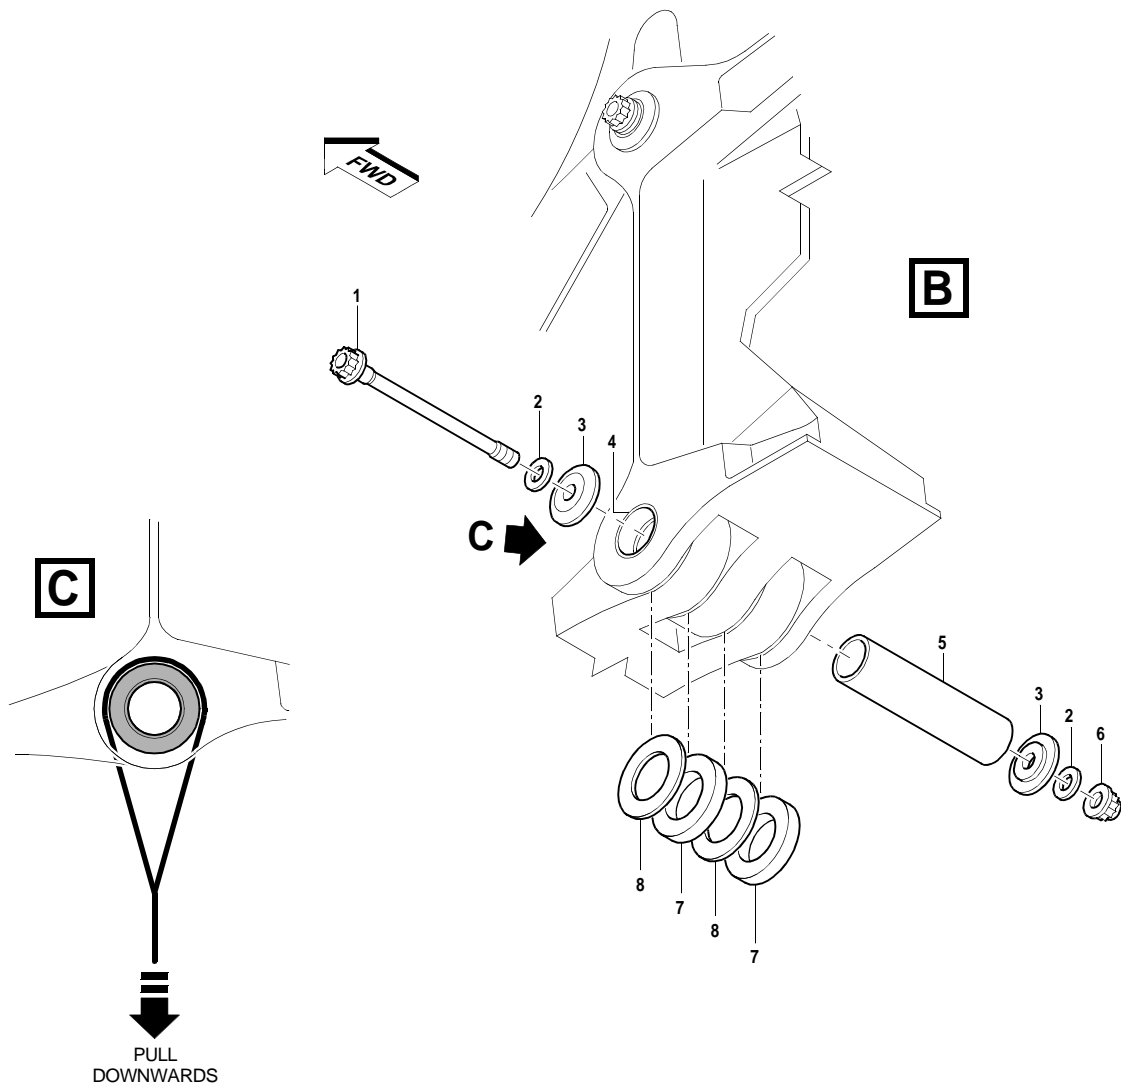
Forward Lower Wing-to-Fuselage Attachment
Figure 1

Several aircraft have been found to have the torlon plates incorrectly installed in the forward lower wing-to-fuselage attachment.

Incorrect sequence of torlon plates in the forward lower wing-to-fuselage attachment.

- (1) Inspect the sequence of torlon plates in the left and the right wing lower main spar to fuselage attachment. The sequence of torlon plates in the lower joint from forward to aft must be thin, thick, thin, thick.

NOTE: The thin torlon plates are 2,0 mm thickness, the thick torlon plates are 4,0 mm thickness.

Inspect and if necessary remove and install the torlon plates in the correct sequence.

- (6) Adjust the hydraulic jack to hold the weight of the left wing.
- (7) Refer to AMM 57-00-00-00A-520A-A (aircraft with hydraulic landing gear) or 57-00-00-00A-520B-A (aircraft with electro mechanical landing gear) and Figure 1. At the forward lower wing-to-fuselage attachment remove the nut (6), the washers (2 and 3), the tension bolt (1) and the long bolt (5).

- (10) Use pliers and pull the sling downwards to slide the torlon plate (8) out of the attachment fittings (this may take significant hand force).
- (11) Do steps (8) thru (10) again to remove the other torlon plates from the attachment joint. It may not be necessary to use screwdriver to remove the other torlon plates.

- (14) Examine the torlon plates (7 and 8). If the torlon plates are not damaged they can be re-used.
- (15) Refer to AMM 57-00-00-00A-720A-A (aircraft with hydraulic landing gear) or 57-00-00-00A-720B-A (aircraft with electro mechanical landing gear) and Figure 1. Install the forward lower long bolt and the torlon plates in the wing-to-fuselage attachment. Make sure the torlon plates are installed in the correct sequence.

NOTE: Use a new tension bolt (1) (P/N 557.10.12.055) and nut (6) (P/N 938.09.14.306) when you install the forward bottom long bolt (5).
