Service Bulletin No: 71-009

ATA Chapter: 71

**POWER PLANT - ENGINE MOUNTING FRAME
ULTRASONIC INSPECTION OF SWAGED TUBE ENDS****1. Planning Information****A. Effectivity**

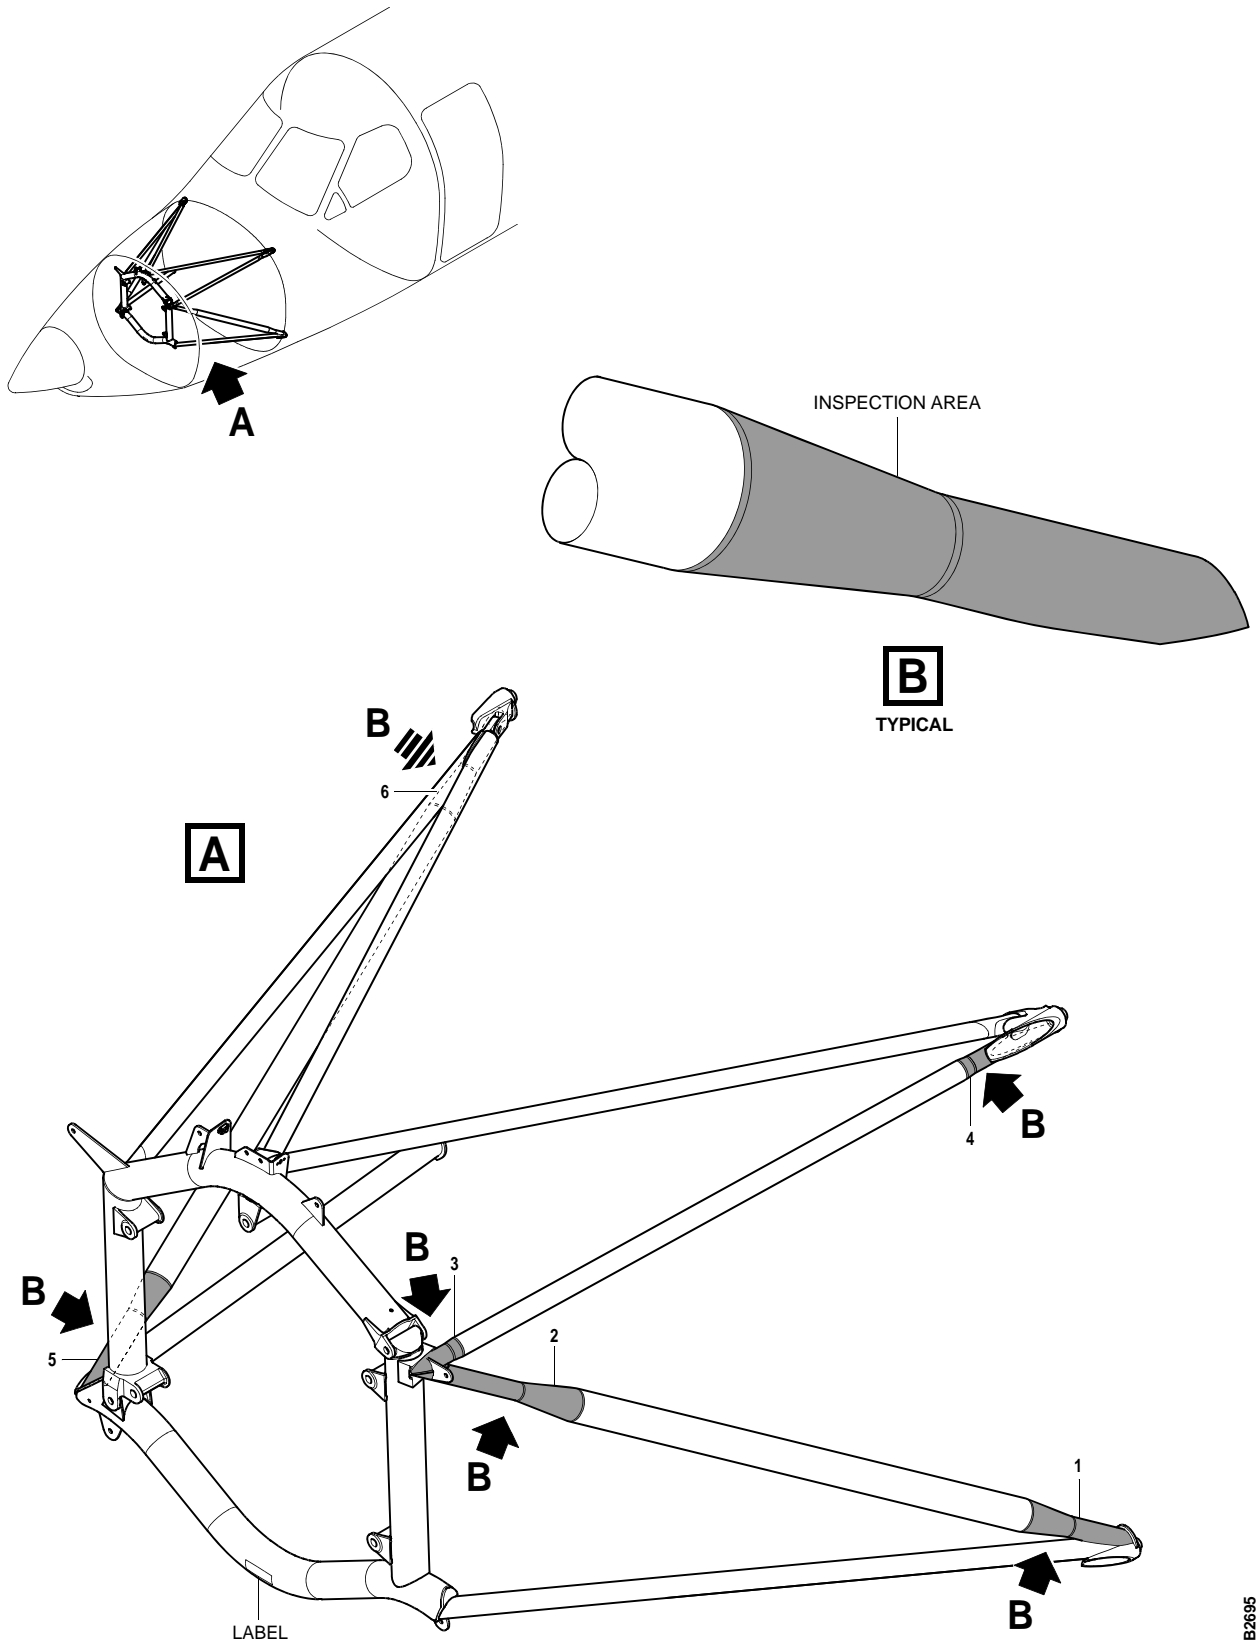
Engine Mounting Frame Assembly Inspection Areas
Figure 3

NOTE: This inspection procedure is valid for the six inspection locations on the swaged tube ends of the engine mounting frame assembly, refer to Figure 3.

- 1 Apply the coupling medium to the inspection location surface area (1), refer to Figure 3.
- 2 Do the equipment calibration 3.B.(1)(b).
- 3 Use the Direct Scan and do an ultrasonic inspection of the swaged tube area (1).
