Service Bulletin No: 27-026

**FLIGHT CONTROLS - FLAP DRIVE SYSTEM - INSPECTION OF THE INBOARD FLAP FAIRINGS AFT AND THE FRONT INBOARD TENSION RODS****1. Planning Information****A. Effectivity**

PC-12/47E aircraft MSN 1819 thru 1843 and 1845 thru 1854 only.

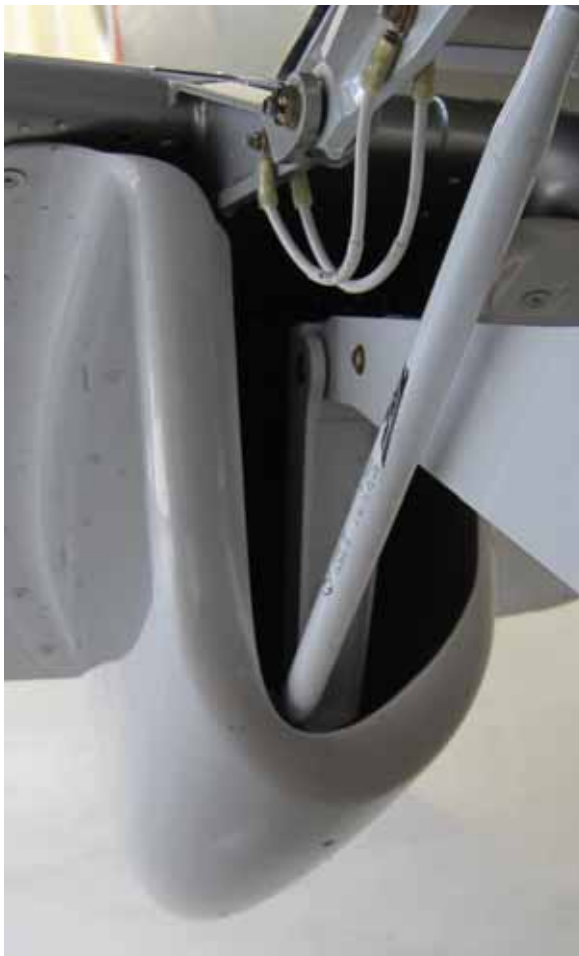
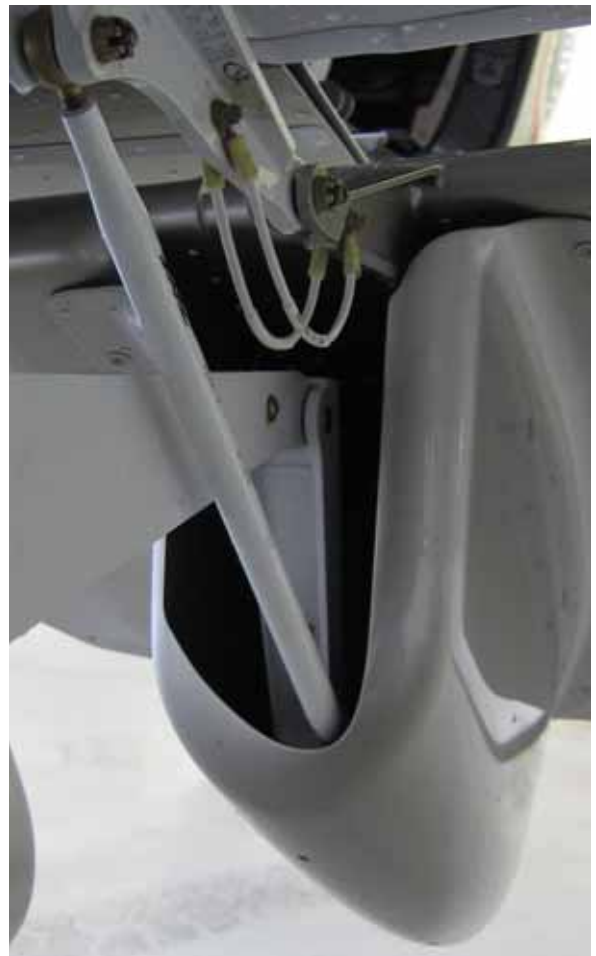
Correct Contours - Inboard Flap Fairing Aft  
Figure 2

- (1) Do an inspection of the left and right IFFA to determine if the contour is the correct shape:
  - Figure 2 shows the correct (non symmetrical) contours of the left and right IFFA
  - Figure 3 shows the incorrect (symmetrical) contours of the left and right IFFA.
- (2) If the left and right IFFAs each have the correct contours as shown in Figure 2, do step 3.D.Close Up.
- (3) If the left or the right IFFA has incorrect contours as shown in Figure 3, do step 3.C.Modification.

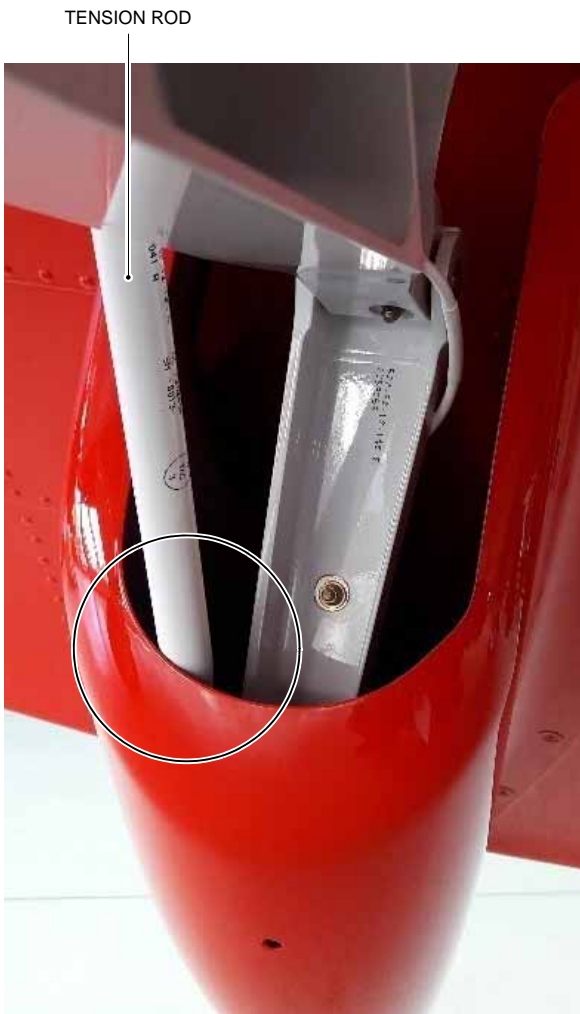
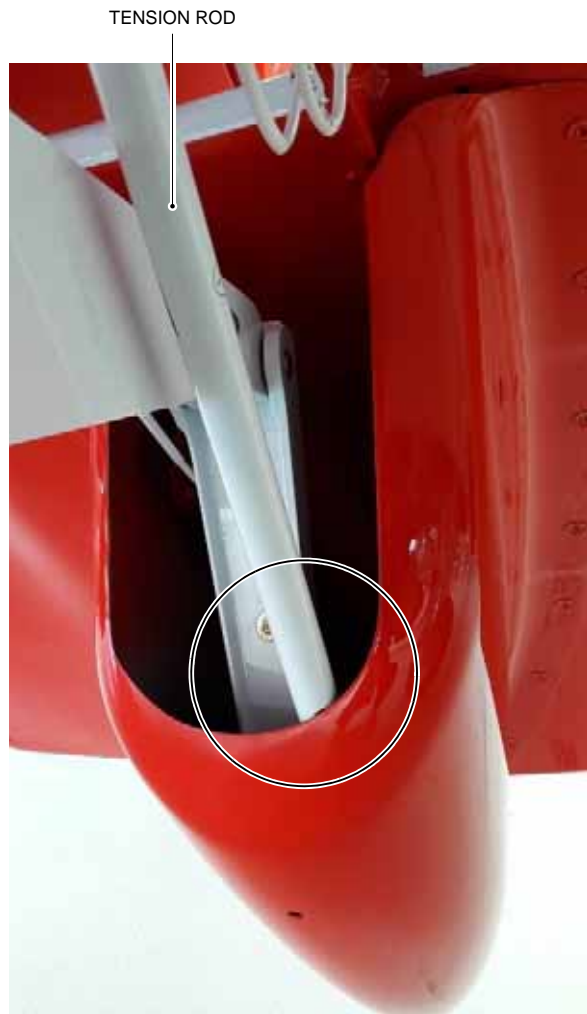
Incorrect Contours - Inboard Flap Fairing Aft  
Figure 3

Chafing can occur between the left or right Inboard Flap Fairing Aft (IFFA) (P/N 557.52.12.223 and 557.52.12.224) and the left or right front inboard tension rod (P/N 527.52.12.135).

For the affected aircraft, IFFAs with an incorrect contour were possibly installed on new production aircraft. This could cause interference between the IFFAs and the tension rods due to incorrect clearance. No affected IFFAs were supplied to operators as spares.

Do an inspection of the shape of the left and right IFFA contours and modify them if necessary. Examine the tension rods and replace them if there is chafing damage.

- (a) Examine the tension rod of the related left and/or right IFFA [1] for chafe damage.
  - (b) If chafe damage is found, replace the tension rod, refer to AMM 12-B-27-51-01-00A-920A-A.
- (13) Install the IFFA [1] with the screws [2] and washers [3].
