Service Bulletin No: 28-015

ATA Chapter: 28

**FUEL - STORAGE
APPLICATION OF CHROMATE CONVERSION COATING TO INWARD VENT VALVE****1. Planning Information****A. Effectivity**

SERVICE BULLETIN

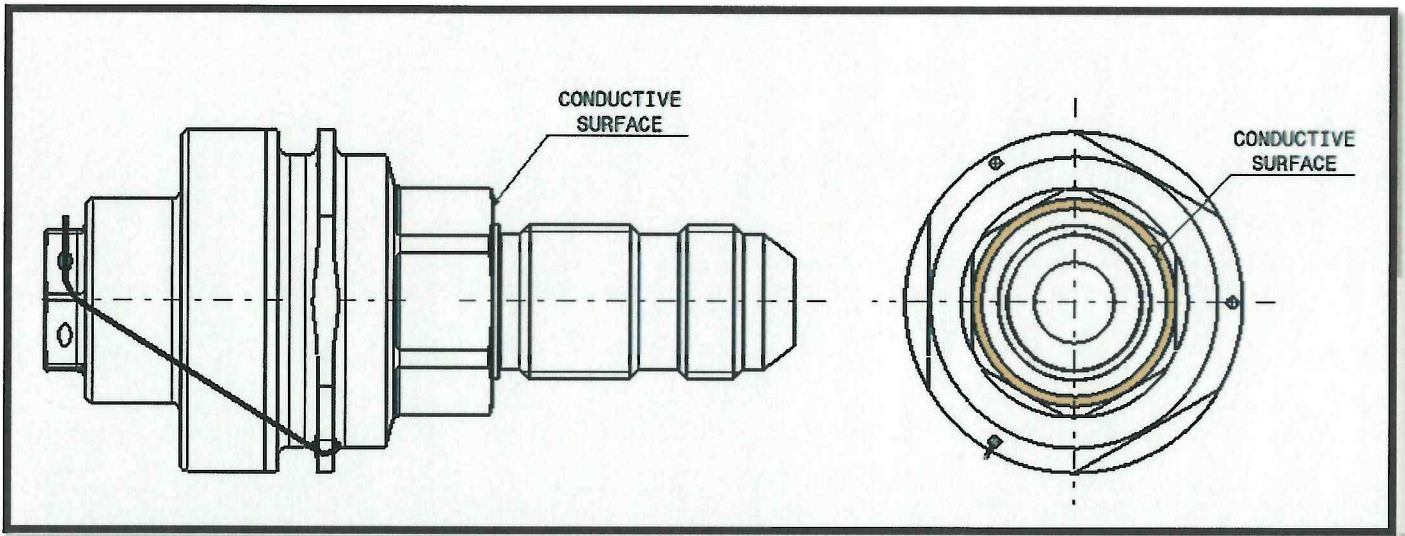
Fig 1. Location of the conductive surface on the valve body.

Some valves have been identified by the vendor (Pall Aerospace) with this chromate conversion coating omitted during manufacture.

Lack of discrete routing operation to apply this coating during equipment manufacture.

The conductive surface on the valve is identified in Fig 1 and Fig 1A.

- A. VERY LIGHTLY ABRADE CONDUCTIVE SURFACE (FIG 1) USING FINE GRADE ABRASIVE PAPER SCOTCH-BRITE TYPE A OR ABRASIVE PAPER (320 GRADE).
IF ADJACENT AREA IS INADVERTENTLY ABRADED, APPLY CCC PER THIS REWORK PROCEDURE.
- B. REMOVE ANY ABRADED DEBRIS USING USE A LINT-FREE CLOTH MADE MOIST WITH THE SOLVENT OR ETHANOL TO CLEAN THE ABRADED SURFACE AND ADJACENT AREA.

- D. CLEAN CONDUCTIVE SURFACE USING A LINT-FREE CLOTH MADE MOIST WITH THE SOLVENT OR ETHANOL.
- E. USE A BRUSH, NYLON (ACID RESISTANT) AND QUICKLY APPLY A SMOOTH CONTINUOUS LAYER OF CCC TO THE BARE METAL SURFACE. APPLY THE COATING ONLY TO THE BARE METAL SURFACE AS PER FIG 1 AND FIG 1A.
