SERVICE BULLETIN NO: 32-020

ATA CHAPTER: 32

LANDING GEAR - MAIN LANDING GEAR SPECIAL BOLTS - INSPECTION AND REPLACEMENT

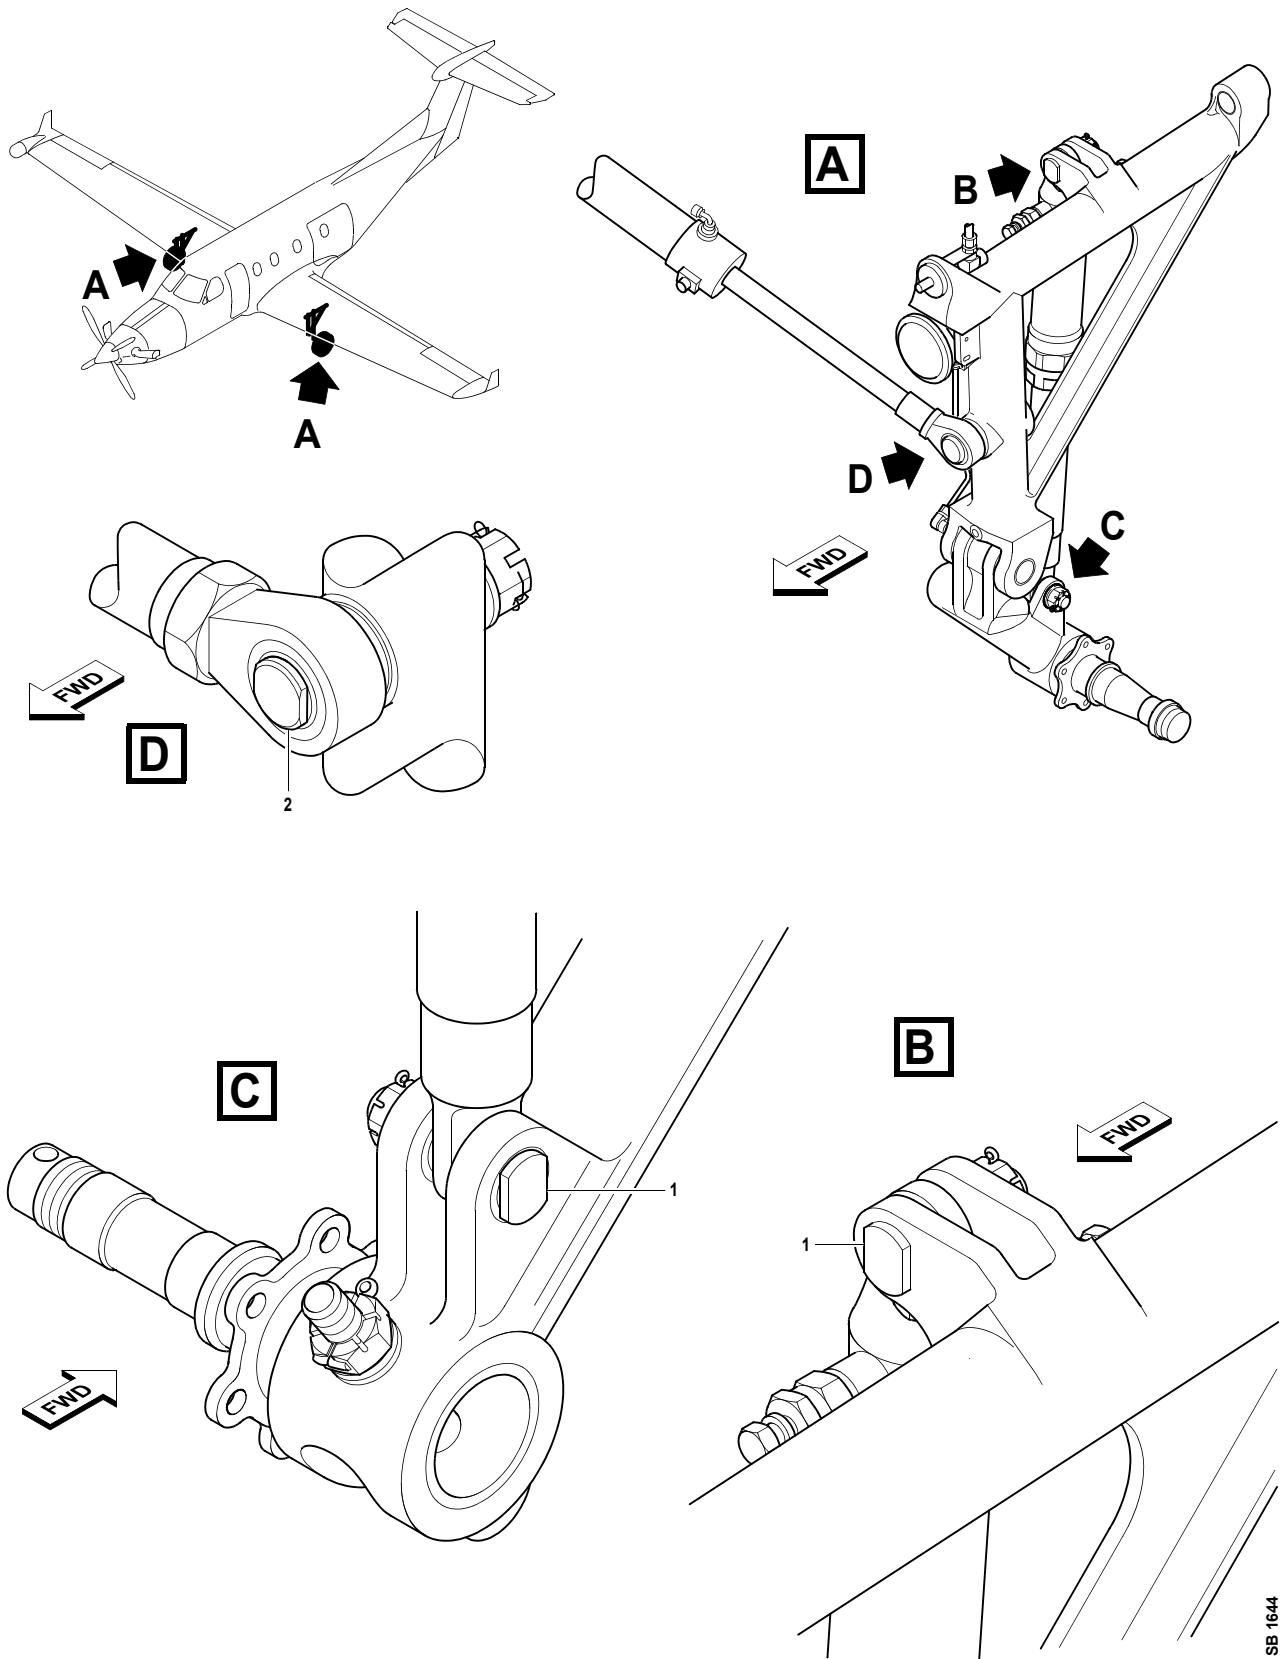
Special Bolts - Inspection
Figure 1

It is possible for some bolts of the MLG assemblies to be defective. The problem is only applicable to specific bolts with serial numbers that start with the letters AT or have the supplier code AT. If the bolt is not marked or has a mark other than AT (for example VLG), the bolt is not affected.

It is known that it is possible for hydrogen embrittlement to occur during the manufacture of the special bolts.

- (1) Do a check of the special bolts (2) that attach the MLG retraction actuators to the MLG assemblies for serial numbers that start with the letters AT. If you find a special bolt (2) with a serial number that starts with the letters AT, replace the bolt (Ref. 3. B.).

NOTE: On affected bolts, the serial number is permanently marked on the bolt head.

- (2) Do a check of the special bolts (1) that attach the shock absorbers to the MLG assemblies for supplier code AT. If you find a special bolt (1) with a supplier code AT, replace the special bolt (Ref. 3. B.).

NOTE: On affected bolts, the supplier code is permanently marked on the threaded (tail) end of the bolt.

Unless already accomplished at initial issue of this Service Bulletin, do a check of all special bolts that have serial numbers that start with the letters AT or have the supplier code AT and replace them.

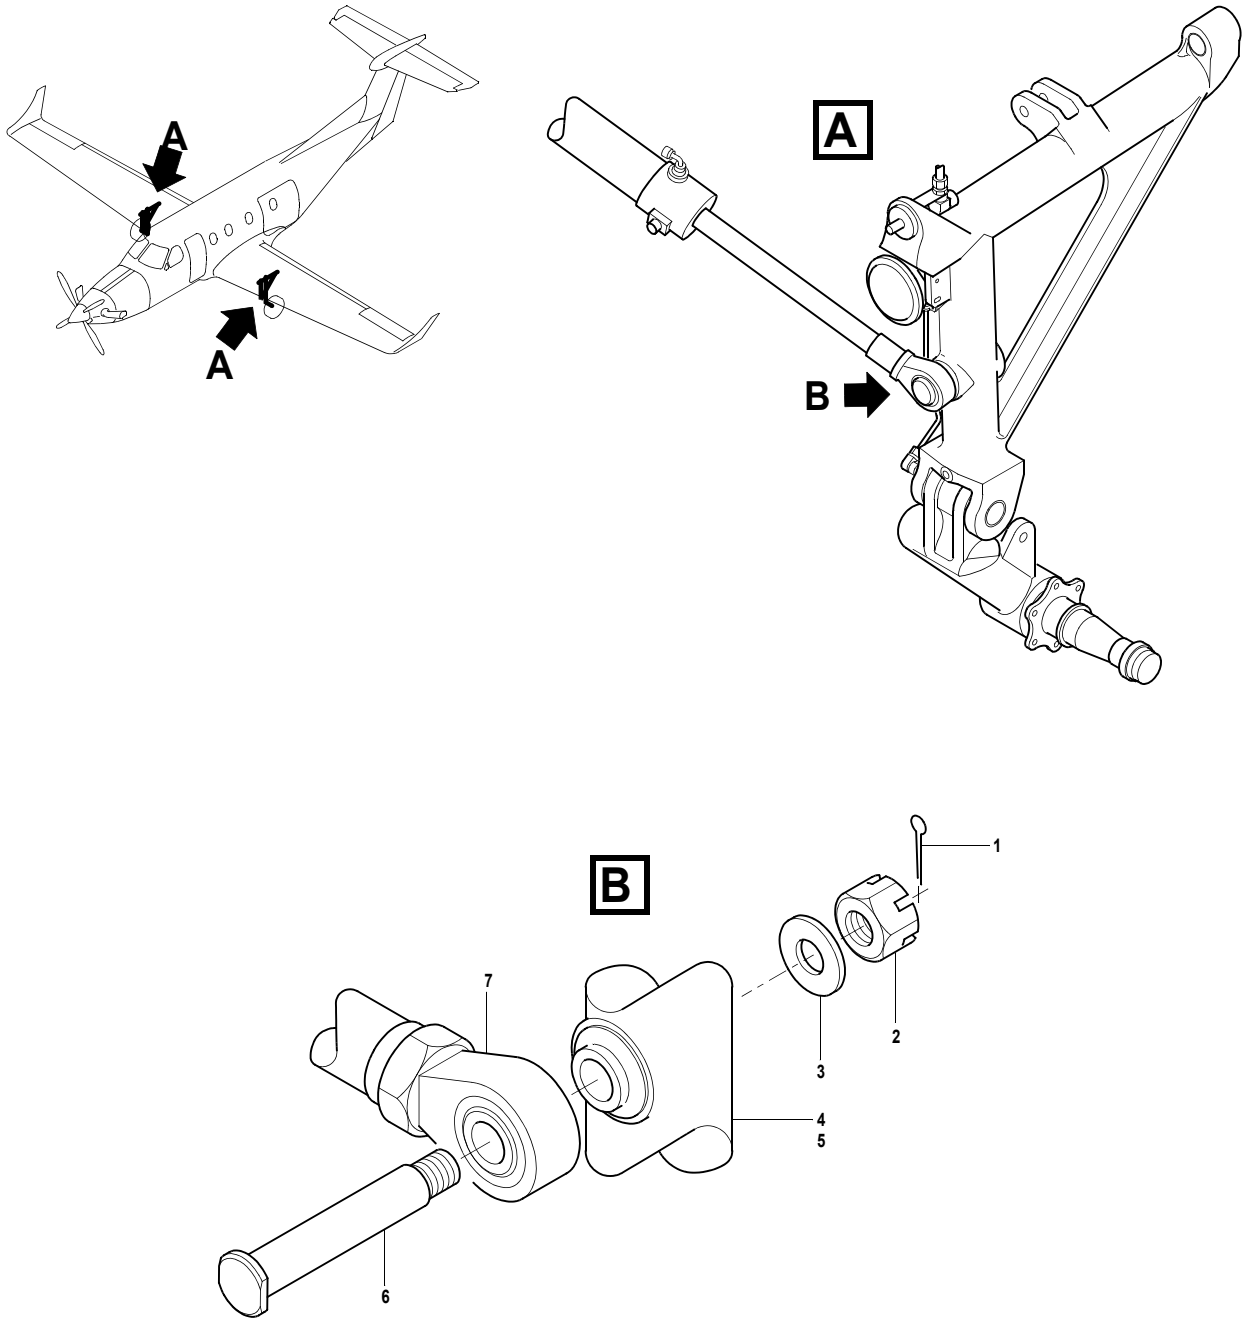
Retraction Actuator - Special Bolt - Replacement
Figure 2

NOTE: This procedure is only necessary if you found a special bolt that has a serial number that starts with the letters AT (Ref. 3. A. (1)).

- (a) From the applicable bolt, remove the cotter pin (1), the nut (2), the washer (3) and the bolt (6) and disconnect the actuator (7) from the left MLG assembly (4). Discard the cotter pin (1), the nut (2) and the washer (3).

- (b) Send the bolt (6) to PILATUS.
 - (c) Use the cloth (Material No. P02-003) made moist with the solvent (Material No. P01-008) and clean the bolt holes in the MLG assembly (4) and eye end of the actuator (7).

- (d) Apply layers of the corrosion preventative (Material No. P04-012) on the faying surfaces of the new bolt (6), the eye end of the actuator (7) and the MLG assembly (4).

- (e) Align the eye end of the actuator (7) with the bolt hole in the MLG assembly (4). Put the new bolt (6) in position.
 - (f) Put the new washer (3) on the bolt (6) and install the new nut (2).

- (g) Torque the nut (2) to between 1800 and 2000 lbf in. (200 and 220 Nm). (Ref. AMM, 20-20-01, Page Block 1).
 - (h) Use the cloth (Material No. P02-003) made moist with the solvent (Material No. P01-008) and remove the unwanted corrosion preventative (Material No. P04-012).

- (i) Install the new cotter pin (1) (Ref. AMM, 20-20-00, Page Block 1).
 - (j) Do Steps 3. B. (2)(a) thru (i) again for the right MLG assembly (5) if the special bolt fails the inspection (Ref. 3. A. (1)).

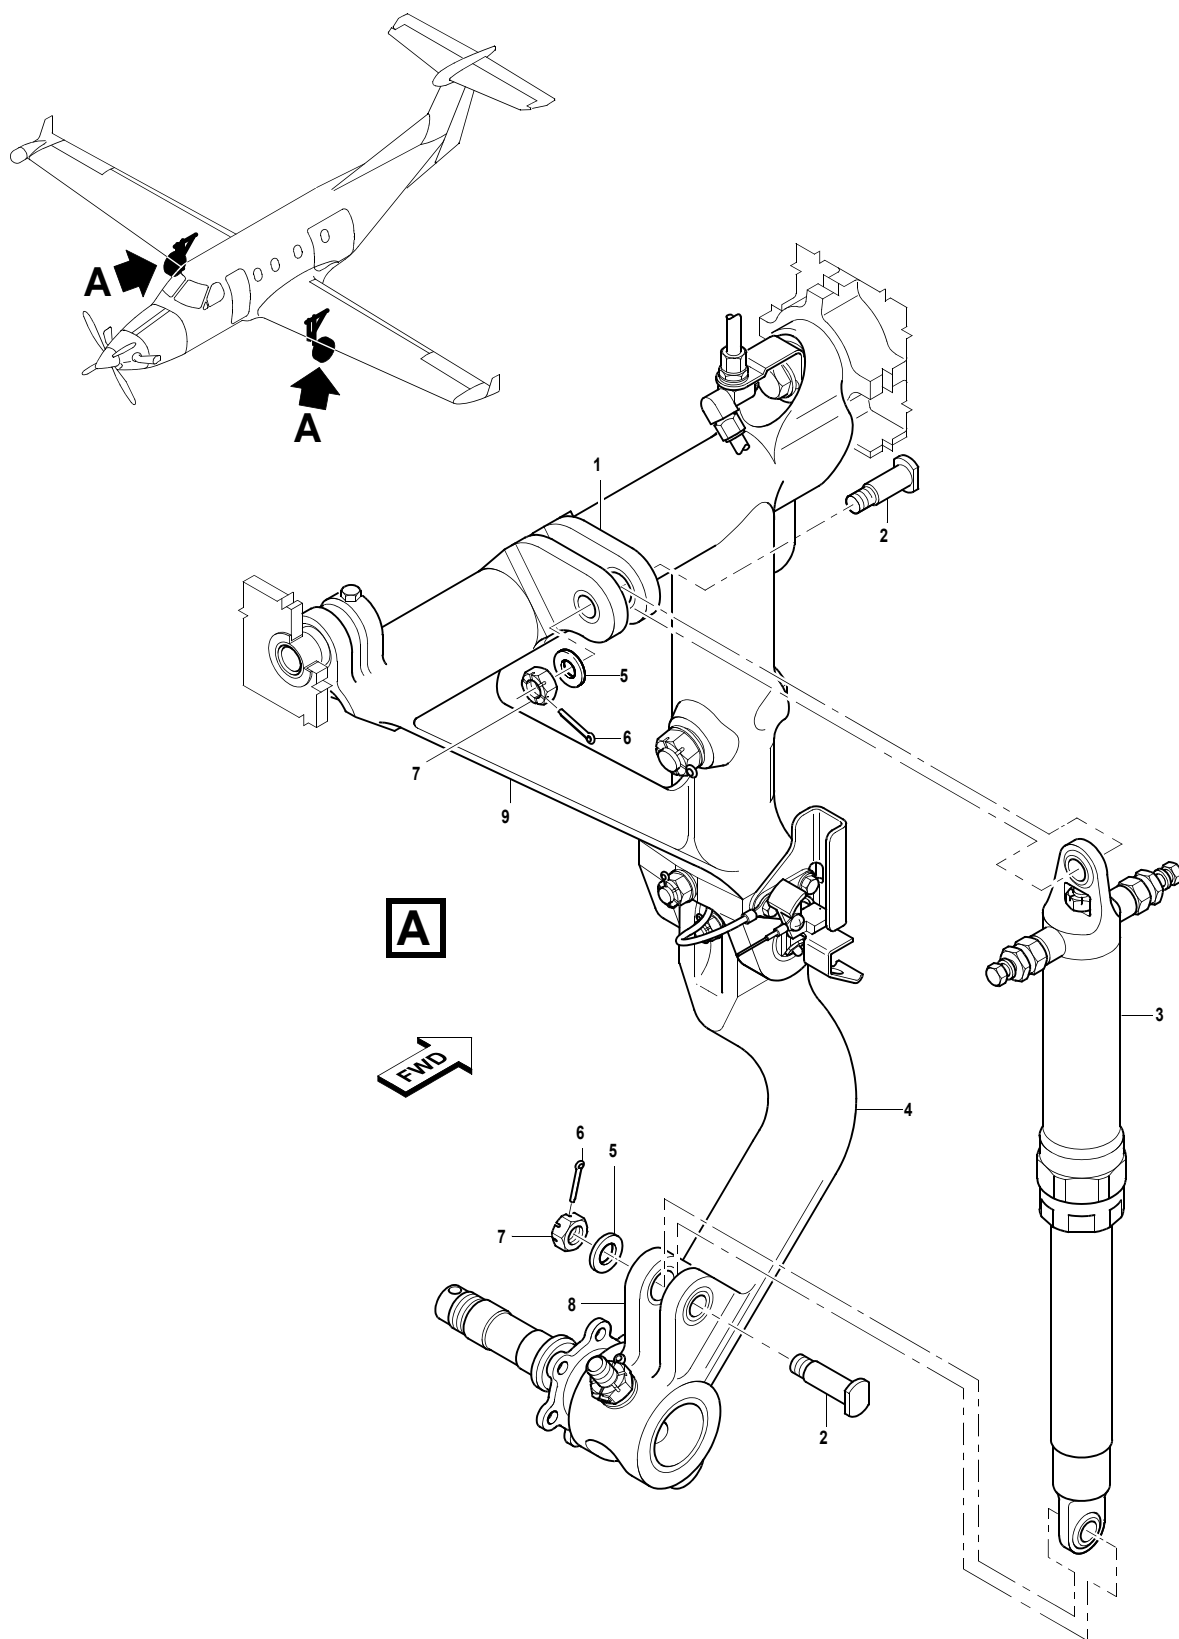
Shock Absorber - Special Bolt - Replacement
Figure 3

NOTE: This procedure is only necessary if you found a special bolt that has supplier code AT (Ref. 3. A. (2)).

- (a) From the applicable bolt, remove the cotter pin (6), the nut (7) the washer (5) and the special bolt (2). Discard the cotter pin (6).
- (b) Send the special bolt (2) to PILATUS.
- (c) Use the cloth (Material No. P02-003) made moist with the solvent (Material No. P01-008) and clean the bolt holes in the MLG assembly (4) and the upper and/or lower eye end of the shock absorber (3).
- (d) Apply layers of the corrosion preventative (Material No. P04-012) on the faying surfaces of the new bolt (2), the upper and/or lower eye end of the shock absorber (3) and the MLG assembly (4).

- (e) Make sure the shock absorber (3) is in the correct position.
 - (f) Put the new special bolt (2) in position and install the washer (5) and the nut (7).
 - (g) Use the cloth (Material No. P02-003) made moist with the solvent (Material No. P01-008) and remove the unwanted corrosion preventative (Material No. P04-012).
 - (h) Install the new cotter pin (6) (Ref. AMM, 20-20-00, Page Block 1).
 - (i) Do Steps 3. B. (3)(a) thru (h) again for each special bolt that fails the inspection (Ref. 3. A. (2)).
- (4) Close-Up
- (a) Make sure the landing-gear operating lever is set to DOWN.
 - (b) Close the circuit breakers:
