Service Bulletin No: 27-022

ATA Chapter: 27

**FLIGHT CONTROLS - AILERON CONTROL SYSTEM  
REPLACEMENT OF THE UNIVERSAL JOINTS IN THE FLIGHT CONTROLS****1. Planning Information****A. Effectivity**

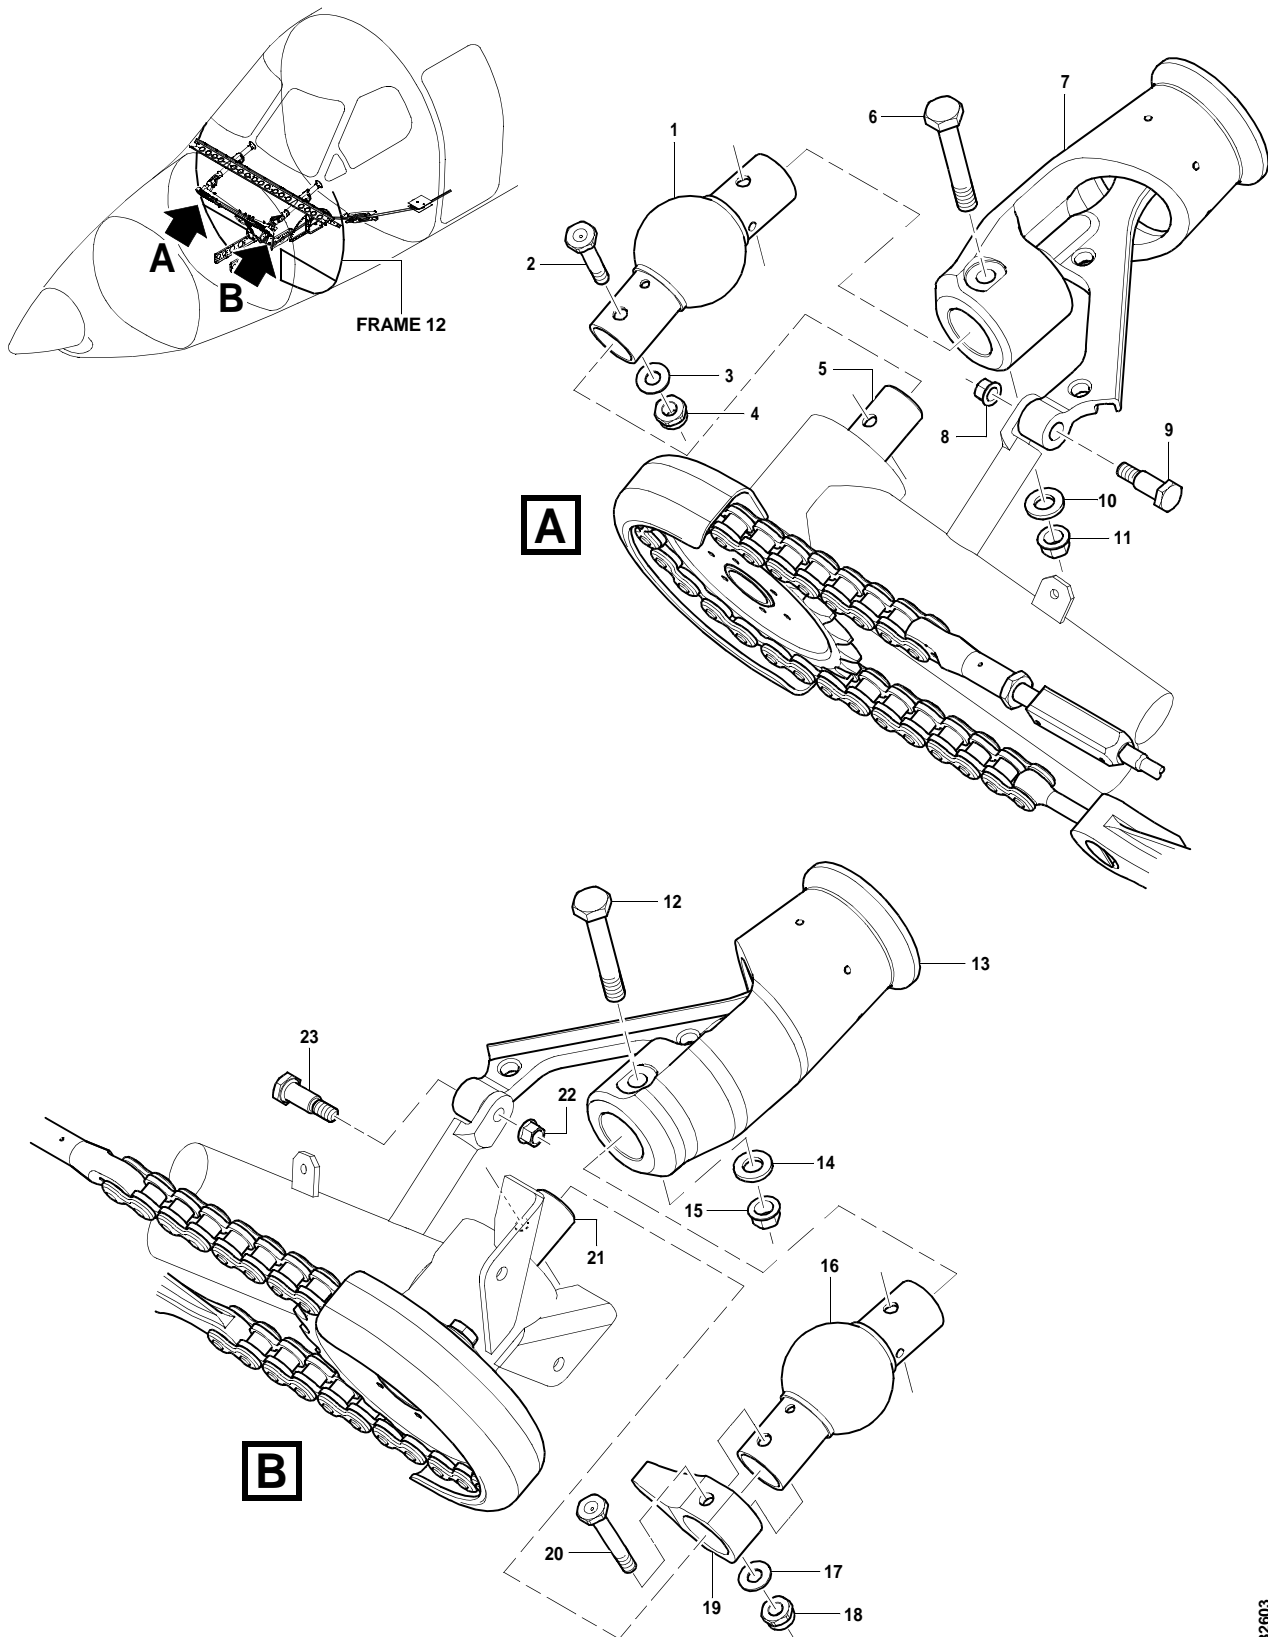
Universal Joint - Removal/Installation  
Figure 1

A universal joint installed between the control tube assembly and the control column malfunctioned.

Replace the universal joints, as defined in 1. A., with new parts ordered from Pilatus.

- (1) Remove the nut (22) and the bolt (23).
- (2) Remove and discard the nut (15), washer (14) and the bolt (12).
- (3) Remove and discard the nut (18), washer (17) and the bolt (20).
- (4) Move back the control wheel and remove the universal joint (16) (P/N 527.10.12.195) from the control tube assembly (13) and the control column (21).
- (5) Remove the stop block (19) from the universal joint.

- (1) Apply corrosion preventive (Material No. P04-039) to the internal surface of the stop block (19).
- (2) Apply corrosion preventive (Material No. P04-039) to the mating surfaces of the control tube assembly (13) the control column (21) and the new universal joint (16) (P/N 527.10.12.195).
- (3) Put the stop block (19) on the universal joint (16) (P/N 527.10.12.195) and align the holes.
- (4) Install the new universal joint (16) (P/N 527.10.12.195) to the control column (21).
- (5) Install the control tube assembly (13) to the universal joint (16) (P/N 527.10.12.195) and align the holes.
- (6) Install the new bolt (20) (P/N 932.35.14.016), washer (17) (P/N 938.77.11.112) and the nut (18) (P/N 938.07.68.304).

- (7) Install the new bolt (12) (P/N 932.19.60.814), washer (14) (P/N 938.77.11.115) and the nut (15) (P/N 938.07.68.505).
- (8) Install the bolt (23) and the nut (22).
- (9) Torque the nuts to the standard torque values, refer to AMM 12-B-20-20-01-00A-040A-A.

- (1) Remove the nut (8) and the bolt (9).
- (2) Remove and discard the nut (11), washer (10) and the bolt (6).
- (3) Remove and discard the nut (4), washer (3) and the bolt (2).
- (4) Move back the control wheel and remove the universal joint (1) (P/N 527.10.12.195) from the control tube assembly (7) and the control column (5).

- (1) Apply corrosion preventive (Material No. P04-039) to the mating surfaces of the control tube assembly (7) the control column assembly (5) and the new universal joint (1) (P/N 527.10.12.195).
- (2) Install the new universal joint (1) (P/N 527.10.12.195) to the control column (5).
- (3) Install the control tube assembly (7) to the universal joint (1) (P/N 527.10.12.195) and align the holes.
- (4) Install the new bolt (2) (P/N 932.35.14.012), washer (3) (P/N 938.77.11.112) and the nut (4) (P/N 938.07.68.304).
- (5) Install the new bolt (6) (P/N 932.19.60.814), washer (10) (P/N 938.77.11.115) and the nut (11) (P/N 938.07.68.505).
- (6) Install the bolt (9) and the nut (8).
- (7) Torque the nuts to the standard torque values, refer to AMM 12-B-20-20-01-00A-040A-A.
