Service Bulletin No: 76-002

ATA Chapter: 76

**ENGINE CONTROLS - POWER CONTROL
CHECK THE POWER CONTROL LEVER REVERSE THRUST LATCH FOR STICKING****1. Planning Information****A. Effectivity**

PC-12/47E Aircraft, MSN 1001, 1003 to 1140.

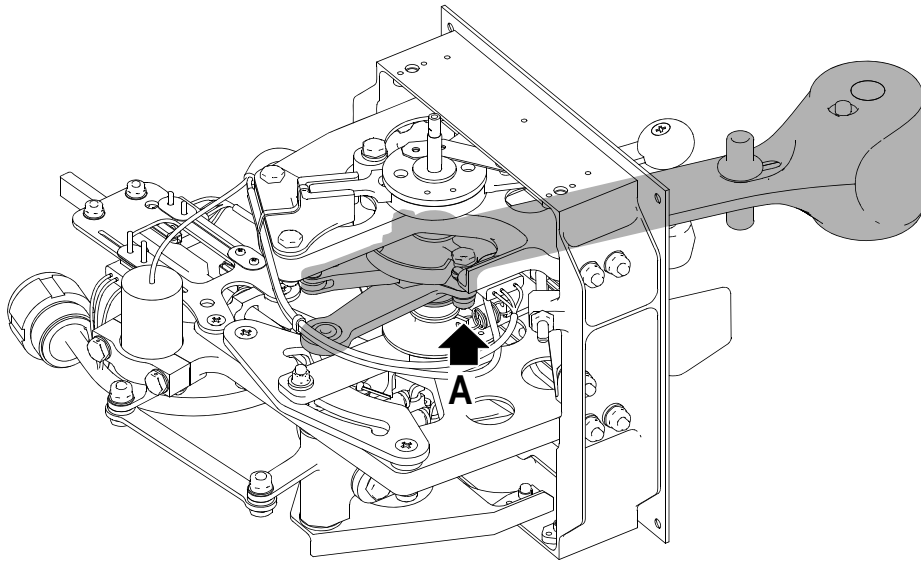
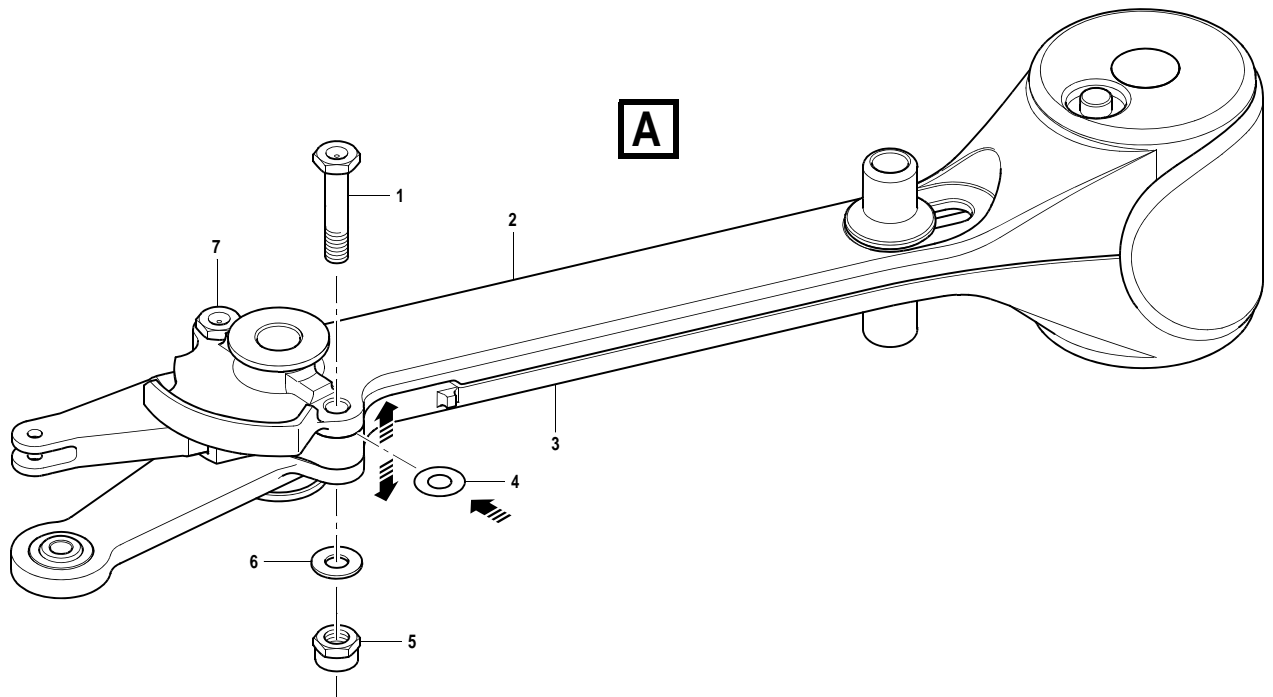
Power Control Lever - Modification
Figure 2

Field reports have been received that, if the Power Control friction wheel is tightened, the reverse thrust latch may stick and allow the Power Control Lever to be inadvertently retarded aft of the Idle detent.

Revision 1 to this Service Bulletin corrects Figure 2 to show the correct installation of the washer in the Power Control Lever. It also adds a copyright paragraph. Customers who have already incorporated Part 2 of this Service Bulletin at initial issue must make sure that the washer is correctly installed in the Power Control Lever. This can be confirmed either by a visual inspection, or by carrying out Paragraph 3.A Part 1 again.

- (a) Move the PCL to the full REVERSE position.
- (b) Make a note of the position and remove the cable tie that holds the electrical loom to the PCL.
- (c) Loosen the bolt and nut (7, Fig 2) two to three turns.
- (d) Remove the nut (5, Fig 2) and washer (6, Fig 2).
- (e) Move the bolt (1, Fig 2) out of the PCL to give access to install the washer in the next step.

- (f) Use a small plastic wedge to separate the PCL halves (2, Fig 2) and (3, Fig 2) enough to slide the new washer (4, Fig 2) (P/N 938.77.81.012) into position between the two PCL halves to engage on the bolt (1, Fig 2).

- (g) Remove the plastic wedge.
- (h) Install the bolt (1, Fig 2), washer (6, Fig 2) and nut (5, Fig 2).
- (i) Tighten the bolt and nut (7, Fig 2).
- (j) Install a cable tie (Material P09-005) to hold the electrical loom on the PCL as noted in step (b).
