SERVICE BULLETIN NO: 27-020

FLIGHT CONTROLS - ELEVATOR CONTROL SYSTEM DO A CHECK OF THE TENSION ON THE STICK-PUSHER SERVO-CABLES

All PC-12, PC-12/45, PC-12/47 MSNs 101 thru 544 and MSNs 546 thru 888, and PC-12/47E MSN 545 and MSNs 1001 thru 1101.

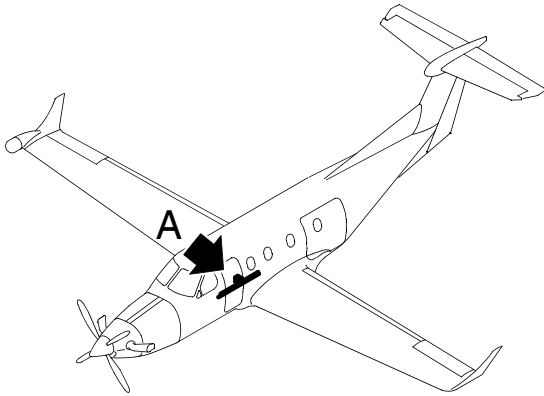
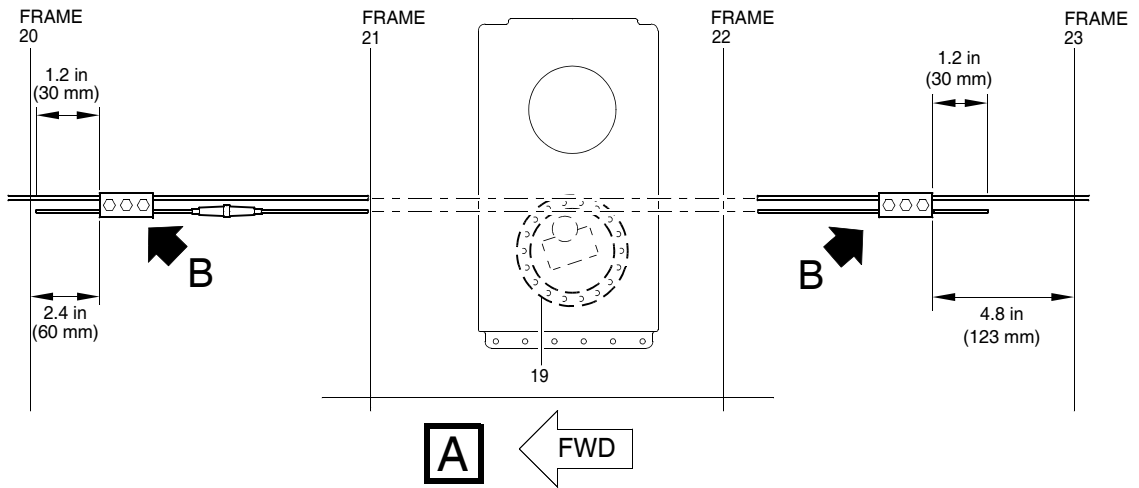
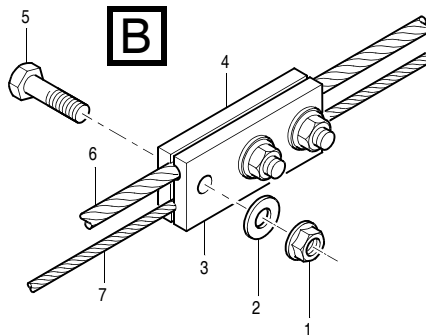
Replacement of the Attachment Hardware and Location of the Cable Clamps
Figure 1

Some Operators have reported that the stick-pusher servo-cables are loose.

Ambiguous information in the adjustment procedure for the stick-pusher cable tension.

(3) If the stick-pusher servo-cables are not at the correct tension, look for signs that the cables have moved in the cable clamps (3) and (4) installed between FR20 and FR23.

(4) If there are signs that the stick-pusher servo-cables have moved in the cable clamps (3) and (4) installed between FR20 and FR23:

CAUTION: THE ELEVATOR CABLE (6) HAS A LARGER DIAMETER THAN THE STICK-PUSHER SERVO-CABLE (7) AND MUST BE INSTALLED IN THE LARGER GROOVE OF THE CLAMPS (3) AND (4).

- (a) Remove the two locking clips from the turnbuckle that connects the two stick-pusher servo-cables. Discard the locking clips.
- (b) Loosen, but do not disconnect the turnbuckle.
- (c) Remove and discard the nuts (1), the washers (2) and the bolts (5) from the forward and aft cable clamps (3) and (4).
- (d) Remove and discard the cable clamps (3) and (4).

- (e) Examine the cables (6) and (7) adjacent to the position where you removed the cable clamps (3) and (4) (Ref. AMM 12-A-27-00-00-00A-313A-A or 12-B-27-00-00-00A-313A-A). Replace as necessary.
- (f) Get new cable clamps (3) and (4), as necessary, and new nuts (1), washers (2) and bolts (5).

- (g) Put the clamps (3) and (4) in position on the elevator cable (6) and the stick-pusher servo-cable (7).
- (h) Apply grease (Material No. P04-029) to the threads of the bolts (5) and the nuts (1) and loosely install all six bolts (5), washers (2) and nuts (1).
- (i) Make sure the stick-pusher servo-cable is correctly installed on the capstan (Ref. AMM 12-A-22-20-06-00A-920A-A or 12-B-22-20-06-00A-920A-A).
- (j) Make sure the clamps (3) and (4) are in correct position and tighten the nuts (1).

- (k) Torque the nuts to between 4 and 4,5 Nm (35 and 40 lb in.).
