# SERVICE BULLETIN

SERVICE BULLETIN NO: 32-021

## LANDING GEAR - NOSE WHEEL STEERING REPLACEMENT OF THE CRANK BAR ASSY

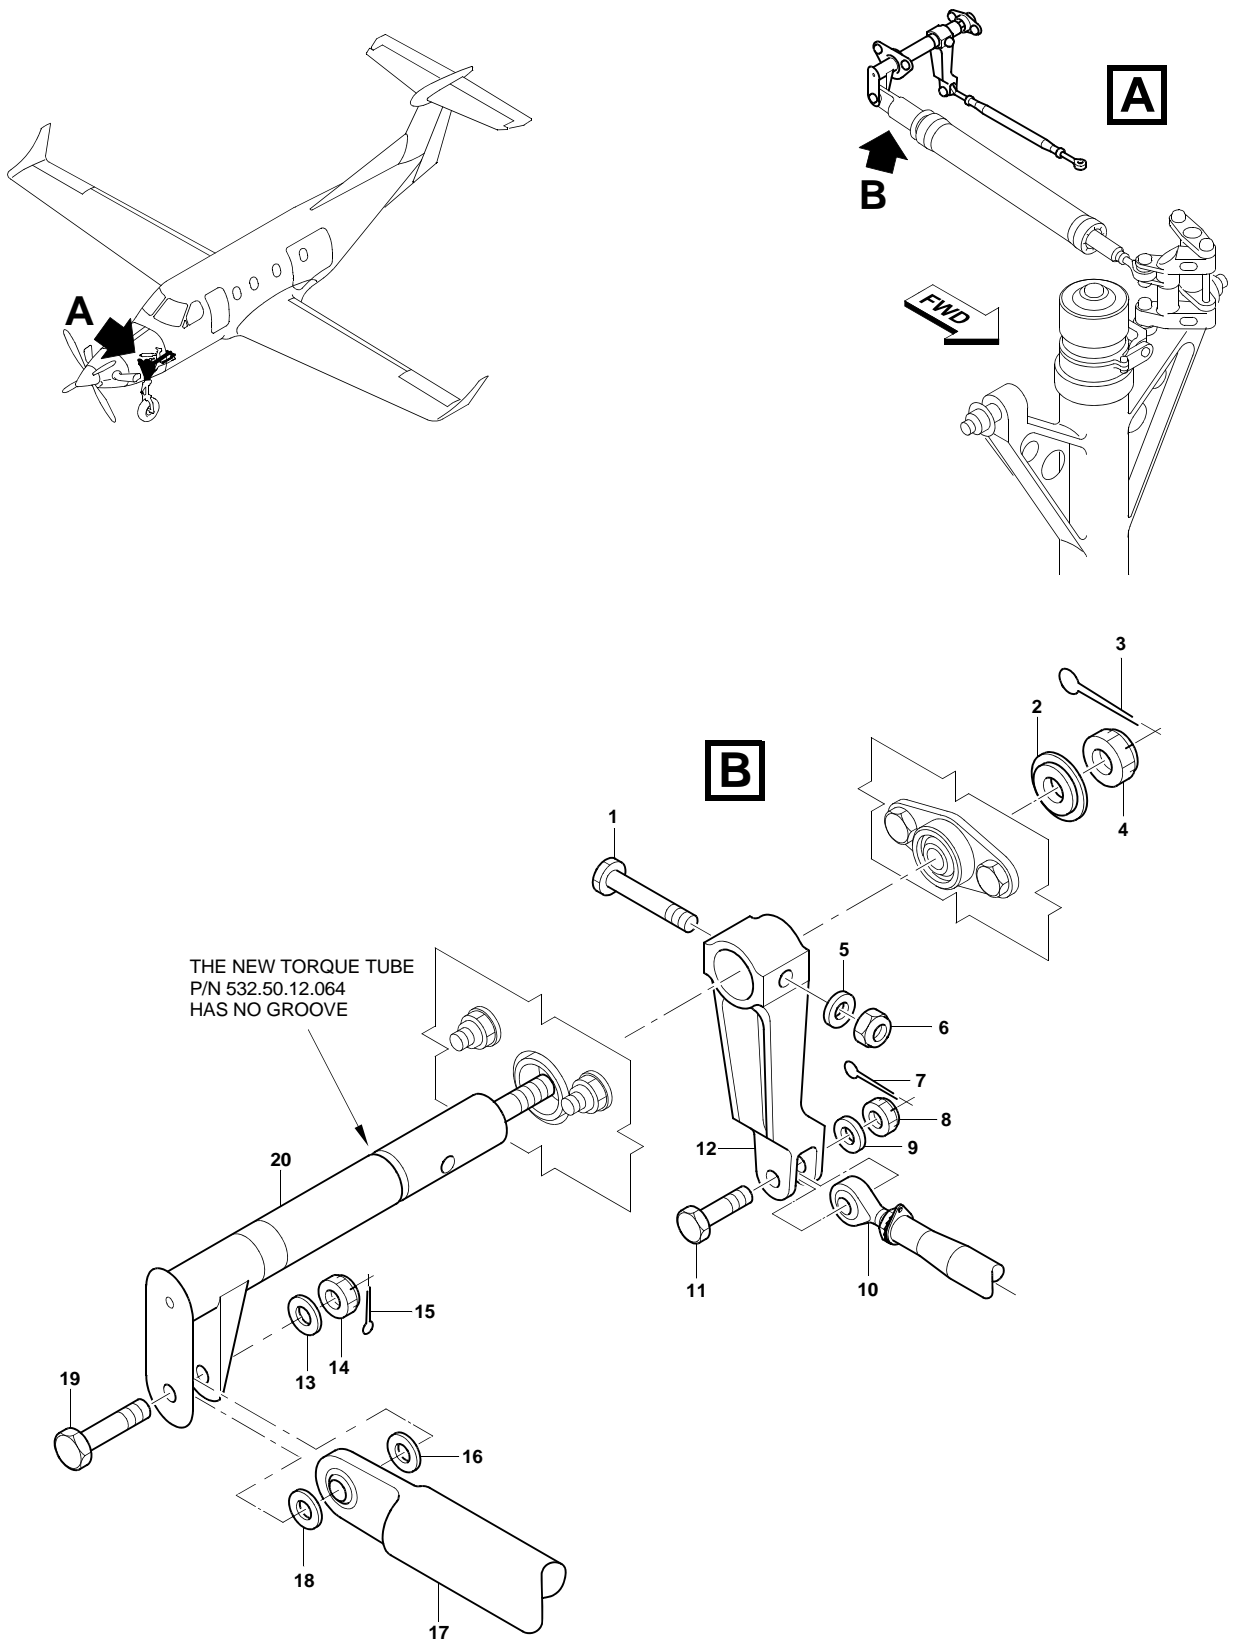
Crank Bar Assy - Removal/Installation  
 Figure 1

Failure of the nose wheel steering system because of fatigue cracking of the torque tube in the crank bar assy.

Some torque tubes were bored off-center during manufacture. This results in a reduced wall thickness at one side of the torque tube. The torque tube can also crack at the bolt holes for the lever attachment bolt.

Install a new crank bar assy which is manufactured to a higher standard.

**A. Removal (Ref. Fig. 1)**

HYDR CTL (NON ESSENTIAL BUS)
- (3) Make sure the nose wheel is in the neutral position and there is no load on the spring strut (17).
- (4) Open the access panel 11AL (Ref AMM.12-A-06-20-00-00A-040A-A).
- (5) If necessary, remove the Orcotape and insulation to get access to the nut (4).
- (6) Remove the cotter pin (7), the nut (8) and the washer (9).
- (7) Remove the bolt (11) and disconnect the rod (10).
- (8) Remove and discard the nut (6), the washer (5) and the bolt (1)
- (9) Make sure that the lever (12) can turn on the torque tube (20). If you cannot turn the lever (12) with your hand:
  - (a) Lower the aircraft until the nose wheel is on the ground and cannot turn.
  - (b) Use force to make the lever (12) free to turn.

**NOTE:** You can use penetrating oil to help to release the lever.
  - (c) When you can turn the lever (12) on the torque tube (20), lift the nose wheel.
- (10) Remove the cotter pin (15), the nut (14) and the washer (13).
- (11) Remove the bolt (19) and disconnect the spring strut (17). Collect the washers (16) and (18).
- (12) Remove the cotter pin (3), the nut (4) and the washer (2). Make a note of the installation position of the washer (2).
- (13) Hold the lever (12) and remove the torque tube (20) from the lever and bearings.
- (14) Keep the lever (12) and the torque tube (20) and send them to Pilatus Aircraft Ltd.

**B. Installation (Ref. Fig. 1)**

- (1) Apply a thin layer of corrosion preventative (Material No. P04-012) to the inside mating surface of the lever (12)
- (2) Hold the lever (12) (P/N 532.50.12.051) between the bearings and install the torque tube (20) (P/N 532.50.12.064). Make sure the lever (12) is installed in the correct position as shown in Fig. 1.
- (3) Install the bolt (1) (P/N 932.19.60.801), the washer (5) (P/N 938.77.11.114) and the nut (6) (P/N 938.07.68.305).

- (4) Use the absorbent paper (Material No. P02-031) and the solvent (Material No. P01-008) to remove unwanted corrosion preventative from the torque tube (20).
- (5) Install the washer (2) (in the position noted in the removal procedure), the nut (4) and the new cotter pin (3).
- (6) Connect the spring strut (17) with the two washers (16) and (18) and the bolt (19).
- (7) Install the washer (13), the nut (14) and the new cotter pin (15).
- (8) Connect the rod (10) with the bolt (11).
- (9) Install the washer (9), the nut (8) and the new cotter pin (7).
