Service Bulletin No: 24-005

**ELECTRICAL POWER - DC ELECTRICAL LOAD DISTRIBUTION
INTRODUCTION OF ADDITIONAL ATTACHMENT HARDWARE TO HOLD A CABLE LOOM AT THE LH
COCKPIT RAIL INSTALLATION****1. Planning Information****A. Effectivity**

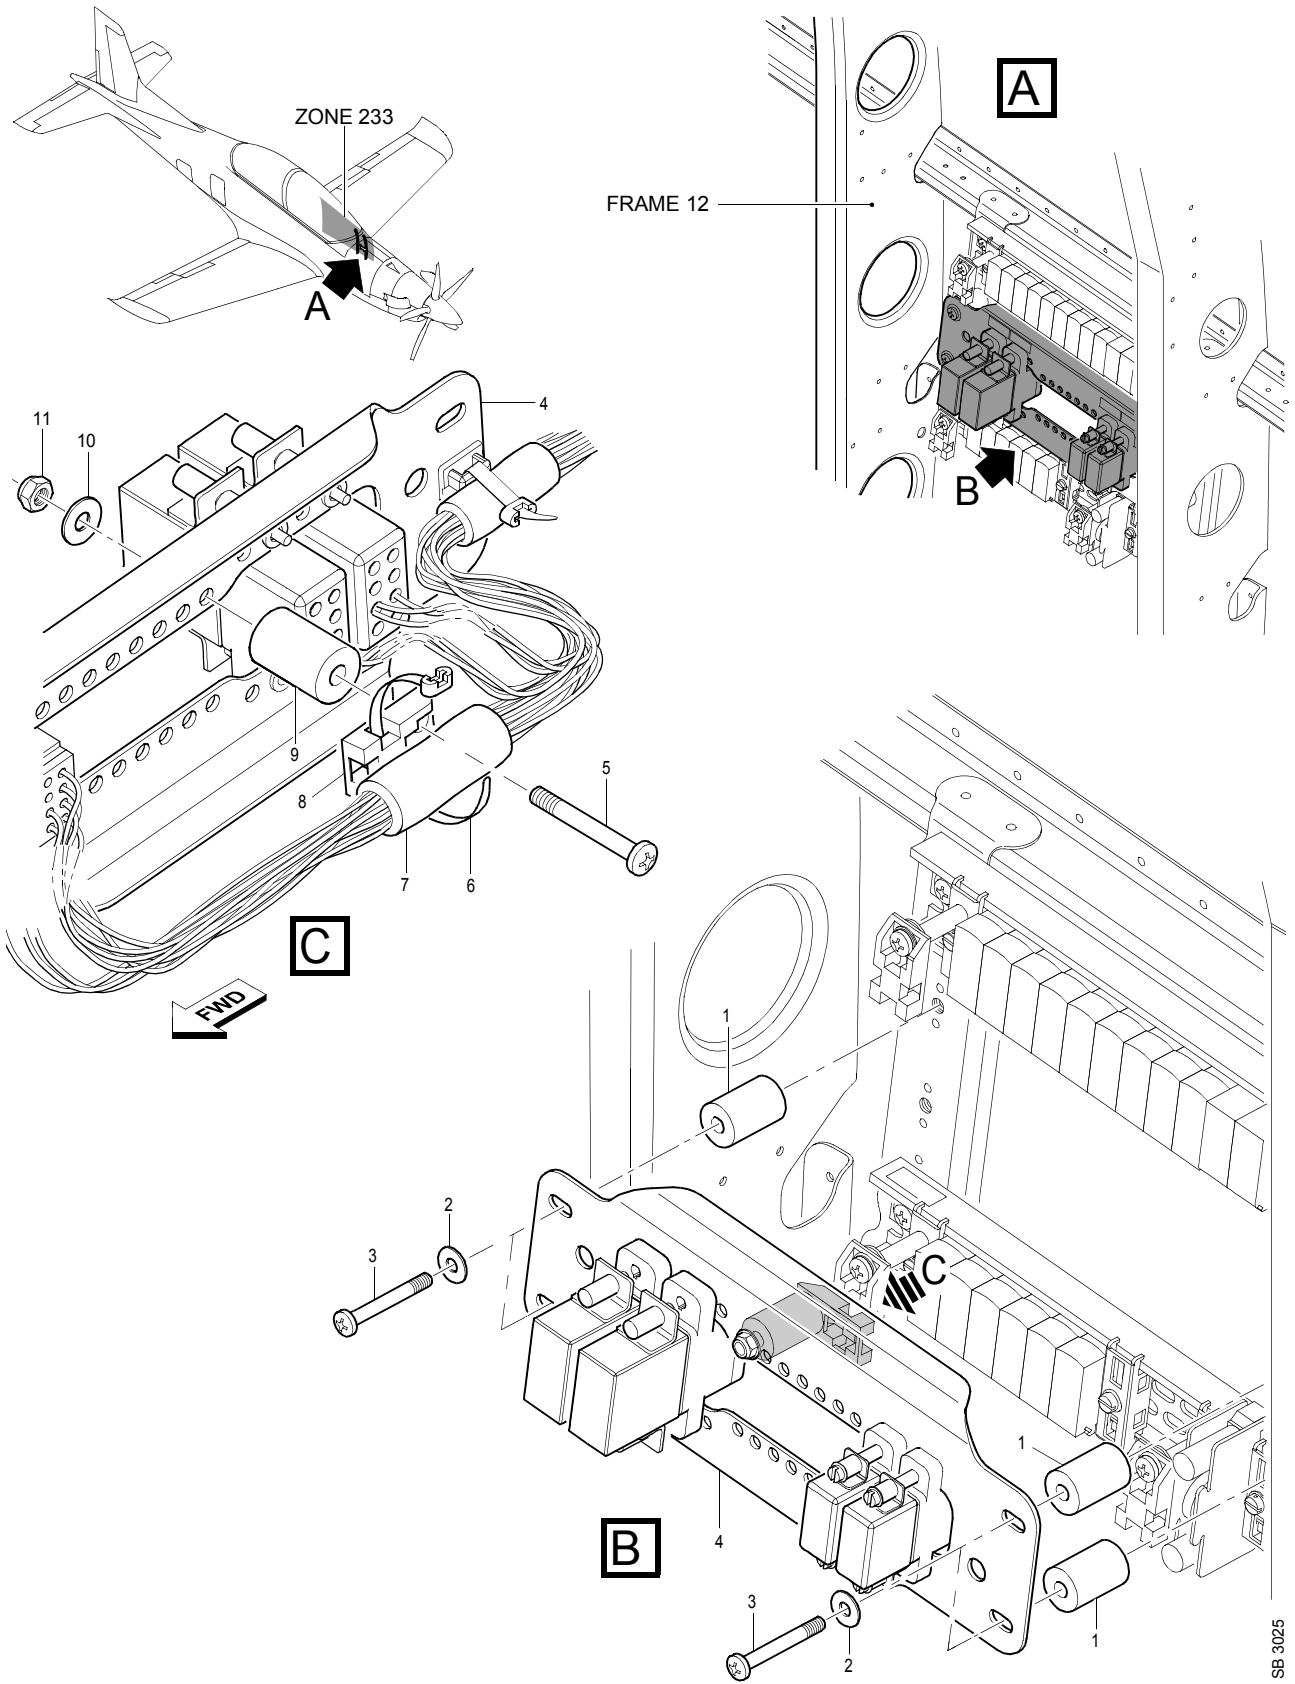
Installation of Additional Attachment Hardware to the LH Cockpit Rail Assembly Wiring-Loom
Figure 1

Five wires that are part of a cable loom behind the LH cockpit rail installation were found to be damaged. The damage was caused by the attachment screws of the relays K106 and K107. The relays are installed to the frame support assembly of the LH cockpit rail installation.

The frame support assembly is partially removed and a visual inspection is made of the cable loom for chafing and damage. If necessary, the chafed and damaged wires are repaired. To prevent future chafing and damage to the wires, additional attachment hardware is installed to hold the cable loom away from the attachment screws of the relays K106 and K107.

B. Modification (Ref. Fig. 1)

- (1) Identify the frame support assembly (4) on the LH cockpit rail installation (Ref. Detail A).
- (2) Remove one screw (3) and washer (2) and then carefully remove the distance bush (1) from the frame support assembly (4).

- (4) Carefully pull the frame support assembly (4) sufficiently away from the aircraft structure to get access to the rear of the frame support assembly (4).
- (5) Do a visual inspection of the cable loom behind the frame support assembly (4).
- (6) If you find damage to the cable loom, contact Pilatus for technical support and do the repairs as necessary. When you have done the repairs, or if you do not find damage, continue with this Service Bulletin from Step 3.B.(7).
- (7) Put the new attachment hardware in position on the rear side of the frame support assembly (4) as follows:
 - The screw (5) (Pos. No. 30)
 - The mounting base (8) (Pos. No. 20)
 - The distance bush (9) (Pos. No. 10).
- (8) Loosely install the new washer (10) (Pos. No. 50) and the new nut (11) (Pos. No. 40) on the screw (5) (Pos. No. 30).

- (9) Align the mounting base (8) (Pos. No. 20) longitudinally with the frame support assembly (4) and hold it in position.
- (10) Tighten the nut (11) (Pos. No. 40) on the screw (5) (Pos. No. 30).

- (11) In the area where the cable loom interfaces with the mounting base (8) (Pos. No. 20), apply the red fiberglass tape (7) (Material No. P09-064) to the cable loom (Ref Detail C).

- (12) Install the new cable tie (6) (Material No. P09-005) to the mounting base (8) (Pos. No. 20) and the cable loom.
- (13) Make sure that there is clearance between the cable loom and the attachment screws of the relays K106 and K107.
