PILATUS AIRCRAFT LTD, STANS, SWITZERLAND

SERVICE BULLETIN

Service Bulletin No: 27-012 Ref No: 169

FLIGHT CONTROLS - SPOILERS LUBRICATION OF THE SPOILER CONTROL ROD-TO-SPOILER ACTUATOR CONNECTION-BOLT AND INSTALLATION WITH AXIAL PLAY

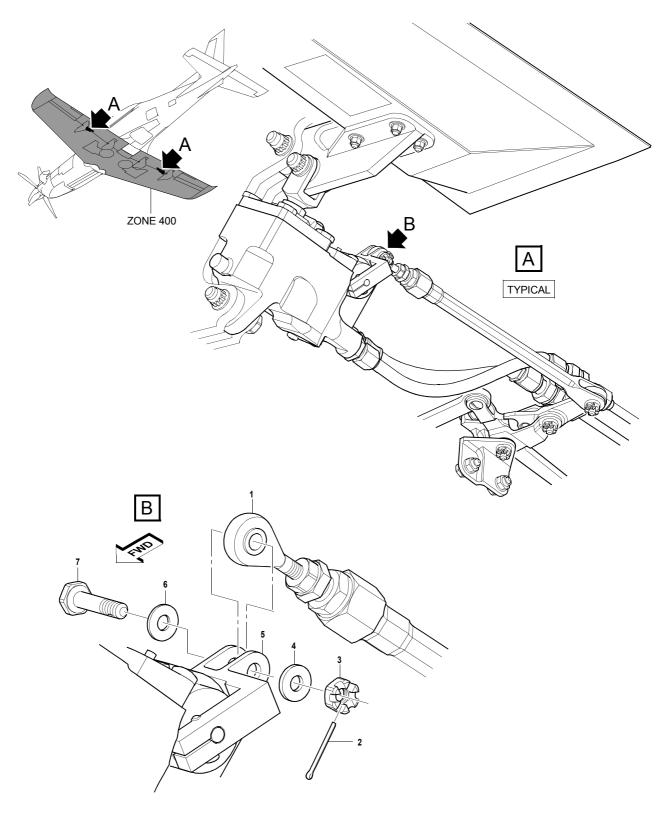
Removal, Lubrication and Re-installation of the Rod End Bolts With Axial Play Figure 1

On some aircraft installed with spoiler control rod end P/N 944.61.12.001, spoilers have been found slightly deployed when the pilot had selected the aileron to the neutral position.

- (1) Remove and discard the cotter pin (2).
- (2) Remove the nut (3), the washer (4), the washer (6) and the bolt (7) and disconnect the spoiler control rod (1) from the spoiler actuator lever (5).
- (3) Clean the bolt (7), the washers (4) and (6) and the nut (3) with the absorbent paper (Material No. P02-031) made moist with the solvent (Material No. P01-010).

- (7) Apply a layer of the grease (Material No. P04-028) to the plain part of the bolt (7).
- (8) Install the bolt (7), the washer (4), the washer (6) and the nut (3).

- (9) Tighten the nut (3) until there is 0.4 mm (0.016 in.) axial play on the bolt (7).
- (10) If necessary, continue to tighten the nut (3) until the hole for the new cotter pin (2) aligns with the next cut-out in the nut (3).

- (11) Make sure the axial play is more than 0.1 mm (0.004 in.).
- (12) Safety the nut (3) with the new cotter pin (2) (P/N 940.17.02.317).
- (13) Do Steps 3.B.(1) thru (12) for the other spoiler.
