Service Bulletin No: 27-015

ATA Chapter: 27

**FLIGHT CONTROLS - ROLL CONTROL
INTRODUCTION OF A FIXED AILERON TAB INSTALLATION**

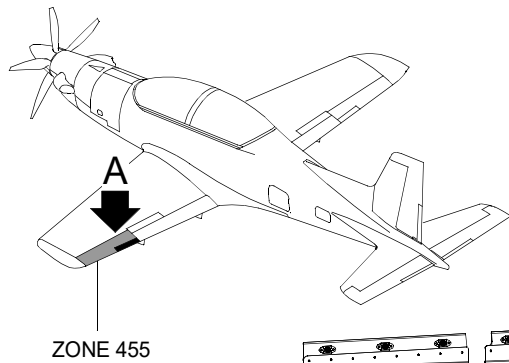
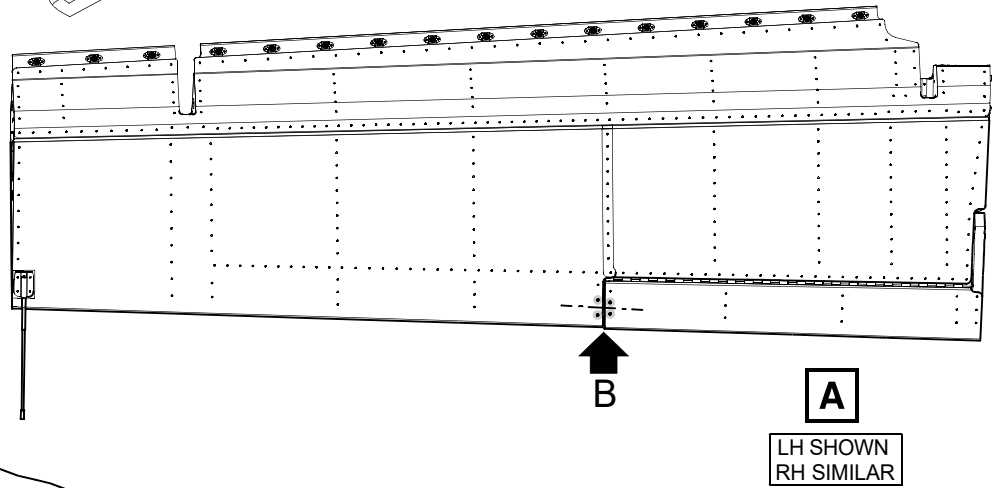
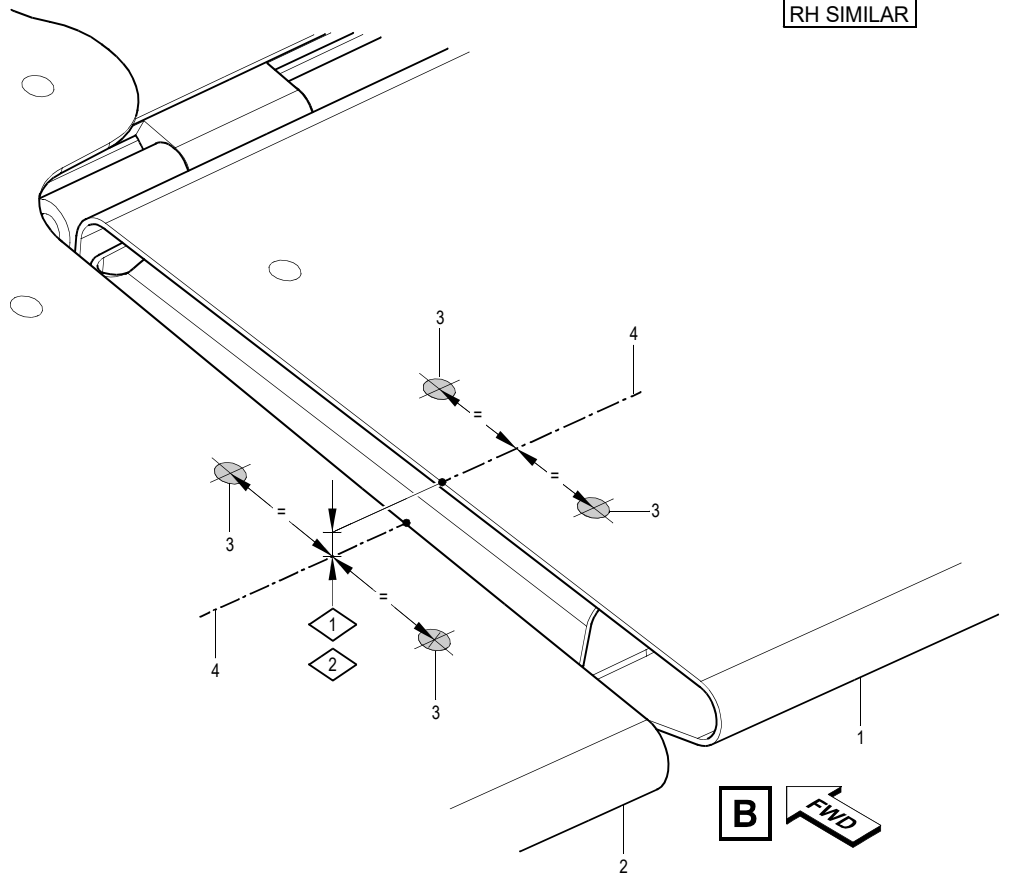
Measurement of the Aileron Trim-Tab Deflection
Figure 1

- ① MEASURE THE DISTANCE BETWEEN THE AILERON (2) AND THE TAB (1).
- ② SHOWN WITH TAB (1) DEFLECTED ABOVE THE AILERON (2), IT IS POSSIBLE FOR THE TAB (1) TO BE DEFLECTED BELOW THE AILERON (2).

- (a) Install the aileron trim control rigging-pin (Ref. AMM, 27-10-03-00A-344A-A).
- (b) Use a straight edge (A ruler held on its edge or equivalent) and hold it in position on the upper surface of the aileron (2) or tab (1) as follows:
 - If the tab (1) is deflected above the aileron (2), hold straight edge (4) on the tab (1)
 - If the tab (1) is deflected below the aileron (2), hold straight edge (4) on the aileron (2).
- (c) Use a pencil (or equivalent) to make a mark on the relevant surface where you hold the straight edge (4).
- (d) Use a feeler gauge (or equivalent) and measure the gap between the underside of the straight edge (4) and the relevant surface (the aileron (2) or the tab (1)).

- (e) Make record of the left and right measurements as follows:
- Assign a positive value (+) when the measurement of the tab is above the aileron
 - Assign a negative value (-) when the measurement of the tab is below the aileron.
- NOTE:** You will use these measurements to set the aileron tabs to the correct system trim position when you fix the tabs to the ailerons.
- (f) Remove the aileron trim control rigging-pin (Ref. AMM, 27-10-03-00A-344A-A).
- (4) Remove the left and right aileron assemblies (Ref. AMM, 27-10-04-00A-520A-A).
- (5) Examine the aileron tab main-rib on the LH and RH ailerons. If any structural damage is found, please contact Pilatus for guidance.

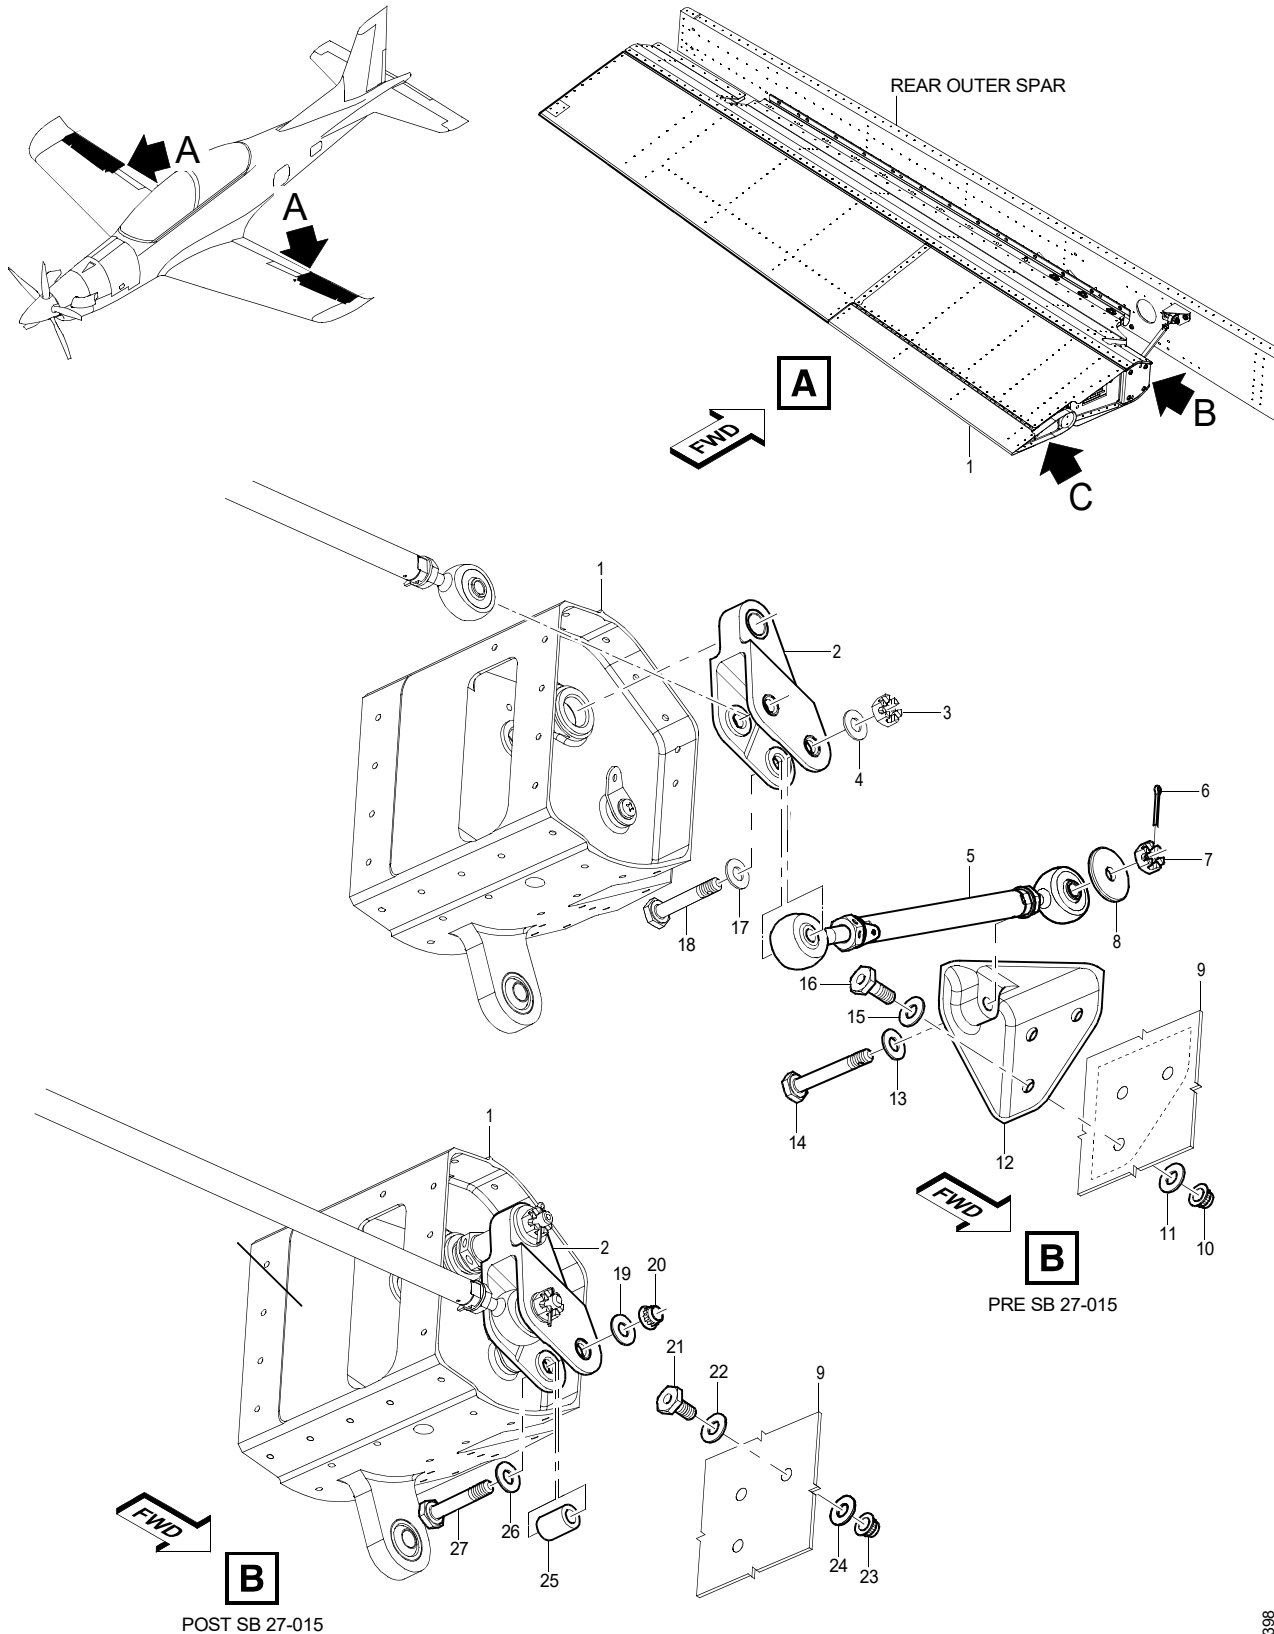
Modification to Introduce a Fixed Aileron Trim Tab Installation
Figure 2 (Sheet 1 of 2)

During flutter analysis of under wing stores configurations, it was found that the failure case with disconnected aileron Flettner tabs shows a dynamic instability within the flight envelope for all aircraft configurations.

- (1) Do the modification to remove the trim tab input mechanism.
- (a) Remove the trim tab pushrod (5) and the trim tab bracket (12).
- 1 Remove and discard the cotter pin (6).

- 2 Remove and discard the nut (7), the washers (8) and (13) and the bolt (14).
 - 3 Remove and discard the pushrod (5) from the trim tab bracket (12).

- 4 Remove and discard the three nuts (10) and washers (11).
 - 5 Remove and discard the three bolts (16), three washers (15) and the trim tab bracket (12) from the rear spar.
