PILATUS AIRCRAFT LTD, STANS, SWITZERLAND

SERVICE BULLETIN

Service Bulletin No: 32-016 Ref No: 193

LANDING GEAR - MAIN GEAR AND DOORS INSPECTION OF THE MAIN LANDING GEAR (MLG) LH AND RH FOLDING STRUTS

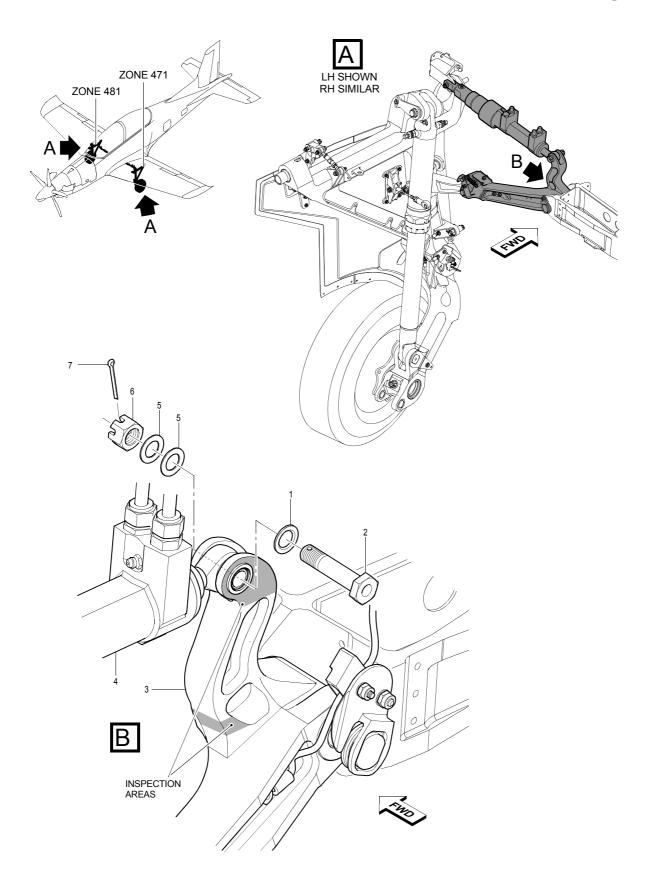
Inspection of the MLG LH and RH Folding Struts Figure 1 (Config. 1)

During an after flight inspection, a folding strut of the right MLG was found cracked and damaged around the area of the MLG actuator eye end.

- (1) Config. 1 Aircraft (Ref. Fig. 1).
 - (a) Remove the bolt (2) that connects the MLG actuator (4) and the MLG folding strut (3) for access to do the inspection.

- Obey the manufacturer's operating instructions and calibrate the eddycurrent crack-detection equipment.
 - <u>3</u> Move the probe of the eddy-current crack-detection equipment over the inspection areas shown in Detail B.

- 4 If you find cracks:
 - If you find cracks in upper MLG actuator connection area of the MLG folding strut (3):
 - Remove the MLG folding strut (3) (Ref. AMM 32-31-01-03A-520A-A)

- Install a new MLG folding strut (3) (Ref. AMM 32-31-01-03A-720A-A).

- If you find cracks in lower area of the MLG folding strut (3):
 - Remove the MLG folding strut (3) (Ref. AMM 32-31-01-03A-520A-A)
 - Do the blend repair given in Step 3.B.(4)

- If the MLG folding strut (3) is assessed as serviceable, install the repaired MLG folding strut (3) (Ref. AMM 32-31-01-03A-720A-A)
 - If the MLG folding strut (3) is assessed as unserviceable, install a new MLG folding strut (3) (Ref. AMM 32-31-01-03A-720A-A)

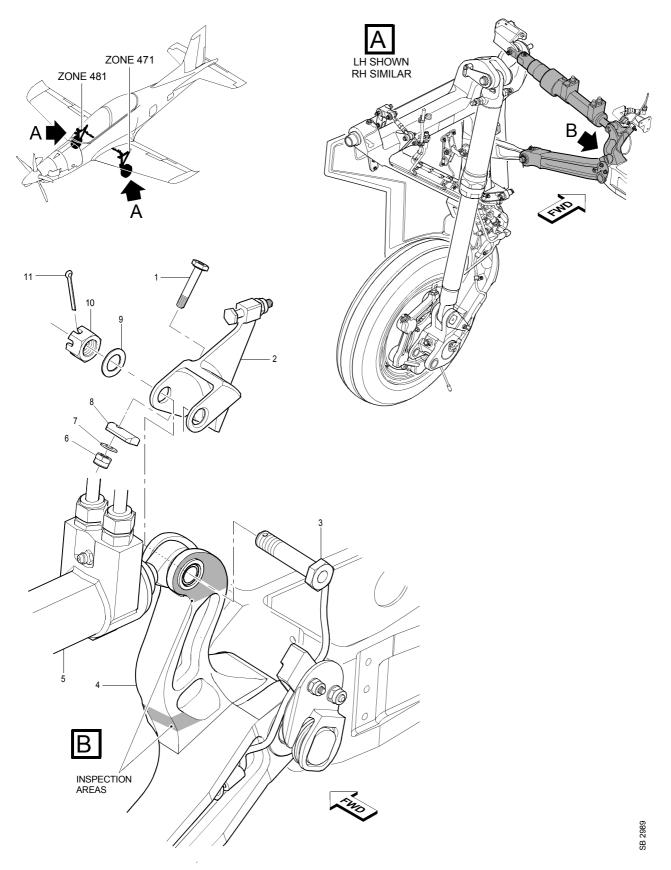
Inspection of the MLG LH and RH Folding Struts Figure 2 (Config. 2)

- (a) Remove the bolt (3) that connects the MLG actuator (5) and the MLG folding strut (4) and the extension lever (2) for access to do the inspection.

- Obey the manufacturer's operating instructions and calibrate the eddycurrent crack-detection equipment.
 - <u>Move the probe of the eddy-current crack-detection equipment over the areas shown in Detail B.</u>

- 4 If you find cracks:
 - If you find cracks in upper MLG actuator connection area of the MLG folding strut (4):
 - Remove the MLG folding strut (4) (Ref. AMM 32-31-01-03A-520A-A)

- Install a new MLG folding strut (4) (Ref. AMM 32-31-01-03A-720A-A).
 - If you find cracks in lower area of the MLG folding strut (4):
 - Remove the MLG folding strut (4) (Ref. AMM 32-31-01-03A-520A-A)

- Do the blend repair given in Step 3.B.(4)
 - If the MLG folding strut (4) is assessed as serviceable, install the repaired MLG folding strut (4) (Ref. AMM 32-31-01-03A-720A-A)

- If the MLG folding strut (4) is assessed as unserviceable, install a new MLG folding strut (4) (Ref. AMM 32-31-01-03A-720A-A)
- Contact Pilatus with the results of the inspection.

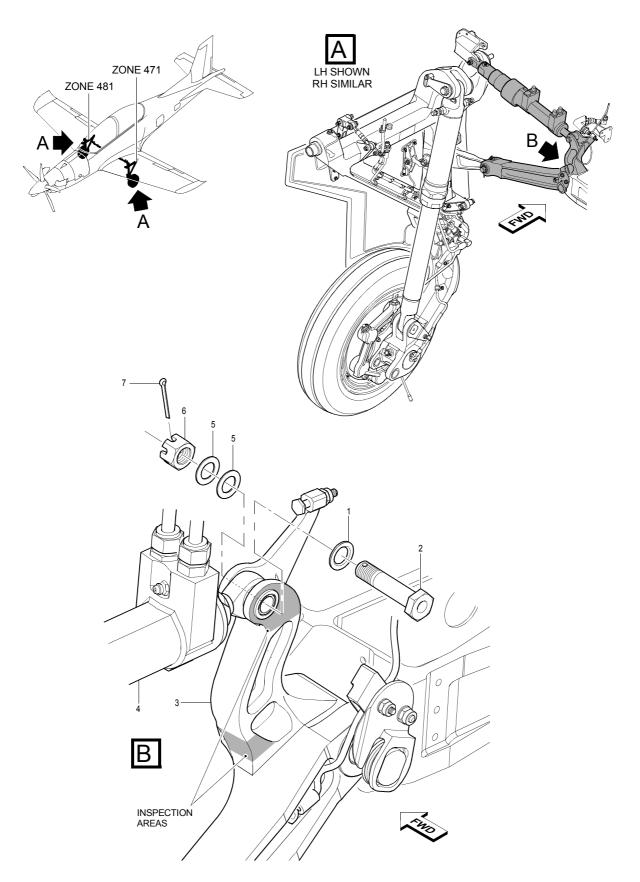
Inspection of the MLG LH and RH Folding Struts Figure 3 (Config. 3)

- 5 If you do not find cracks, continue with this Service Bulletin from Step 3.B.(6).
- (3) Config. 3 Aircraft (Ref. Fig. 3).
 - (a) Remove the bolt (2) that connects the MLG actuator (4) and the MLG folding strut (3) for access to do the inspection.

- Obey the manufacturer's operating instructions and calibrate the eddycurrent crack-detection equipment.
 - <u>Move the probe of the eddy-current crack-detection equipment over the areas shown in Detail B.</u>

- 4 If you find cracks:
 - If you find cracks in upper MLG actuator connection area of the MLG folding strut (3):
 - Remove the MLG folding strut (3) (Ref. AMM 32-31-01-03A-520A-A)

- Install a new MLG folding strut (3) (Ref. AMM 32-31-01-03A-720A-A).
 - If you find cracks in lower area of the MLG folding strut (3):
 - Remove the MLG folding strut (3) (Ref. AMM 32-31-01-03A-520A-A)

- Do the blend repair given in Step 3.B.(4)
 - If the MLG folding strut (3) is assessed as serviceable, install the repaired MLG folding strut (3) (Ref. AMM 32-31-01-03A-720A-A)

- If the MLG folding strut (3) is assessed as unserviceable, install a new MLG folding strut (3) (Ref. AMM 32-31-01-03A-720A-A)
 - Contact Pilatus with the results of the inspection.

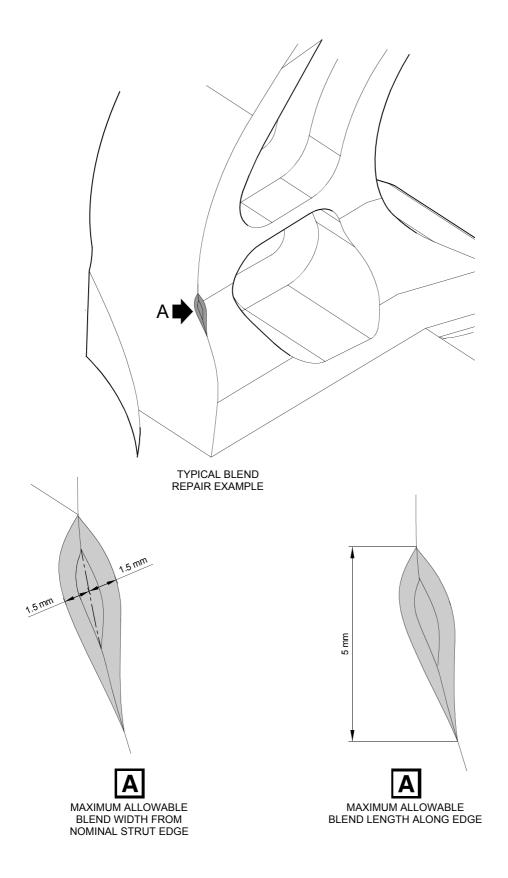
Typical Blend Repair to the LH and RH MLG Folding Struts Figure 4

NOTE: The maximum allowable material to be removed is as follows:

- A 3 mm (total) maximum dimension measured from the nominal corner of the strut to the edge of the blend repair
- A maximum of 1.5 mm depth measured from the nominal corner

- A maximum of 5 mm length measured along the edge to the full extent of the blend repair.
- (b) Restore the surface finish of the MLG folding strut, refer to SRM 51-70-15-00A-663A-A).

- (4) If necessary, do the blend repair to the MLG folding strut (Ref. Fig. 4).
 - Remove the crack damage gradually and carefully until the crack is completely (a) removed. Make sure there is a smooth transition along the edge of the repair, refer to SRM 51-70-01-00A-663A-A).
