PILATUS AIRCRAFT LTD, STANS, SWITZERLAND

Service Bulletin No: 35-008 Ref No: 233

Modification No: EC-20-0537 ATA Chapter: 35

OXYGEN - EMERGENCY OXYGEN SYSTEM MODIFICATION TO THE EMERGENCY REGULATOR CONNECTOR TO INTRODUCE A NEW MAXIMUM PRESSURE RELIEF VALVE

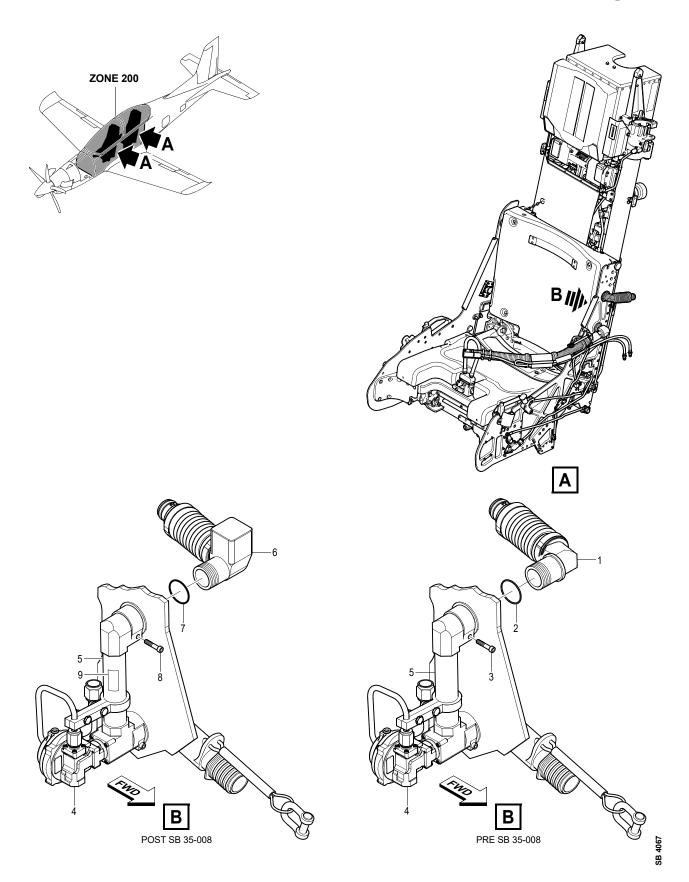
Replacement of the Top Elbow of the Emergency Regulator Connector Figure 1

The manufacturer has identified a design deficiency in the Max Pressure Relief Valve (MPRV) located in the OBOGS Panel Mounted Regulator (PMR) outlet. This can result in the inability to relieve excess pressure that the PMR can potentially deliver to the pilots oxygen mask.

This Service Bulletin gives the data and instructions necessary to modify the Emergency Regulator Connector (ERC) to introduce an additional MPRV at the elbow of the connector installed on the LH side of the ejection seat.

The Emergency Regulator Connector (ERC) is modified to introduce an additional MPRV so if the PMR malfunctions, leading to an overpressure situation, the MPRV on the ERC will open and relieve the excessive pressure to the cockpit.

B. Modification (Ref. Fig. 1)

- (1) Do a check of the ERC assembly (4) part number.
 - (a) Find the identification plate on the ERC assembly (4) and do a check of the part number.
 - (b) If the part number for the ERC assembly (4) is visible on the identification plate, and is 3526W000-002, this Service Bulletin is not applicable.
 - (c) If a modification label (9) is present on the transfer pipe assembly (5) this Service Bulletin is not applicable.

- (d) If the ERC assembly (4) part number '3526W000-001' is visible on the identification plate and there is no modification label on the transfer pipe assembly (5), this Service Bulletin is applicable.

- (2) Remove the old oxygen inlet elbow (1).
 - (a) On aircraft and if installed, disconnect the oxygen hose from the oxygen inlet elbow (1), refer to AMM 35-10-03-02A-520A-A.

- (c) Let the solvent (Material No. P01-035) dry.
 - (d) Hold the oxygen inlet elbow (1) and remove and discard the screw (3) from the transfer pipe assembly (5).

- (e) Remove the oxygen inlet elbow (1) with the O-ring (2) from the transfer pipe assembly (5).
 - (f) Discard the oxygen inlet elbow (1) and the O-ring (2).

- (3) Install the new oxygen inlet elbow (6).

- (h) Loosely install the new screw (8) through the transfer pipe assembly (5) and into the groove in the new oxygen inlet elbow (6).
- (i) Make sure that new oxygen inlet elbow (6) can turn freely and cannot be pulled out of the transfer pipe assembly (5).

- (j) Torque the new screw (8) to between 0,56 and 0,68 Nm (5.0 and 6.0 lbf in).
- (k) Make sure that new oxygen inlet elbow (6) can turn freely and cannot be pulled out of the transfer pipe assembly (5).
- (I) On aircraft, connect the oxygen hose to the oxygen inlet elbow (6), refer to 35-10-03-02A-720A-A.
- (4) Install the new modification Label (9).
