PILATUS AIRCRAFT LTD, STANS, SWITZERLAND

SERVICE BULLETIN

Service Bulletin No: 27-005 Ref No: 51

FLIGHT CONTROLS - SPOILERS LUBRICATION OF THE SPOILER CONTROL ROD-TO-SPOILER ACTUATOR CONNECTION-BOLT

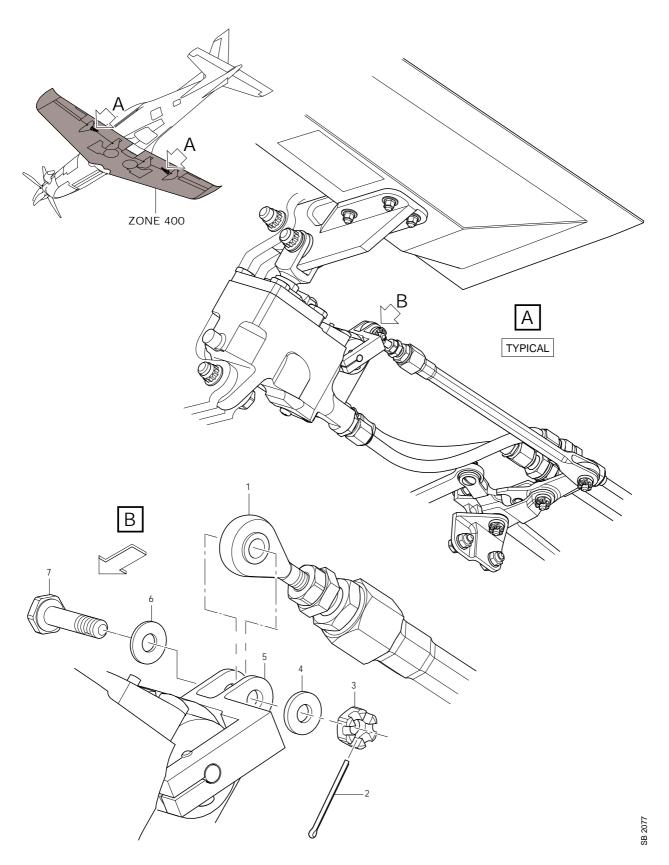
Lubrication of the Bolt Figure 1

A customer reported that the spoilers of some of their PC-21 aircraft were found slightly deployed when the pilot had selected the ailerons to the neutral position.

Normally the return spring (installed on the spoiler actuator input-lever) puts the spoiler linkage to the down position when the pilot returns the control column to the neutral position. On some aircraft it was found that the rod-end on the actuator lever (P/N 527.12.21.097) (where it attaches to the input lever of the spoiler actuator) could not move easily. The spring could not overcome this additional force and the spoiler did not fully return to the down position.

B. Lubrication of the Bolt (Ref. Fig. 1)

- (1) Remove and discard the cotter pin (2).
- (2) Remove the nut (3), the washer (4), the washer (6) and the bolt (7) and disconnect the spoiler control rod (1) from the spoiler actuator lever (5).
- (3) Clean the bolt (7), the washers (4 and 6) and the nut (3) with the absorbent paper (Material No. P02-031) made moist with the solvent (Material No. P01-010).

- (7) Apply a layer of the grease (Material No. P04-028) to the plain part of the bolt (7).
- (8) Install the bolt (7), the washer (4), the washer (6) and the nut (3).

- (9) Tighten the nut until there is 0.4 mm (0.016 in.) axial play on the bolt (7).
- (10) If necessary, continue to tighten the nut (3) until the hole for the cotter pin (5) aligns with the next cut-out in the nut (3).

- (11) Make sure the axial play is more than 0.1 mm (0.004 in.).
- (12) Safety the nut (3) with the cotter pin (2).
- (13) Do Steps 3.B.(1) thru (12) for the other spoiler.
