Service Bulletin No: 32-006

ATA Chapter: 32

**LANDING GEAR - MAIN GEAR AND DOORS
REPLACEMENT OF THE WASHER ON THE MAIN LANDING GEAR (MLG) GAS STRUT ATTACHMENT-
BOLT****1. Planning Information****A. Effectivity**

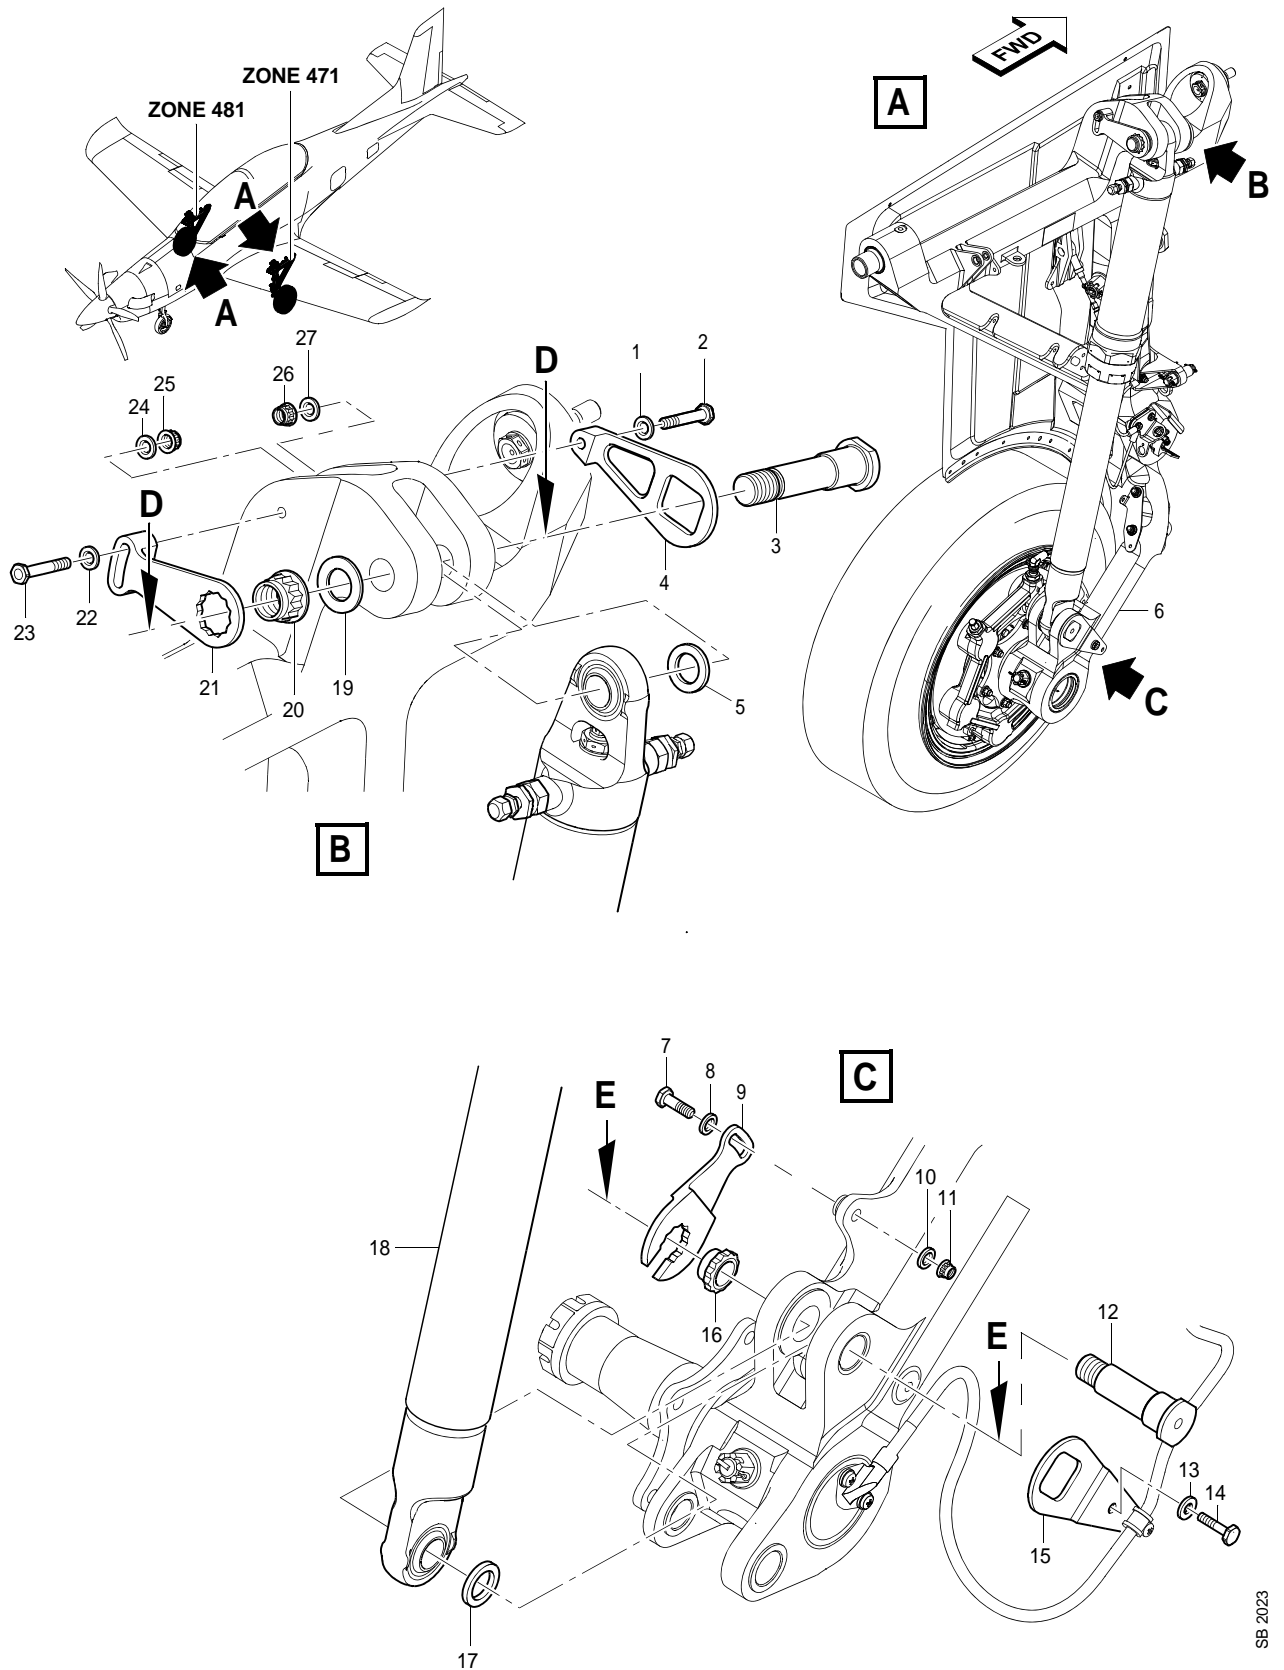
Replacement of the Washer on the MLG Gas Strut Attachment-Bolt
Figure 1, Sheet 1 of 2

On some PC-21 aircraft, the special washer installed between the gas strut and its attachments on the MLG was found installed incorrectly. When installed incorrectly, the non-rounded edge of special washer is pushed into the shoulder of the attachment bolt.

This can cause fatigue/corrosion failure of the bolt.

Replace the special washer (P/N 532.10.21.095) with improved design special washer (P/N 532.10.21.203).

- (1) Look at the aircraft maintenance record and check if the left and/or right gas strut has been:
 - Removed and installed again during the life of the aircraft
 - Replaced during the life of the aircraft.
- (2) If the gas strut (18) has been removed and installed or replaced, make a note of which gas strut (18) it was.
- (3) Remove the upper washer
 - (a) Remove the nut (25), the washer (24), the bolt (23), the washer (22) and the safety lock plate (21).
 - (b) Remove the nut (26), the washer (27), the bolt (2), the washer (1) and the safety lock plate (4).
 - (c) Remove the nut (20) with the spanner (P/N 513.32.21.008).

- (d) Give support to the gas strut (18) and the trailing arm (6) and remove the washer (19), the bolt (3) and the special washer (5).
- (e) If the gas strut has been removed and installed or replaced (Ref. Para. 3.B.(2)), discard the special washer (5) and do the NDI of the upper bolt (3) (Ref. Para. 3.C.). Then continue the Service Bulletin from Para. 3.B.(4).
- (f) Do a check of the installed position of the special washer (5).

- (g) If the special washer (5) is:
 - Installed correctly, discard it and continue the Service Bulletin from Para. 3.B.(4).
 - Not installed correctly, discard it and do a check of the bolt (3) (Ref. Para. 3.C.). Then continue the Service Bulletin from Para. 3.B.(4).

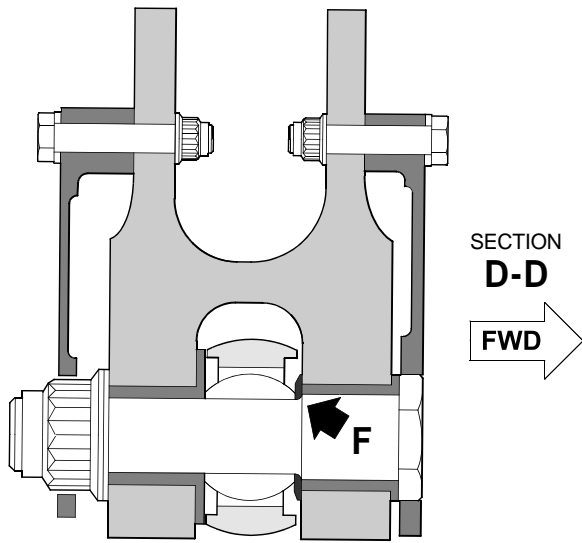
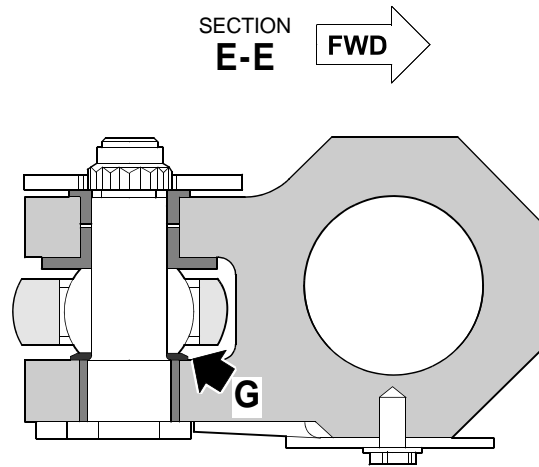
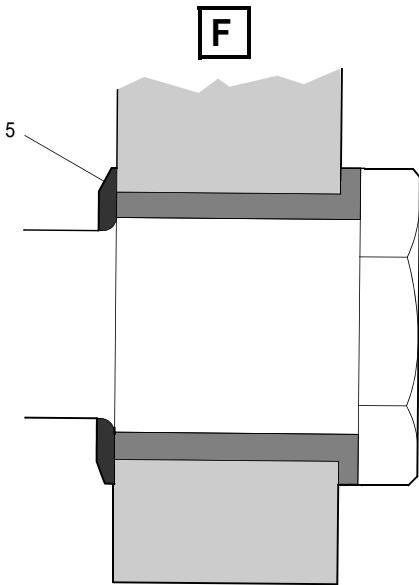
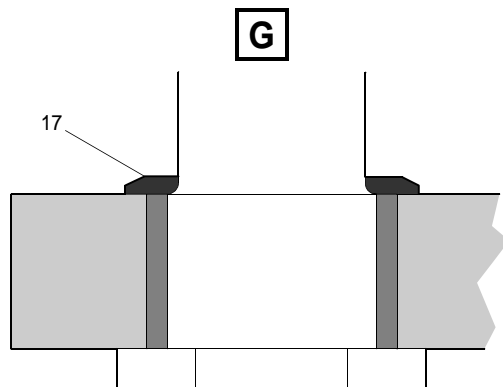
Replacement of the Washer on the MLG Gas Strut Attachment-Bolt
Figure 1, Sheet 2 of 2

NOTE: The old special washer (5) has a radius on the internal hole. The correct installation is when the radius is towards the head of the bolt (3).

NOTE: The old special washer (17) has a radius on the internal hole. The correct installation is when the radius is towards the head of the bolt (12).

NOTE: The new special washer (5) (P/N 532.10.21.203) has a radius on the internal hole and a chamfer on the external diameter. The correct position for the new special washer (5) (P/N 532.10.21.203) is when the chamfer (on the external diameter) is away from the head of the bolt (3) (Ref. Detail F).

NOTE: The new special washer (17) (P/N 532.10.21.203) has a radius on the internal hole and a chamfer on the external diameter. The correct position for the new special washer (17) (P/N 532.10.21.203) is when the chamfer (on the external diameter) is away from the head of the bolt (12) (Ref. Detail G).
