Service Bulletin No: 61-001
Modification No: Inspection

Ref No: 87
ATA Chapter: 61

**PROPELLER - PROPELLER ASSEMBLY
CLEANING AND INSPECTION PROCEDURE FOR GREASE LEAKAGE**

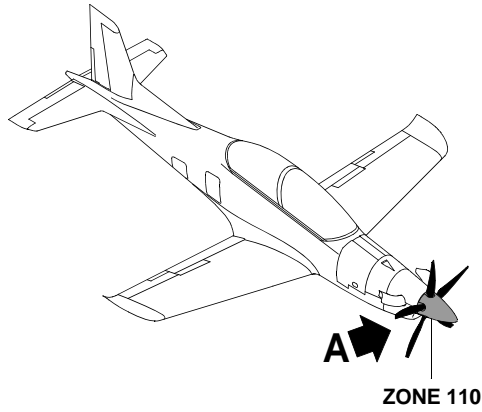
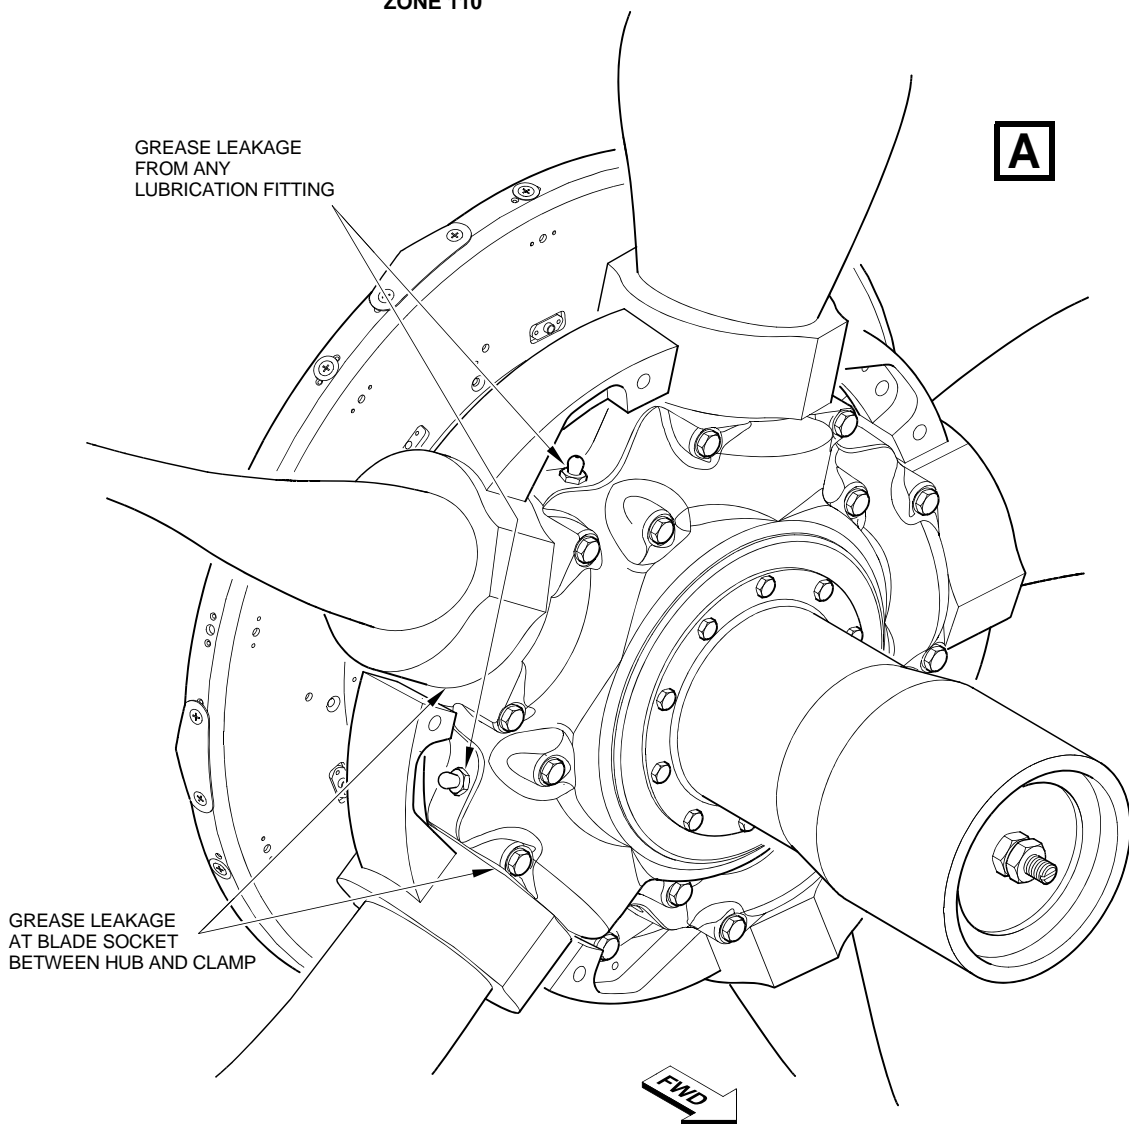
Possible Location for Grease Leakage
Figure 1

NOTE: Unacceptable leakage is clearly more severe than the streaks described above and will contain moderate amounts of grease solids. It normally collects on the inboard surface of the blade counterweight clamp or inside spinner dome.

- (b) Do a visual inspection for cracks in the hub. A crack can be readily visible, or can be indicated by grease leaking from a seemingly solid surface. Extra attention should be given to the blade retention area of the hub. If you find cracks, return the propeller assembly to the overhaul center.
- (c) Do a visual inspection of the hub, the blades and the blade retention areas to locate the origin of the leakage (Ref. Fig. 1).

NOTE: The blade retention bearing-socket is the only source for grease leakage.

- (d) If you find a grease leak, remove the propeller before the next flight and incorporate Hartzell Service Bulletin HC-SB-61-339.
