Service Bulletin No: 71-001

ATA Chapter: 71

**POWER PLANT - GENERAL
ONE-TIME INSPECTION FOR THE CORRECT INSTALLATION OF ATTACHMENT HARDWARE****1. Planning information****A. Effectivity**

PC-24 aircraft MSN 101 thru MSN 162, MSN 164 and MSN 165, and MSN 167 and MSN 168.

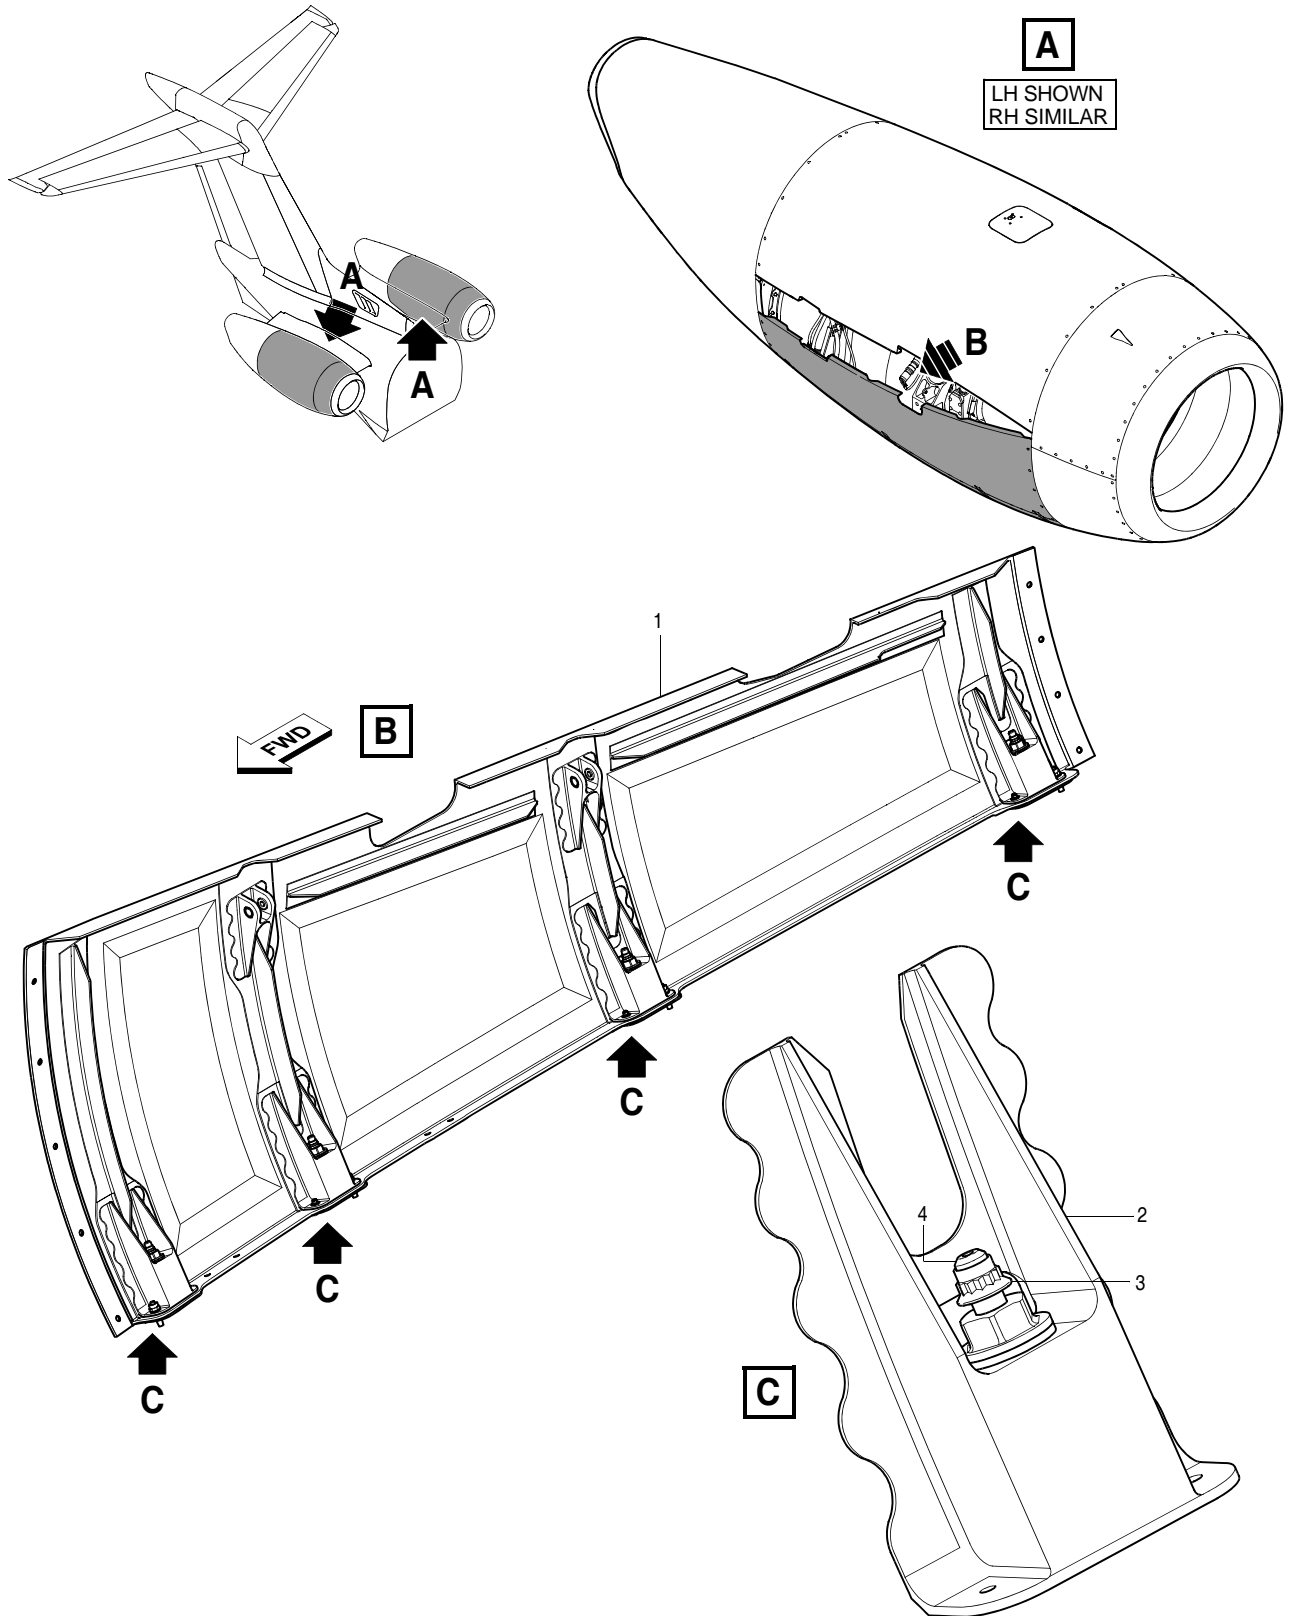
LH/RH Middle inner nacelle - Inspection for loose nuts
Figure 1

- (a) The four attachment bolts for the LH aft isolator assembly were found to have washers missing below the bolt heads. Small damage marks were also found around the edge of the bolt holes on the LH rear engine beam plug due to the bolt head radius being forced into the edge of the bolt holes as they were tightened.
- (b) Some of the keeper fitting attachment bolts on the LH/RH middle inner nacelle were found to have insufficiently tightened nuts.

- (a) Do an inspection to determine if the nuts (3) are sufficiently tightened on the four keeper fitting (2) attachment bolts (4) on the middle inner nacelle (1). Refer to Figure 1 (View C).
- (b) If you find that a nut (3) is not sufficiently tightened:
 - 1 Correctly install the nut (3). Use a new nut (3) (P/N 938.09.14.204) if necessary.
 - 2 Torque the nut (3) plus the run-down torque. Refer to AMM PC24-A-E20-20-0001-00A-040A-A.
- (c) Do the above inspection procedure on the other side of the aircraft.

If the inspection finds loose nuts, tighten/replace the nuts.

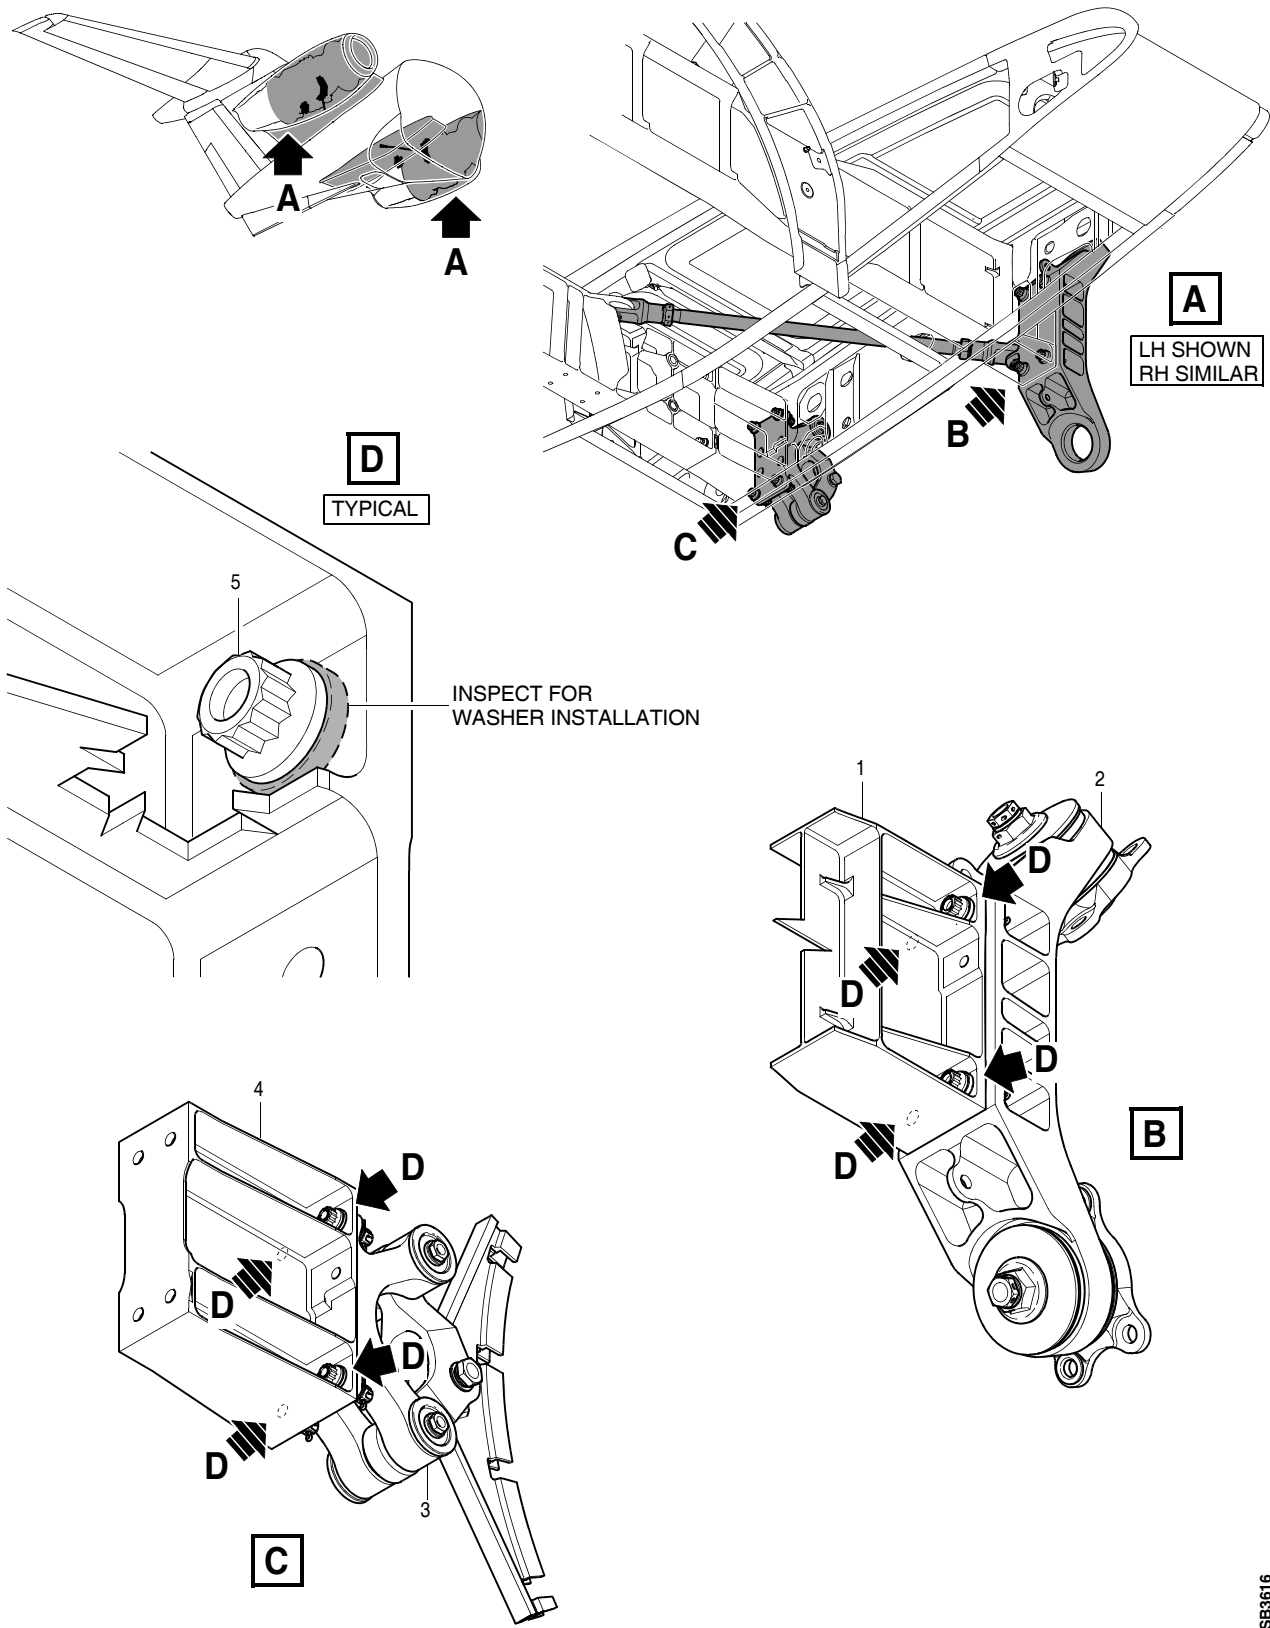
LH/RH Front and rear engine beams - Inspection for washer installation
Figure 2

- (a) Do an inspection to determine if washers are installed below the bolt heads (5) at the:
 - Four attachment points of the front engine beam (1) to yoke (2). Refer to Figure 2 (View B and D)
 - Four attachment points of the rear engine beam plug (4) to aft isolator assembly (3). Refer to Figure 2 (View C and D).
- (b) Do the above inspection procedure on the other side of the aircraft.
- (c) If you find that washers are not installed, continue with this Service Bulletin from Para. **3.C.**
- (d) If you find that all of the washers are installed, continue with this Service Bulletin from Para. **3.D.**

- Do an inspection for damage around the bolt hole
- Replace the bolt and install a new washer.

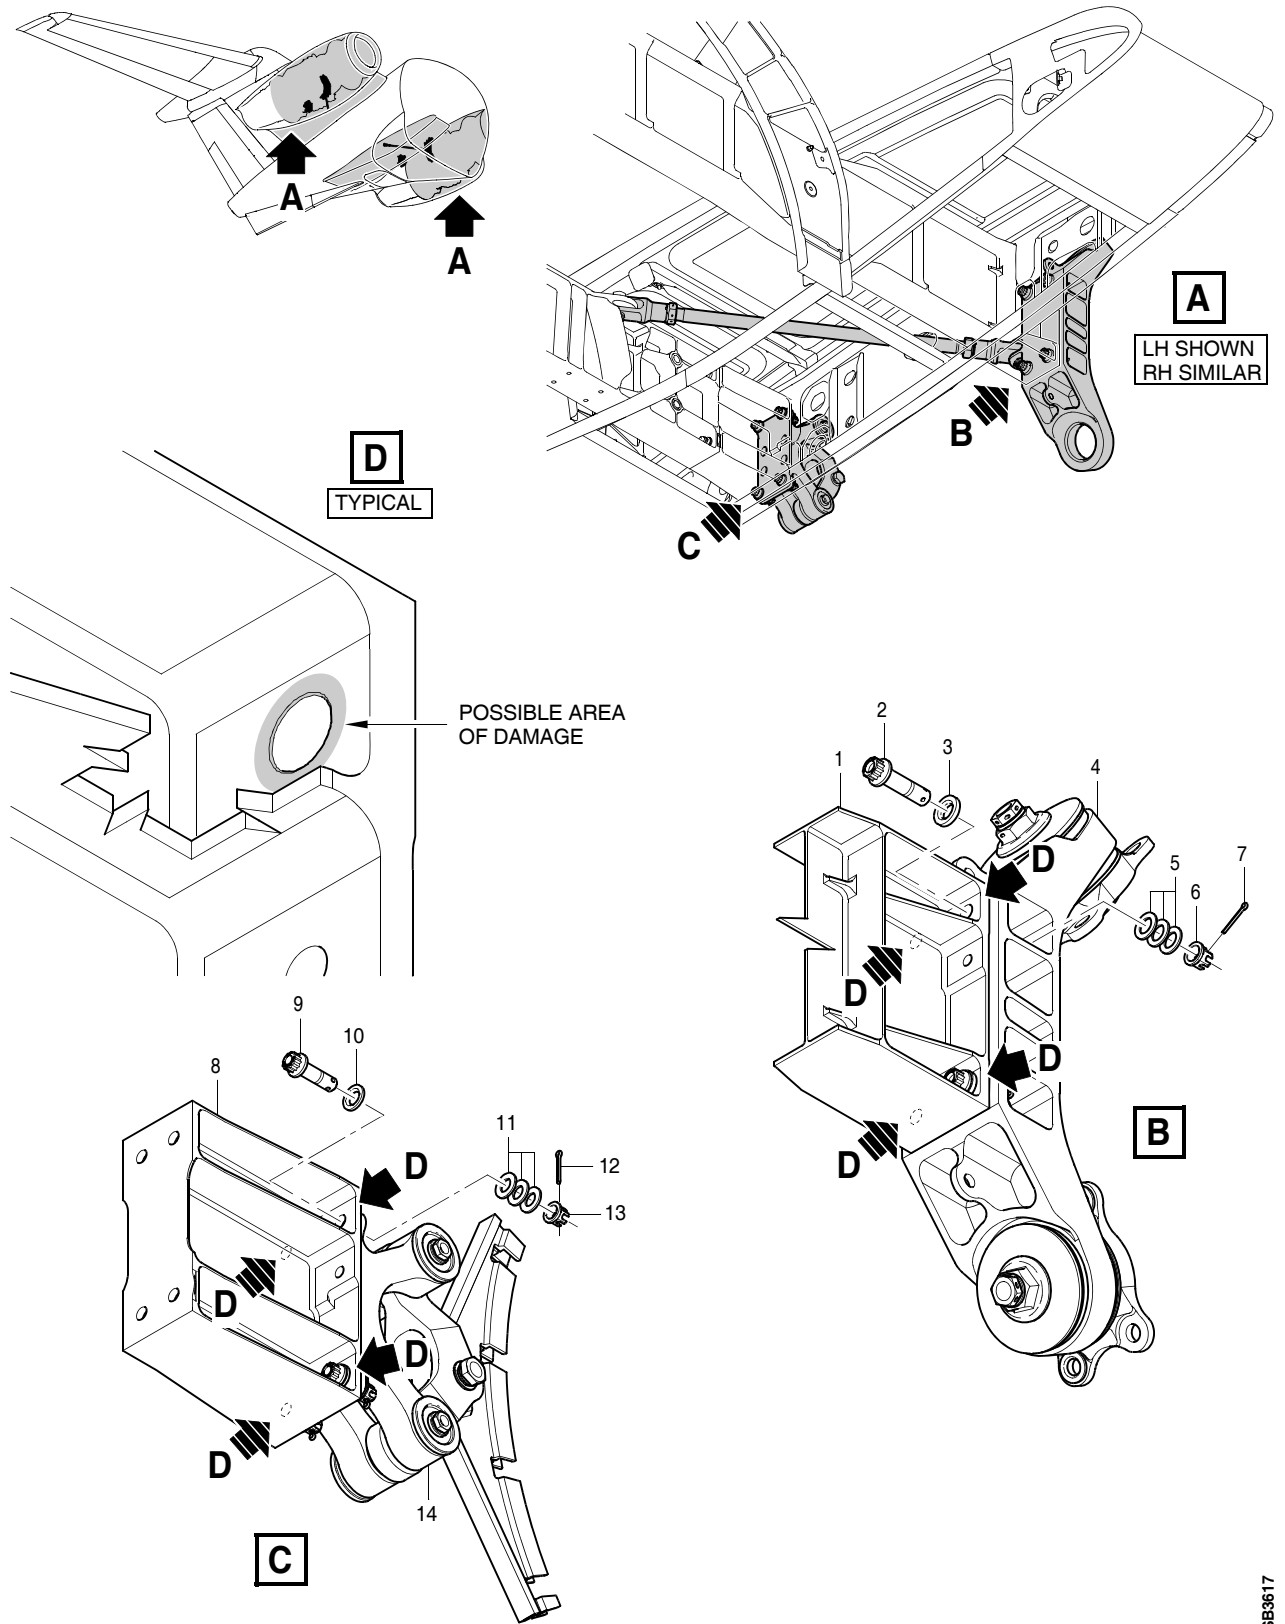
LH/RH Front and rear engine beams - Installation of the washer
Figure 3

NOTE: Due to the bolt (P/N 571.20.24.010) being installed without a washer below the bolt head, the bolt must also be replaced.

NOTE: Due to the bolt (P/N 571.20.24.005) being installed without a washer below the bolt head, the bolt must also be replaced.

- (a) Remove and discard the cotter pin (7).
- (b) Remove the castellated nut (6), the three washers (5) and the bolt (2) that attach the front engine beam (1) to the yoke (4). Discard the bolt (2).
- (c) Use a clean lint-free cleaning cloth (Material No. P02-041) made moist with solvent (Material No. P01-010) and clean the area around the bolt hole.

- (d) Do an Eddy Current NDT inspection for damage around the bolt hole. Refer to SRM PC24-A-E51-20-0006-00A-353A-A.
 - 1 If you find damage, contact Pilatus Aircraft Ltd.

- 2 If you do not find damage, continue from the next step below.
- (e) Apply a thin layer of aeroshell grease 58 (Material No. P04-041) on the shank and threads of a new bolt (2) (P/N 571.20.24.010).

- (f) Loosely install a new washer (3) (P/N 571.20.24.009), the new bolt (2), the three washers (5) and the castellated nut (6). Use a new castellated nut (6) (P/N 560.20.99.012) if necessary.

- (g) Torque the castellated nut (6) to between 487 and 540 in-lb (55 and 61 Nm) plus the run-down torque. Refer to AMM PC24-A-E20-20-0001-00A-040A-A.
- (h) Safety the castellated nut (6) with a new cotter pin (7) (P/N 940.17.02.520).

- (c) Remove the castellated nut (13), the three washers (11) and the bolt (9) that attach the rear engine beam (8) to the aft isolator assembly (14). Discard the bolt (9).

- (e) Do an Eddy Current NDT inspection for damage around the bolt hole. Refer to SRM PC24-A-E51-20-0006-00A-353A-A.
 - 1 If you find damage, contact Pilatus Aircraft Ltd.

- 2 If you do not find damage, continue from the next step below.
- (f) Apply a thin layer of aeroshell grease 58 (Material No. P04-041) on the shank and threads of a new bolt (9) (P/N 571.20.24.005).

- (g) Loosely install a new washer (10) (P/N 938.77.10.244), the new bolt (9), the three washers (11) and the castellated nut (13). Use a new castellated nut (13) (P/N 560.20.99.018) if necessary.

- (h) Torque the castellated nut (13) to between 194.7 and 256.7 in-lb (22 and 29 Nm) plus the run-down torque. Refer to AMM PC24-A-E20-20-0001-00A-040A-A.
- (i) Safety the castellated nut (13) with a new cotter pin (12) (P/N 940.17.02.520).
- (j) Do the above procedure again, as necessary, to install/replace a washer (10)/bolt (9) at any other applicable attachment point.
- (k) If removed, install the shut-off valve(s). Refer to AMM PC24-A-E36-10-0004-00A-720A-A.
