Bundesamt für Zivilluftfahrt (BAZL) Office fédéral de l'aviation civile (OFAC) Ufficio federale dell'aviazione civile (UFAC) Federal Office for Civil Aviation (FOCA) Maulbeerstasse 9 CH-3003 Berne Switzerland		Lufttüchtigkeitsanweisung (LTA) Consigne de Navigabilité (CN) Prescrizione di Aeronavigabilità (PA) Airworthiness Directive (AD)	FOCA AD  HB 1994-087R1
Inkraftsetzung Mise en vigueur Entrata in vigore Effective Date	06 April 1994		Revises HB 94-087

REAR FUSELAGE • Reinforcement between bulkhead 12 and 13.

## **SERVICE BULLETIN**

### **REAR FUSELAGE - REINFORCEMENT BETWEEN BULKHEADS 12 AND 13**

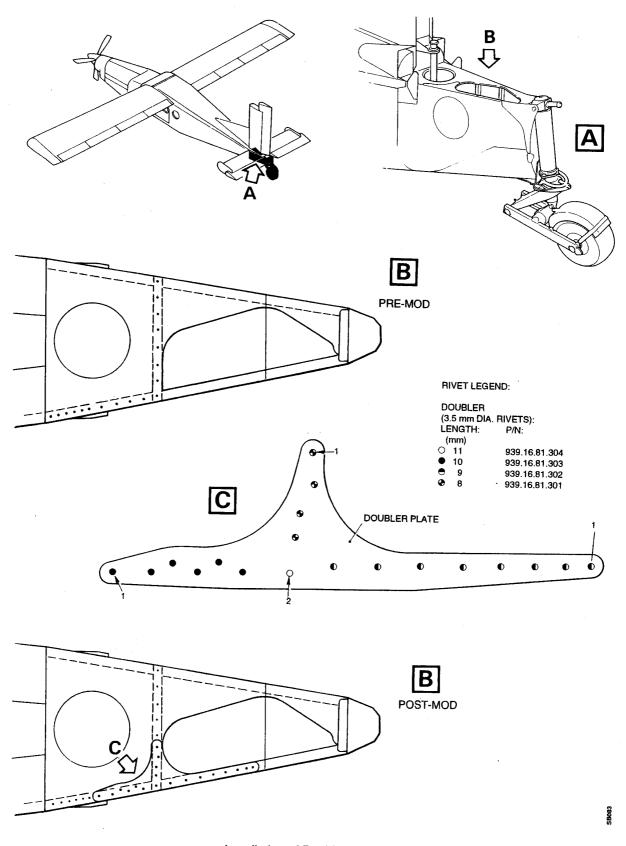
Installation of Doubler Modification Figure 1

To reinforce the rear fuselage section (between bulkheads 12 and 13) when the modified tail wheel (P/N: 114.45.06.050) is fitted.

(1) Install the doubler plate (P/N: 112.36.06.114) on the top of the fuselage box (Ref. Fig. 1):

- (a) Remove rivets, from the fuselage top surface, which are covered by the doubler.
- (b) Clamp the doubler plate in position, as the template.
- (c) Drill oversize (3.6 mm) the three peripheral holes (1) and secure with grip pins.

- (d) Drill oversize (3.6 mm) the center hole (2) and secure with a grip pin.
- (e) Drill oversize (3.6 mm) all holes as shown in the riveting template (Detail C).

- (f) Remove the four grip pins (1 and 2).
- (g) Deburr the fuselage and doubler plate, restore surface treatment and allow to dry.
- (h) Replace the doubler and secure with the four grip pins.
- (i) Rivet holes as shown in riveting plan/legend.
- (j) Remove the four grip pins and rivet the holes as per riveting plan/legend.
- (k) Paint rivets, top and bottom, with yellow wash primer and allow to dry.
- (2) Install the two RH stringers (1 and 2) (P/N's: 112.36.06.112 and 112.36.06.113) on the right inner fuselage wall:
