SERVICE BULLETIN

SERVICE BULLETIN NO: 53-001

FUSELAGE - REAR FUSELAGE STABILIZER-TRIM ATTACHMENT COMPONENTS - INSPECTION

PILATUS
PC-6
SERVICE BULLETIN

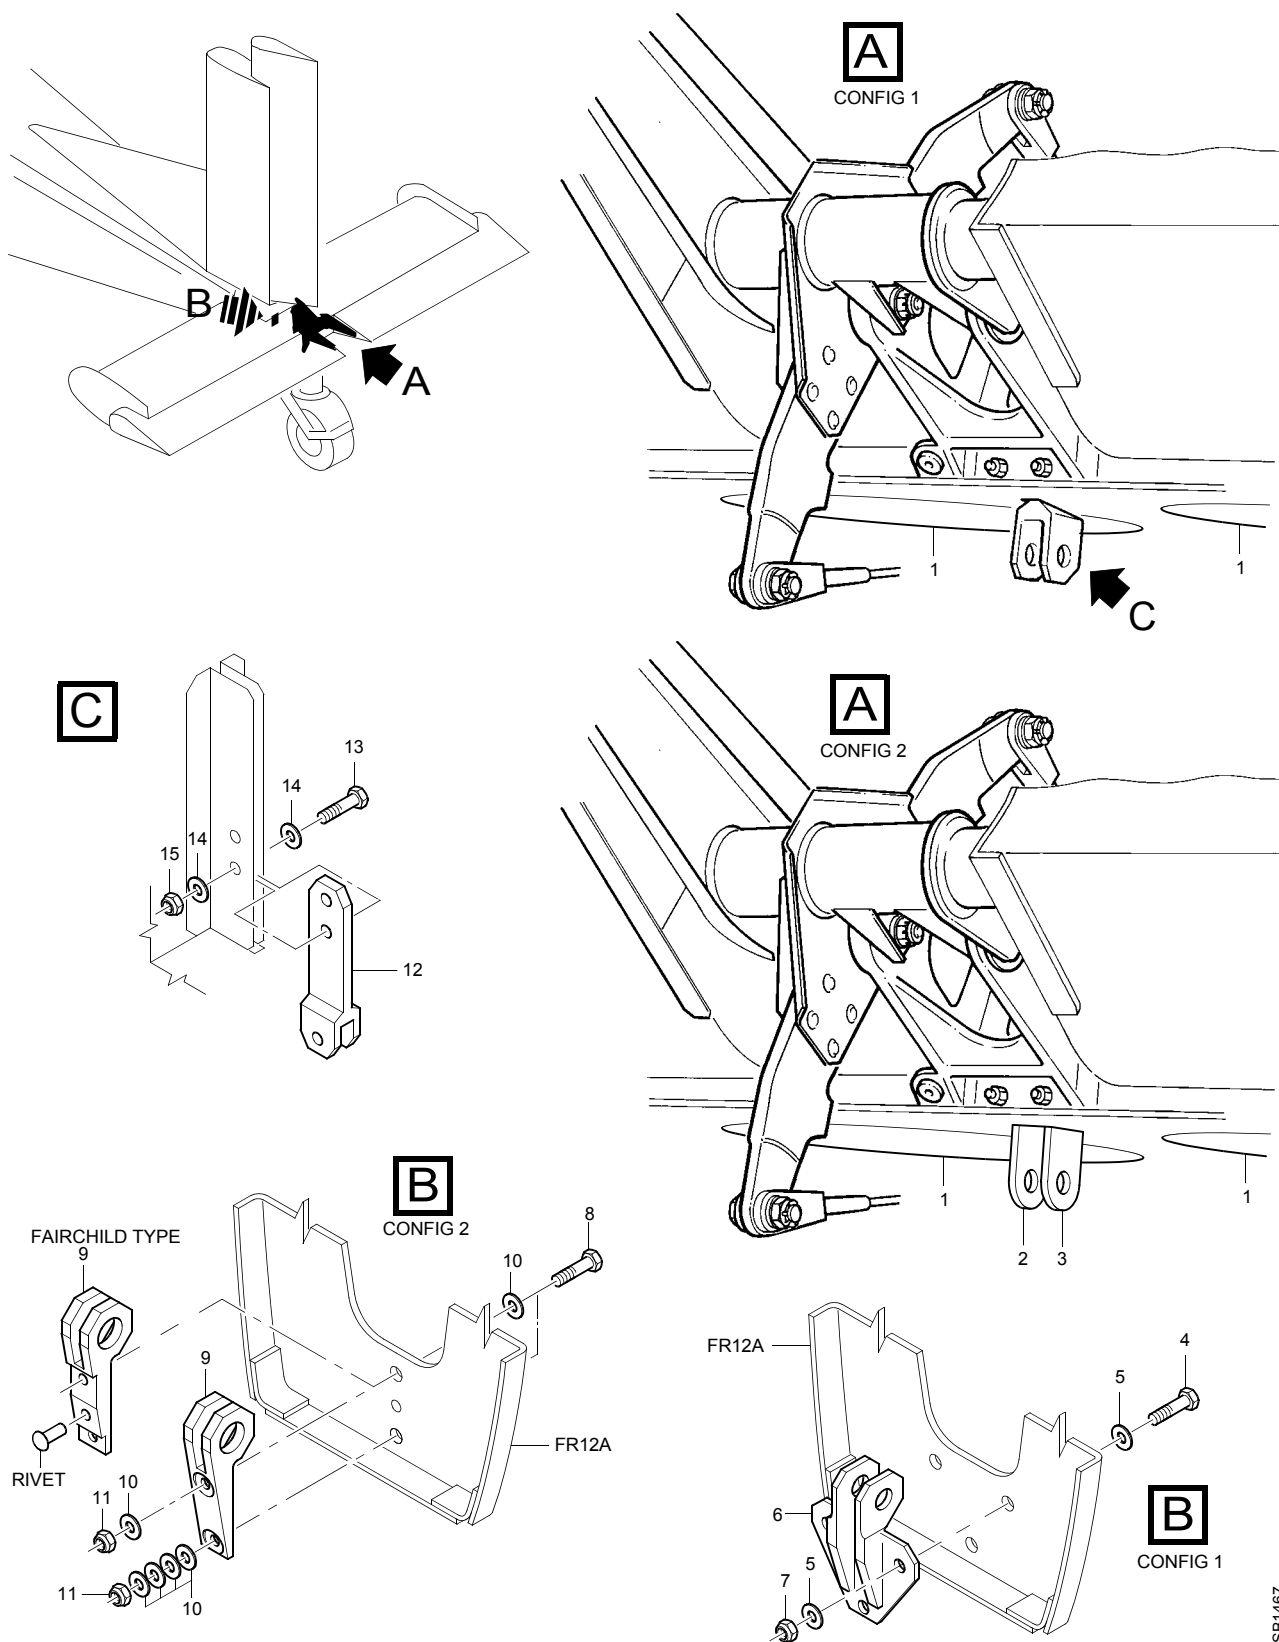
Stabilizer-trim Attachment Components - Inspection and Replacement
Figure 1

It is possible for cracks to occur in the following stabilizer-trim attachment and structural components in PC-6 aircraft:

- Fitting (116.40.06.112) or (116.40.06.033) in aircraft with electrical horizontal-stabilizer control-systems (CONFIG 1)
- Connecting piece (6232.0026 - all variants) in aircraft with mechanical horizontal-stabilizer control-systems (CONFIG 2)
- Bearing fork (116.40.06.034) in all horizontal stabilizers (CONFIG 1)
- Bearing support assembly (6304.0023) (Ref. Fig 1, Items 2 and 3)

- The location on the surface of FR12a where the fitting (6) or connecting piece (9) was installed
 - (b) Obey the manufacturers instructions and use dye flaw detection procedures (fluorescent or color contrast) to do inspections for cracks in the fitting (6) or connecting piece (9) and the bearing fork (12) or bearing supports (2) and (3) and the applicable area of RF12a. No crack damage is permitted. You must replace:

- Cracked components (Ref. Table - Component Replacement Data)
 - The two bearing supports (2) and (3) if only one is found cracked
 - FR12a if cracks are found

- (2) Use a X10 magnifier and a source of bright light to do an inspection of FR12a for crack damage and signs of corrosion. Crack damage is not permitted. You must replace FR12a (Ref. ROM, Chap 2). Surface corrosion is permitted if not less than 90% of the material thickness remains after the corrosion is removed (Ref. ROM, Chap 12).

- (a) Do inspections for crack damage in the applicable stabilizer-trim attachment components and replace defective parts as necessary. No cracks are permitted. All crack damaged components must be replaced.
- (b) Replace Fairchild type connecting pieces (6232.0026) (CONFIG 2) with PILATUS type connecting pieces (6232.0026) without inspection, to prevent possible crack damage problems.
- (c) Replace fittings 116.40.06.033, without an index after the part number, (Ref. Fig. 2) with fittings 116.40.06.033, with an index after the part number or 116.40.06.112, without inspection, to prevent possible crack damage problems.

- (1) Remove the fitting (6). This step is only applicable for CONFIG 1 aircraft.
 - (a) Remove the nuts (7), washers (5), bolts (4).
 - (b) Remove the fitting (6) from FR12a.
 - (c) Discard the fitting if it is P/N 116.40.06.033, without an index after the part number.

- (d) Put the fitting (6) in position on FR12a and install the bolts (4), washers (5) and nuts (7).
 - (e) Obey the manufacturers instructions and use the solvent (Item No. P01-008 or approved alternative) to remove unwanted corrosion preventative.

- (ii) Put the bearing fork (12) in position and install the, bolts (13), washers (14) and the nuts (15).
 - (iii) Obey the manufacturers instructions and use the solvent (Item No. P01-008 or approved alternative) to remove unwanted corrosion preventative.

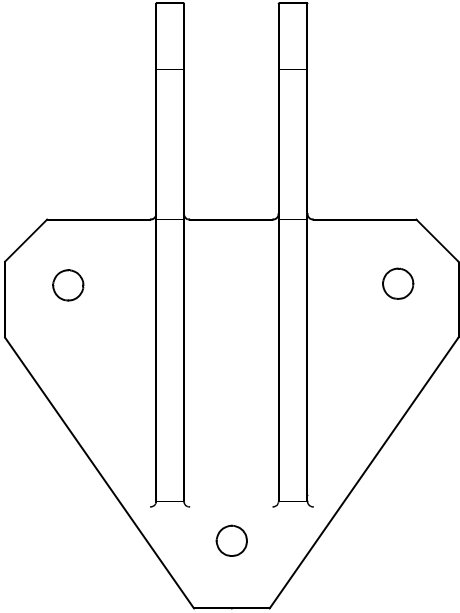
WITHOUT INDEX AFTER
PART NUMBER

NOTE: These fittings can be identified by their lugs having a uniform thickness (Ref. Fig. 2). Fittings (116.40.06.033) with index A or B after the part number (which can be identified by their unequal lugs thickness) (Ref. Fig. 2) are not affected.

NOTE: These fittings can be identified by their lugs having a uniform thickness (Ref. Fig. 2). Fittings (116.40.06.033) with index A or B after the part number (which can be identified by their unequal lugs thickness) (Ref. Fig. 2) require the inspection to be carried out.

Operators who have complied with the original issue of this Service Bulletin (Issue Feb 16/05), do not have to repeat the inspection. They have to get access to the fitting and do a check of part number of the fitting. If the fitting is P/N 116.40.06.033, without an index after the part number, the fitting has to be replaced.

- (1) Discard all fittings (6) P/N116.40.06.033, without an index after the part number.
