PILATUS AIRCRAFT LTD. STANS, SWITZERLAND

SERVICE BULLETIN

Service Bulletin No: 27-005 Ref No: 223

FLIGHT CONTROLS - FLAPS - FLAP ACTUATOR - PUSHROD ASSY INSPECTION FOR INCORRECTLY INSTALLED TAPER PINS AND POSSIBLE REWORK

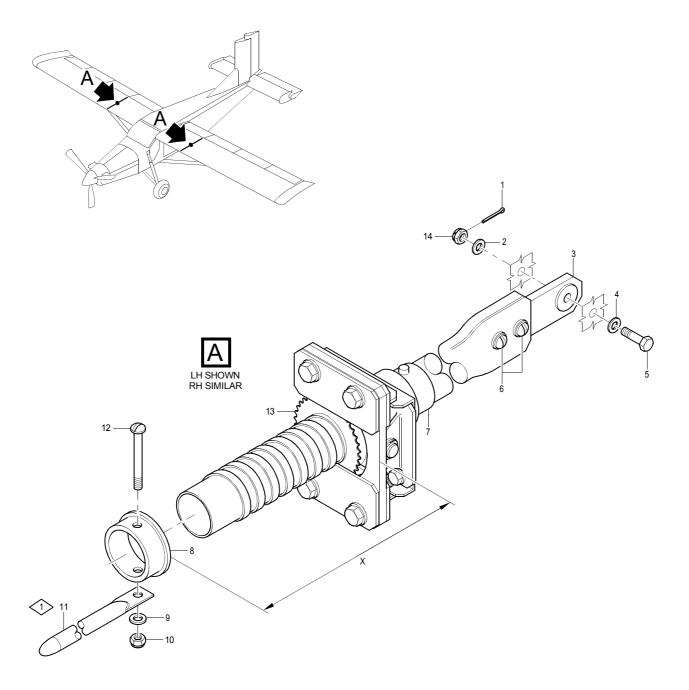
Pushrod Assy - Removal and Installation Figure 1

LH WING ONLY.
DIMENSION X IS MEASURED FROM THE AFT SURFACE OF THE STOP (8)
TO THE FORWARD SURFACE OF THE GUIDE PLATE BEFORE THE STOP (8)
IS REMOVED FROM THE PUSHROD ASSY (7).

- (1) Extend the flaps.
- (2) Move the handle of the drive assy back until you hear one or two audible clicks. This is to release the spring load of the flap chain. This is necessary to remove the pushrod assy (7) only (without removal of the full flap actuator assy).

D. Install the Pushrod Assy (Ref. Fig. 1)

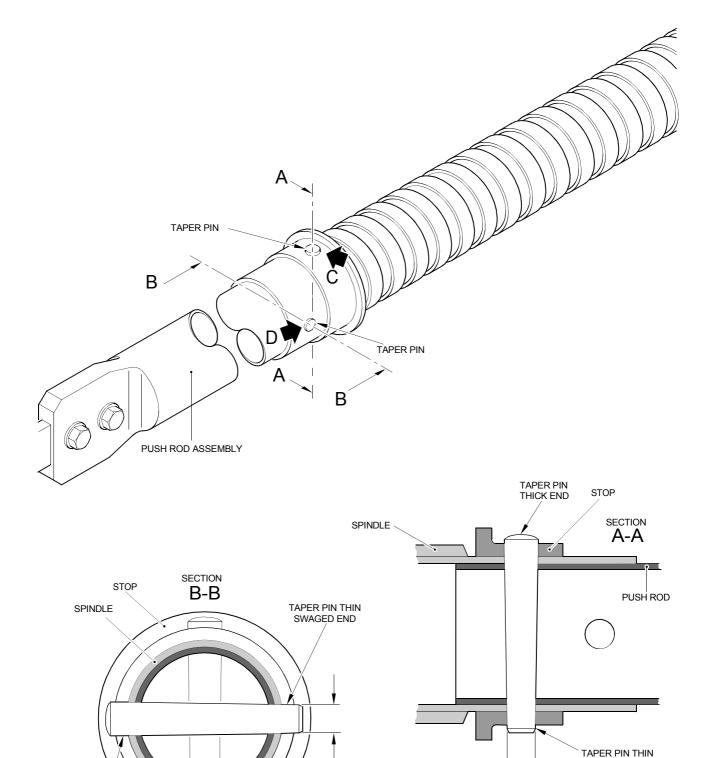
Pushrod Assy - Inspection and Rework of Taper Pin Installation Figure 2 (Sheet 1 of 3)

During a recent PC-6 overhaul two new flap actuators were found to have the taper pins incorrectly installed (not swaged). The taper pins were retained by friction but can potentially become loose due to not being swaged (no form-fit locking).

The taper pins were not correctly swaged in position during manufacture.

- (1) Fully clean the spindle, the stop and taper pin heads with absorbent paper (Material No. P02-031) made moist with solvent (Material No. P01-008) on each pushrod assy.
- (2) Examine the two taper pins installed in each pushrod assy:
 - (a) Damaged or unserviceable taper pins must be replaced. If necessary, cut or drill out the swaged end to remove the damaged taper pin and swage a new taper pin in position (refer to Step 3.C.).
 - (b) Do a check that the thin end of each taper pin has been swaged.
 - (c) If necessary, measure the diameter of the thin end of each taper pin (Ref. Fig. 2, Sections A-A and B-B):
 - The minimum diameter is 5,15 mm (0.203 in.)
 - If the diameter is less than 5,15 mm (0.203 in.) the tapered pin has not been swaged correctly. You must do the taper pin swage procedure, refer to Step 3.C.
- (3) Install the pushrod assemblies, Ref. Step 3.D.

- (1) You must only do this procedure for each taper pin that has failed the inspection procedure
- (2) Measure the protrusion of the taper pin at each end (Ref. Fig. 2, Views C and D):
 - The thick end (un-swaged) must protrude between 0,7 mm (0.028 in.) and 3 mm (0.118 in.).
 - The thin end (to be swaged) must protrude between 1,0 mm (0.039 in.) and 2,5 mm (0.098 in.).
- (3) If necessary, remove the taper pin (cut or drill out the swaged end) and install the longer alternative taper pin (P/N 940.29.09.379) and do Step 3.C.(2) again.
