Service Bulletin No: 57-006

**WINGS - AILERONS  
INSPECTION OF THE AILERON MASS-BALANCE COUNTERWEIGHT ATTACHMENT****1. Planning Information****A. Effectivity**

Pilatus PC-6 Series aircraft MSNs 337 thru 1005.

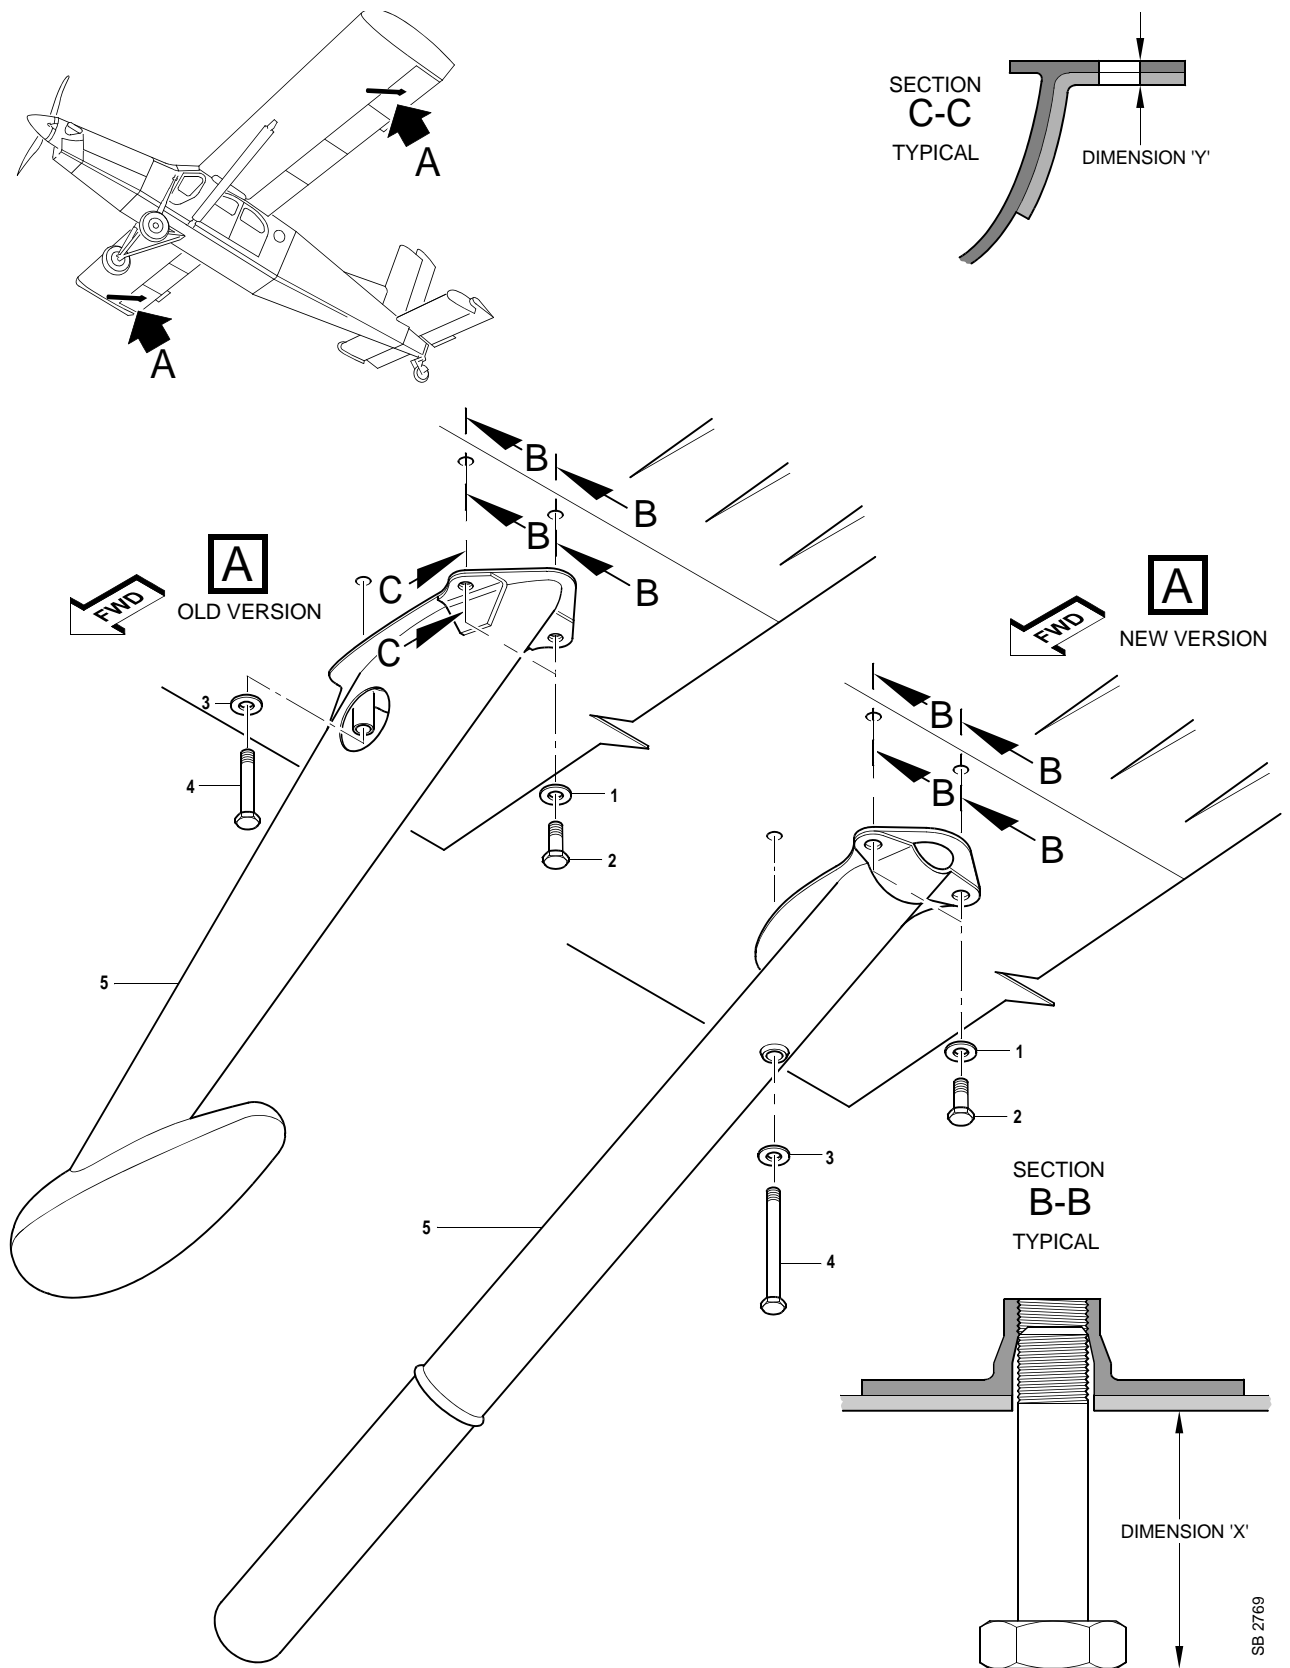
Aileron Balance-Weight Attachment - Inspection/Check  
Figure 1

There are old and new versions of counterweight and it is possible that some bolts that attach the counterweight to the aileron can have inadequate thread engagement.

Several combinations of anchor nuts, bolts and washers can be installed at the aft attachment points. Also, the thickness of the mounting flange on the old version counterweight can vary. Some combinations of counterweight and attaching parts can result in reduced thread engagement.

- (a) Use absorbent paper (Material No. P02-031) made moist with solvent (Material No. P01-008) to clean the surface of the aileron around the two aft attachment holes.
- (b) Put a new bolt (2) (P/N 932.53.47.009) into one of the two aft attachment holes and turn it until the threads engage in the anchor nut.
- (c) Turn the bolt (2) back until it is released from the anchor nut and hold it in this position.
- (d) To determine the type of anchor nut installed, measure the Dimension 'X' as shown on Figure 1, Section B - B.

- 1 If necessary, remove any thick paint from the flange to permit an accurate measurement.
- 2 Measure the Dimension 'Y', as shown on Figure 1, Section C - C, at the flat surface where the washer is installed.

Do an inspection/check to determine the type of anchor nuts installed at the aft attachment points and, if necessary, the thickness of the mounting flange, then install the counterweight with new bolts and the correct washers.

- (a) For each of the two aft attachment positions, refer to Table 1 and determine the correct type and quantity of washers to be installed.

- (b) Support the counterweight (5) in the installed position.
- (c) Install the removed bolt (4) and washer (3).
- (d) At each of the two aft attachment positions, install a new bolt (2) (P/N 932.53.47.009) with the correct type and quantity of washers (1).
- (e) Torque tighten the bolts (2) and (4) to between 3,9 and 4,5 Nm (35 and 40 lbf. in.).
- (4) Do the procedures again for the right outboard aileron.
