PILATUS AIRCRAFT LTD. STANS, SWITZERLAND

Modification No:	INSPECTION	ATA Chapter:	27
Service Bulletin No:	27-006	Ref No:	222

FLIGHT CONTROLS - RUDDER - RUDDER SHAFT ASSY INSPECTION FOR APPROVED RIVET CONFIGURATION

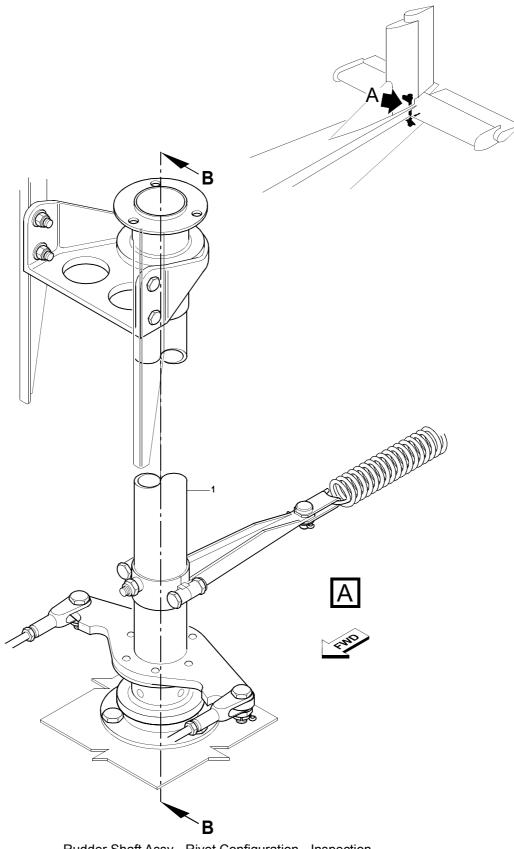
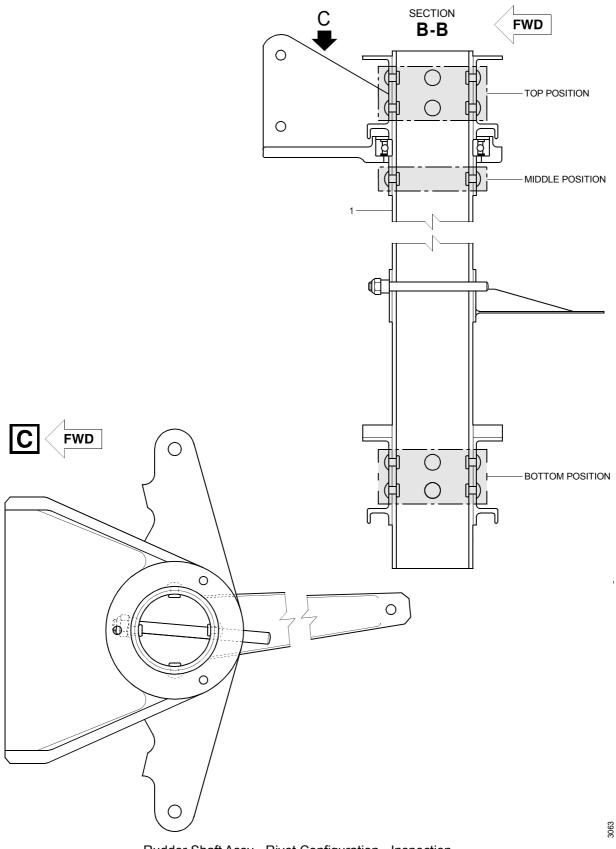
Rudder Shaft Assy - Rivet Configuration - Inspection Figure 1 (Sheet 1 of 2) 3062

Incorrect rivet configurations on the rudder shaft assy have been discovered during a postevent investigation.

The tapered pins of the original design of the rudder shaft assy were replaced with an insufficient quantity of rivets of unknown origin.

- (1) Make absorbent paper (Material No. P02-031) moist with solvent (Material No. P01-008) and fully clean the work area of each of the rivet positions.
- (2) Examine the rudder shaft assy (1) as follows:
 - **NOTE:** If necessary you can remove the rudder shaft assy (1) from the aircraft to do the inspection (Ref. AMM 27-22-01, Page Block 401).
 - (a) Identify and make a record of the quantity, type and size of rivets installed at:
 - Top Position
 - Middle Position
 - Bottom Position.

- (b) If you cannot identify the rivets easily then continue as follows:
 - <u>1</u> Use the applicable diameter drills to remove the rivets (Ref. SRM 51-00-03, Page Block 1).
 - <u>2</u> Measure the hole diameters and contact Pilatus Aircraft Ltd for repair instructions before the next flight.
- (c) If you find any other damage to the rudder shaft assy (1) you must contact Pilatus Aircraft Ltd for repair instructions before the next flight.
- (3) Make sure that the rivet configuration at each position is in accordance with Table 1:

• If the rivet configuration is not an approved design you must contact Pilatus Aircraft Ltd for repair instructions before the next flight.
