Service Bulletin No: 53-003

ATA Chapter: 53

**FUSELAGE - REAR FUSELAGE
STABILIZER-TRIM ATTACHMENT COMPONENTS - INSPECTION****1. Planning Information****A. Effectivity**

Pilatus PC-6 Series aircraft MSNs 337 thru 1005.

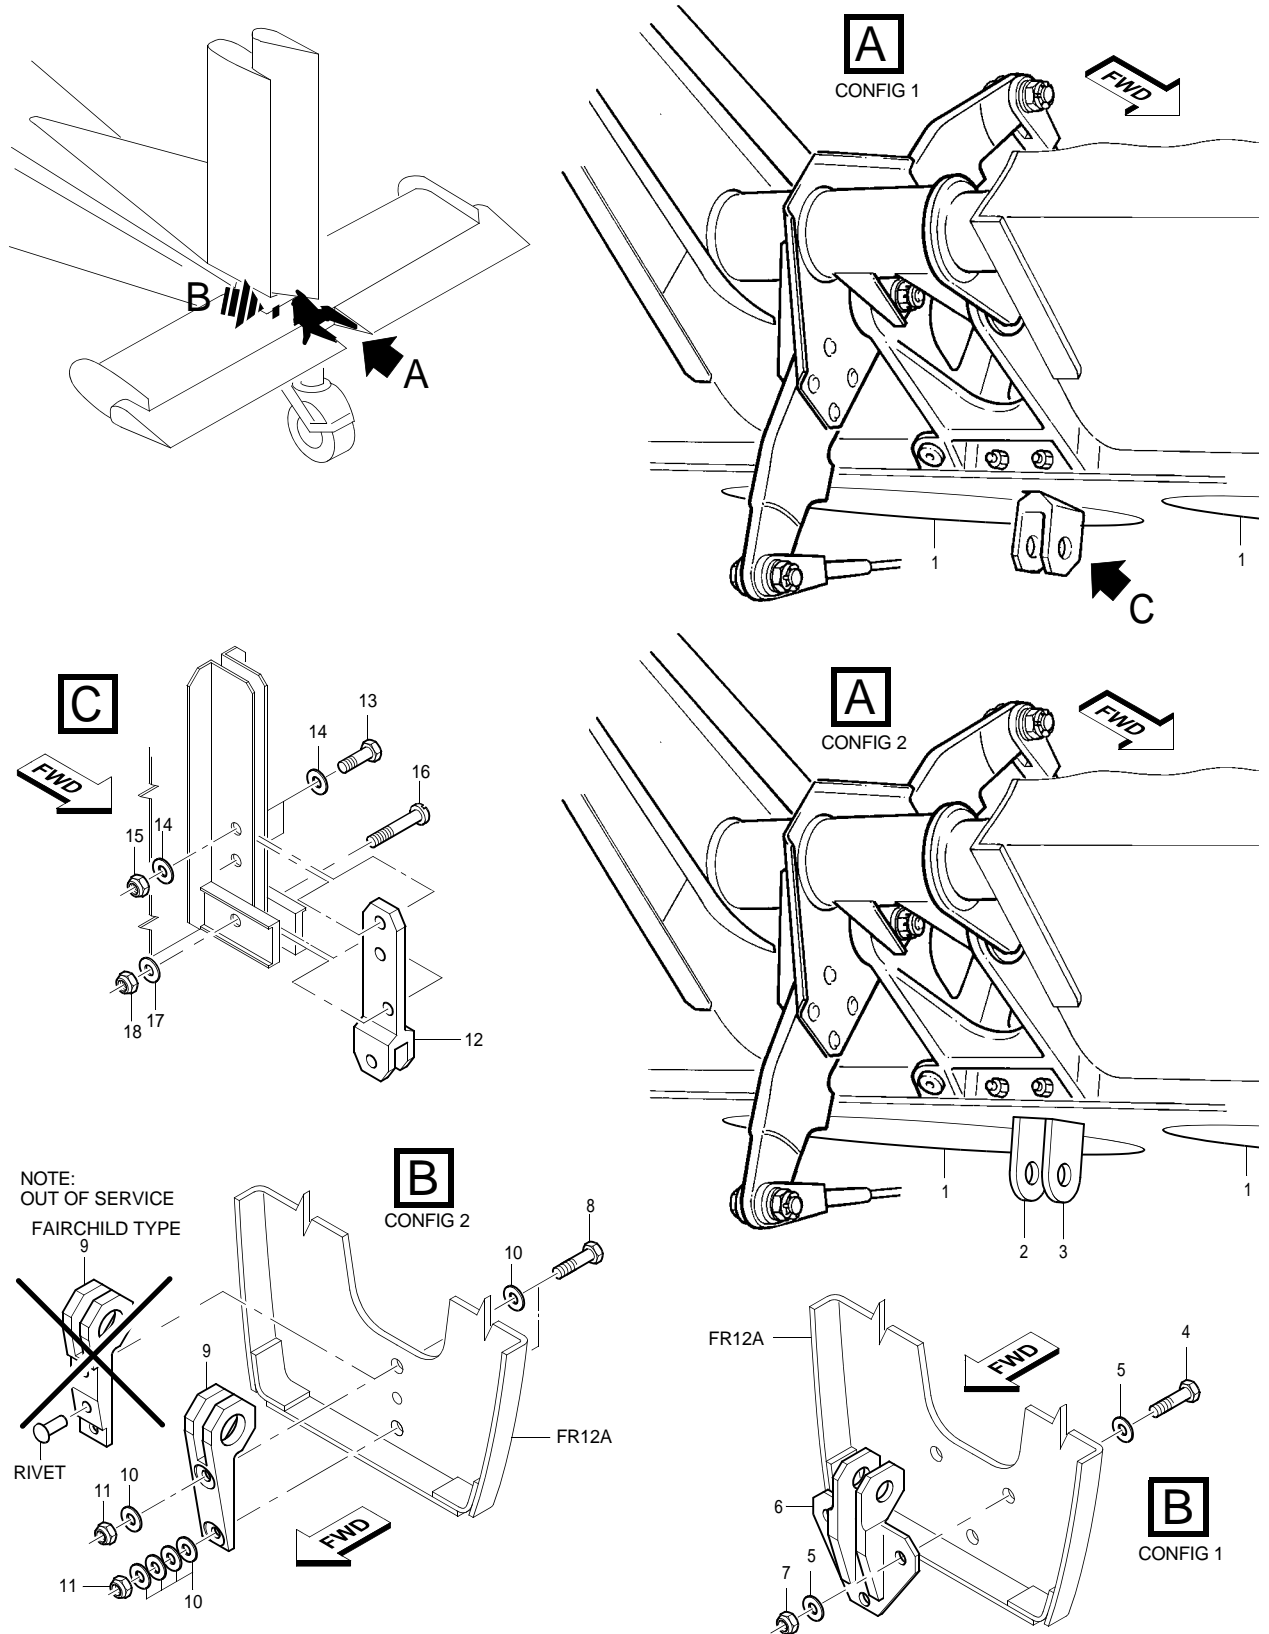
Stabilizer-trim Attachment Components - Inspection and Replacement
 (Riveted Fairchild Type was Removed by SB 53-001 Rev. 1)
 Figure 1

Wear and cracks have been reported in the following Post SB 53-001 R1 stabilizer-trim attachment and structural components:

- Fitting (116.40.06.112) or (116.40.06.033) in aircraft with electrical horizontal-stabilizer control-systems (CONFIG 1 aircraft)
- Connecting piece (6232.0026 - all variants) in aircraft with mechanical horizontal-stabilizer control-systems (CONFIG 2 aircraft).

It is possible that slightly asymmetric installation and/or operational conditions resulting in strong stabilizer vibration can cause the initiation of cracks.

- Cracked components (Ref. Table 1 - Component Replacement Data)
- The two bearing supports (2) and (3) if only one is found cracked
- FR12a if cracks are found.

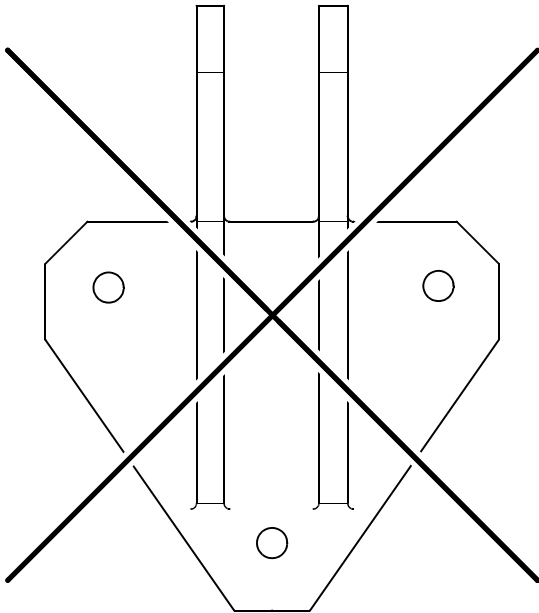
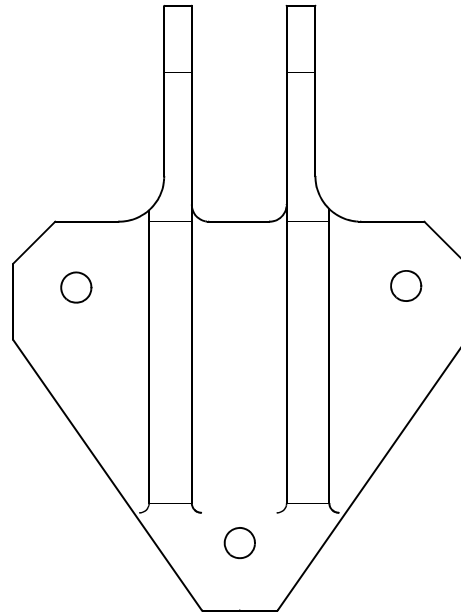
Difference Between Fittings 116.40.06.033
(Fitting Without Index was Removed by SB 53-001 Rev. 1)
Figure 2

NOTE: OUT OF SERVICE

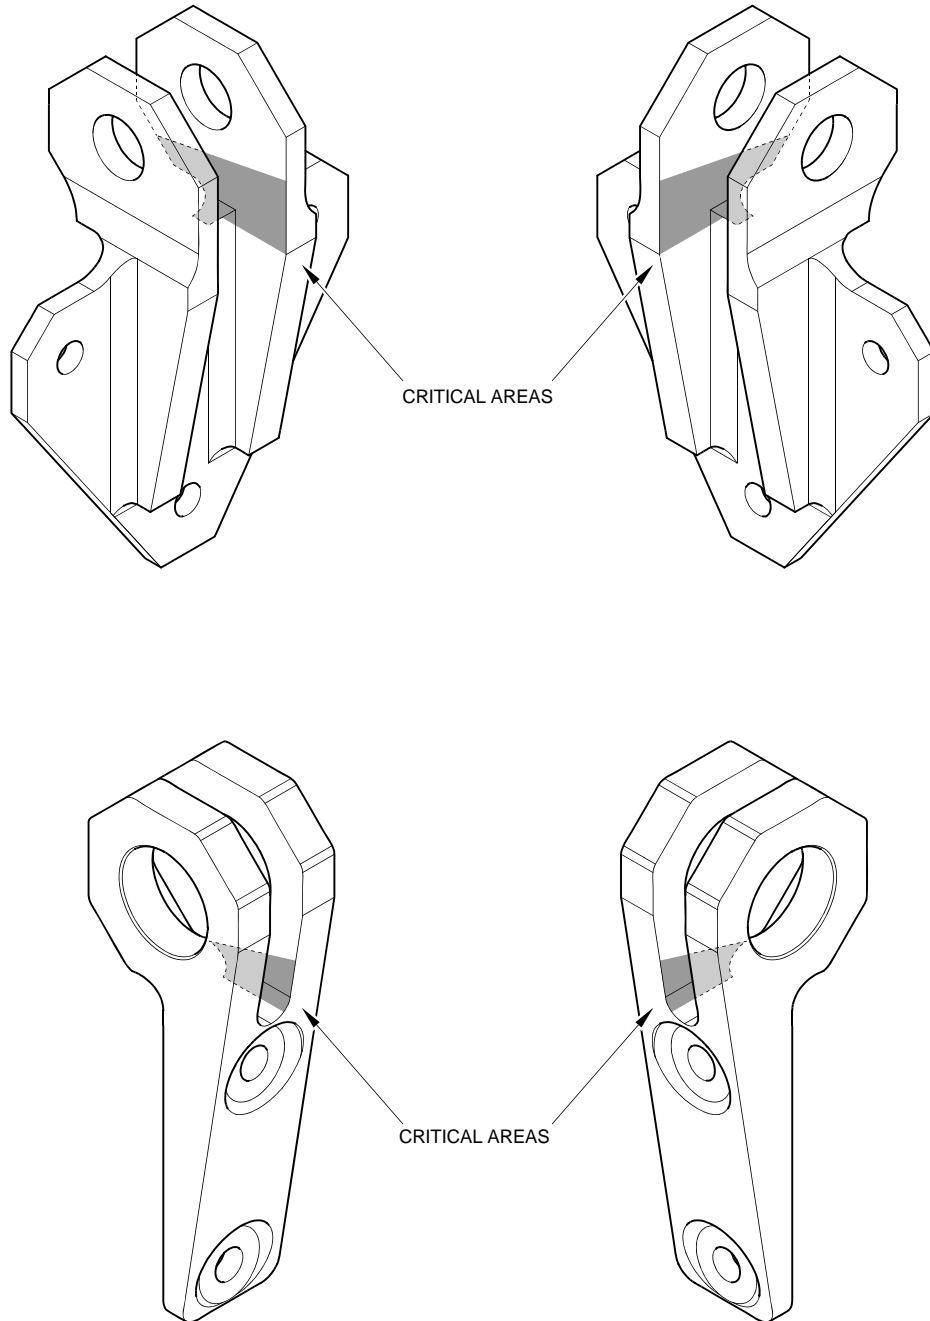
Critical Inspection Areas
Figure 3

- Fitting (6) or connecting piece (9). Make sure you do a thorough inspection of the critical areas shown on Figure 3
- Bearing fork (12) or bearing supports (2) and (3)
- Applicable area of FR12a.
