SERVICE BULLETIN

SERVICE BULLETIN NO: 27-003

FLIGHT CONTROLS - FLAPS REPLACEMENT OF THE LEAF SPRINGS IN THE FLAP OPERATING MECHANISM

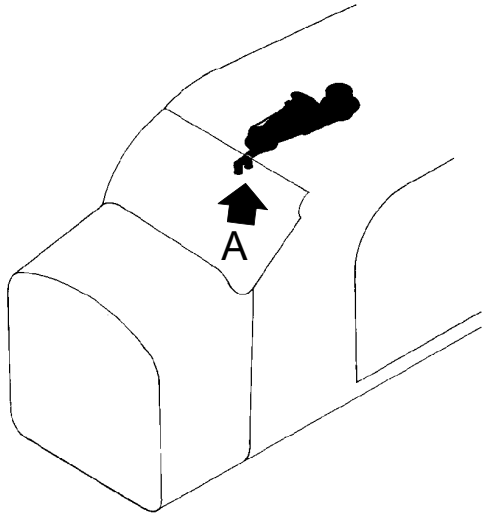
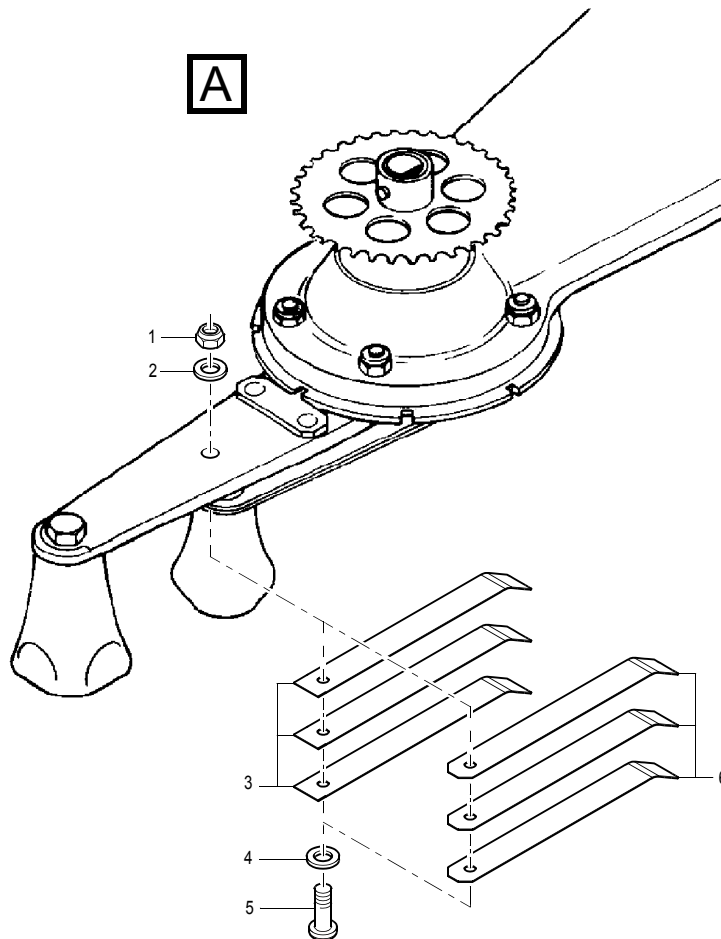
Leaf Springs - Removal / Installation
Figure 1

An Operator reported an un-commanded movement of the flap system. The un-commanded movement was because of cracked leaf springs P/N 6232.0175.01 installed in the overhead flap-operating mechanism of some PC-6 aircraft.

It is possible that the leaf springs P/N 6232.0175.01 were not manufactured correctly.

- (1) Remove the nut (1), the washers (2) and (4) and the screw (5).
- (2) Remove the three leaf springs (3).
- (3) Put the new leaf springs (6) (P/N 116.45.06.040) in position.

NOTE: The new leaf springs (6) (P/N 116.45.06.040) have 45 degree chamfers adjacent to the attachment hole.

- (4) Install the screw (5), the washers (4) and (2) and the nut (1).
