**Lufttüchtigkeitsanweisung  
Consigne de navigabilité  
Prescrizione di aeronavigabilità  
Airworthiness directive**

**HB 90-304**

Pilatus PC-7 aircraft, all serial numbers

**POWER CONTROL SUPPORTING STRUT ASSEMBLY - CRACKING**

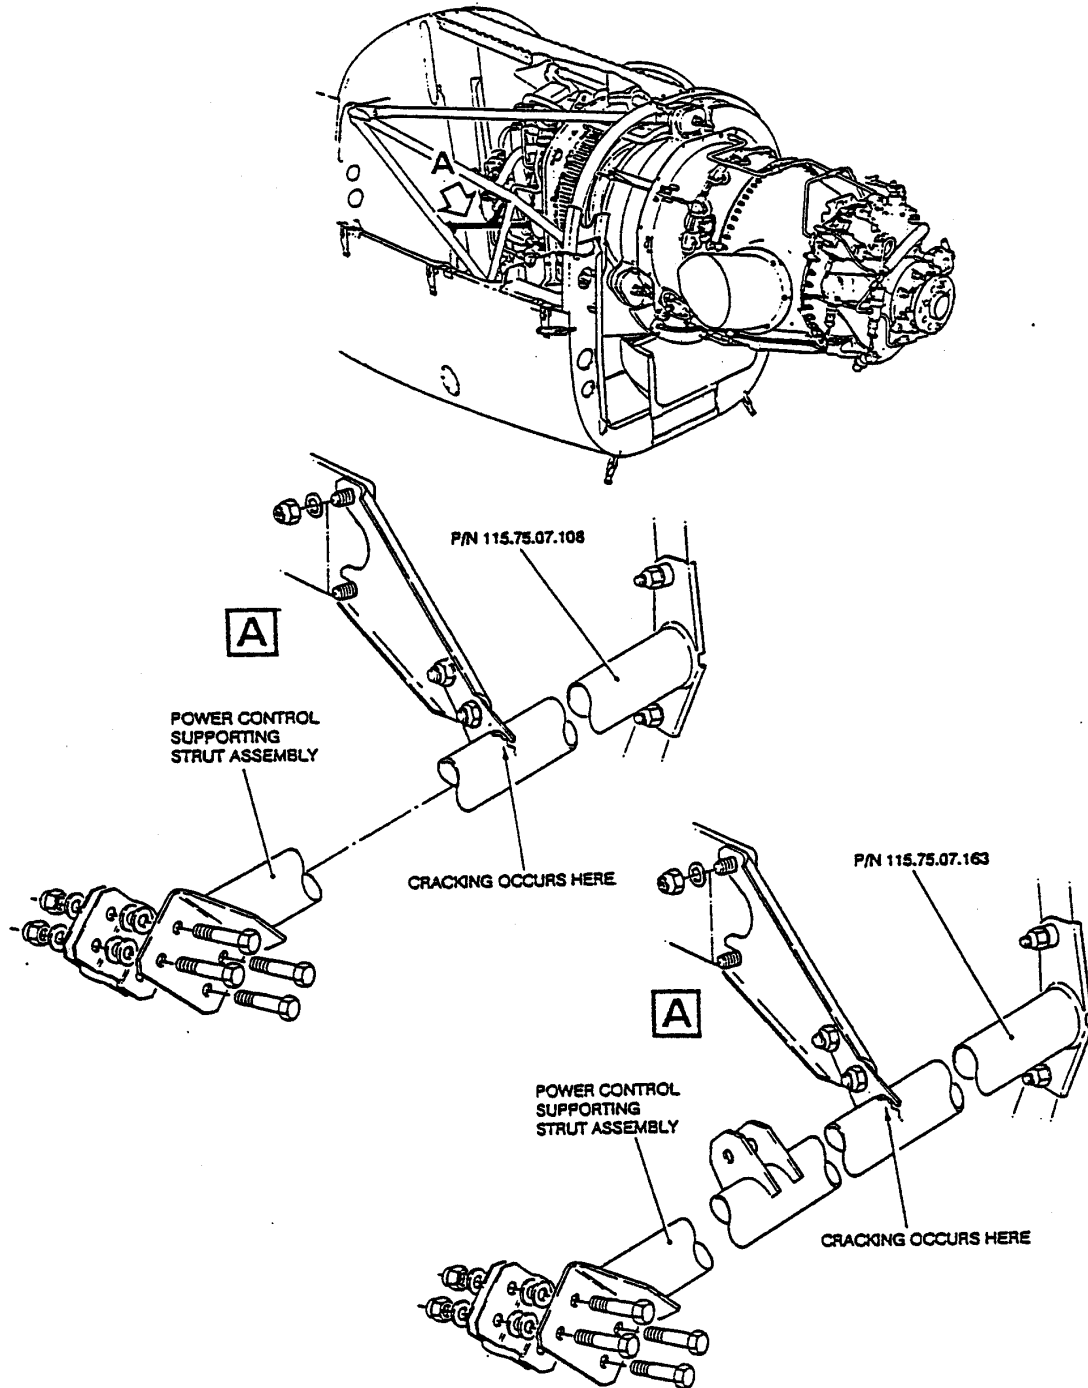
Power Control Supporting Strut - Inspection  
Fig 1

Fatigue cracks have been found on some Power Control Supporting Struts. The struts were cracked at the weld on the HP fuel pump support attachment lug and radially around the strut tube.

- (1) Inspect the weld and the tube structure around from the weld for signs of cracks. Use a torch and mirror.
  - (a). If cracks are found:
    - Replace the support strut before the next flight.
  - (b). If no cracks are found or the strut is replaced:
    - Inspect the support strut every 25 flying hours until further notice.
