<p>Bundesamt für Zivilluftfahrt (BAZL) Office fédéral de l'aviation civile (OFAC) Ufficio federale dell'aviazione civile (UFAC) Federal Office for Civil Aviation (FOCA) 3003 Bern/Berne/Berna</p>	<p>Lufttüchtigkeitsanweisung Consigne de navigabilité Prescrizione di aeronavigabilità Airworthiness directive</p>	<p>HB 91-143</p>
<p>Inkraftsetzung Date en vigueur Entrata in vigore 14.5.1991 Effective Date</p>

All Pilatus PC-7 aircraft

Main Landing Gear (MLG) - Cracks in the main leg housing - Inspection and repair, if necessary

SERVICE BULLETIN NO: PC7-32-013

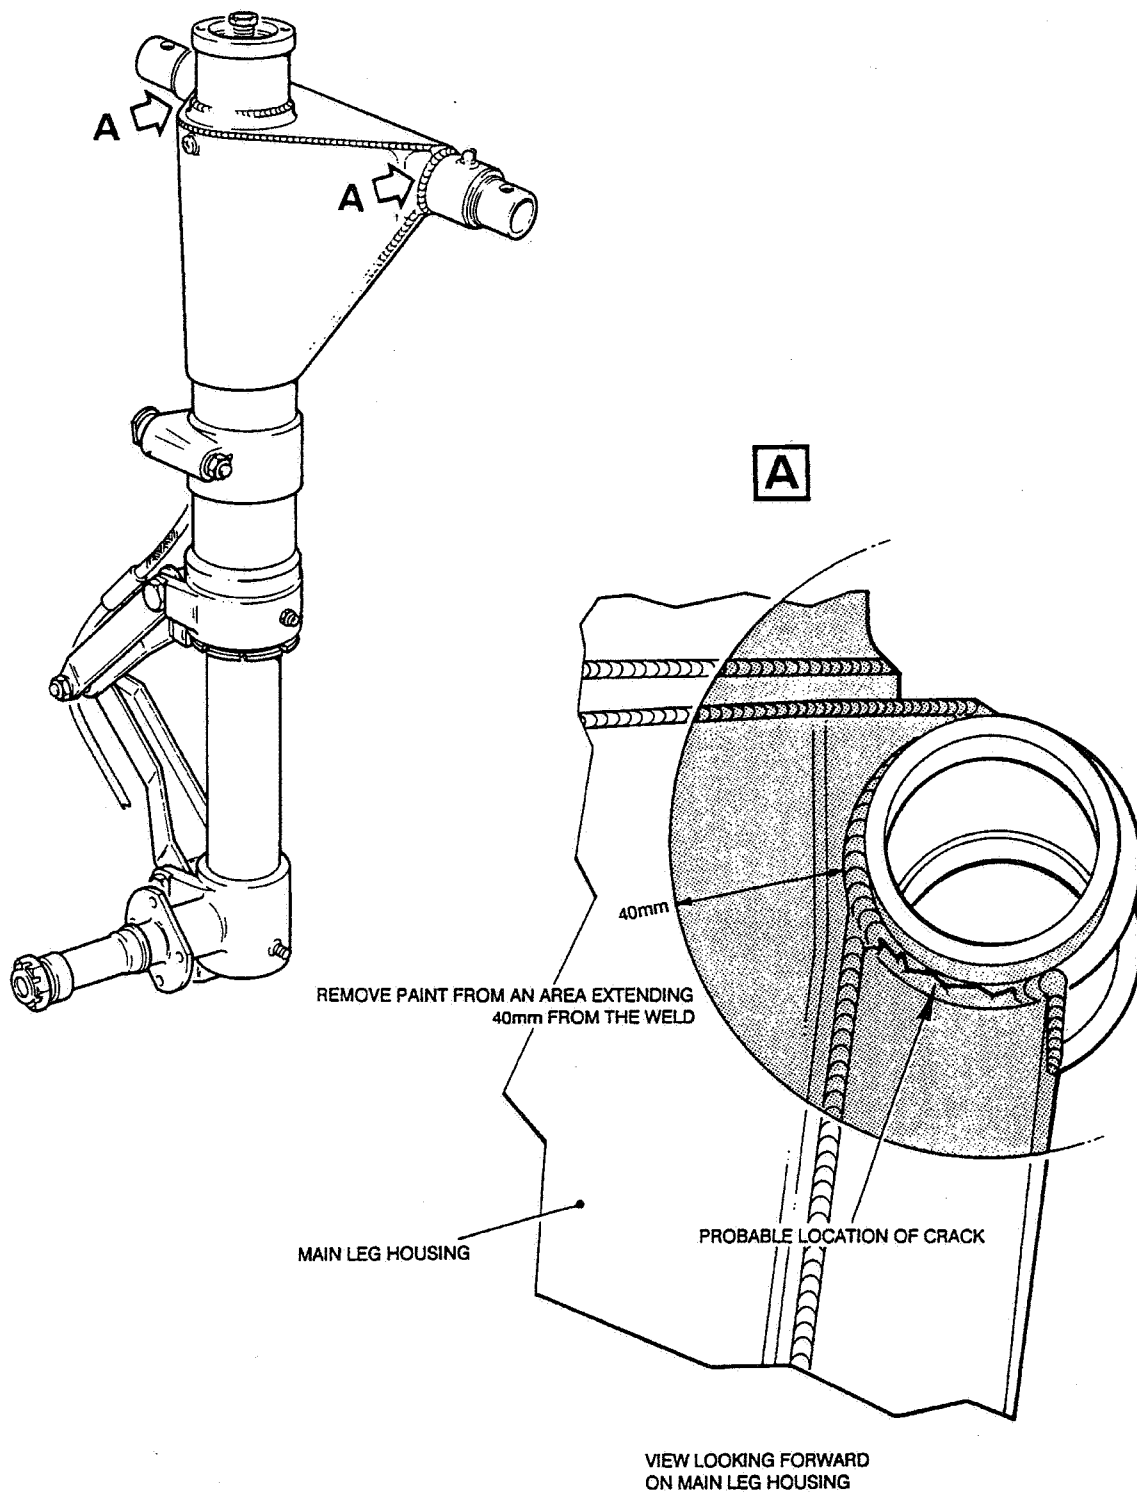
During a heavy landing inspection on a PC-7 aircraft, cracks were found in the leg housings of the main landing gear. The cracks were found in the fabricated part of the leg housing, in the welded seams at the upper axle attachment points (Ref. Fig. 1.).

Subsequent inspections of a number of PC-7 aircraft as a result of this development, have confirmed other cases of cracks in the same location.

The cracks can be extremely difficult to detect, and it is not possible to do an "in situ" inspection with accuracy. The main legs must be removed from the aircraft and they must be inspected using magnetic flaw detection techniques.

Main Landing Gear Installation - Location of Possible Cracks
Figure 1

- (1) Remove the paint from the area to be crack-tested.
- (2) Complete the applicable magnetic flaw detection test(s).
- (3) Repair any cracks which are detected using the TIG welding process.
- (4) Repair the paint finish on the main legs.

Mandatory - To be accomplished within 200 flying hours following receipt of this Service Bulletin.
- Depending on the results obtained, and unless a revision to the SB has been issued, do the following procedures as applicable.

- (i) If no cracks were found during the inspection procedure, repeat the accomplishment instructions of this SB after 1000 flying hours or 2000 landings (whichever comes first).
- (ii) If a crack was found during the inspection procedure and the repair was completed by the Operator, after a further 500 landings, repeat the instructions given in para 2C (Inspection) of the Accomplishment Instructions. If no cracks are found on this inspection, proceed as in para (i) above. If cracks are found, return the defective item(s) to Pilatus for repair.
