# SERVICE BULLETIN

SERVICE BULLETIN NO: 28-004

## FUEL - DISTRIBUTION ENGINE DRIVEN PUMP - TORQUE CHECK OF RELIEF-VALVE-BODY SCREWS

**PILATUS**  
**PC-7 MK II**  
**SERVICE BULLETIN**

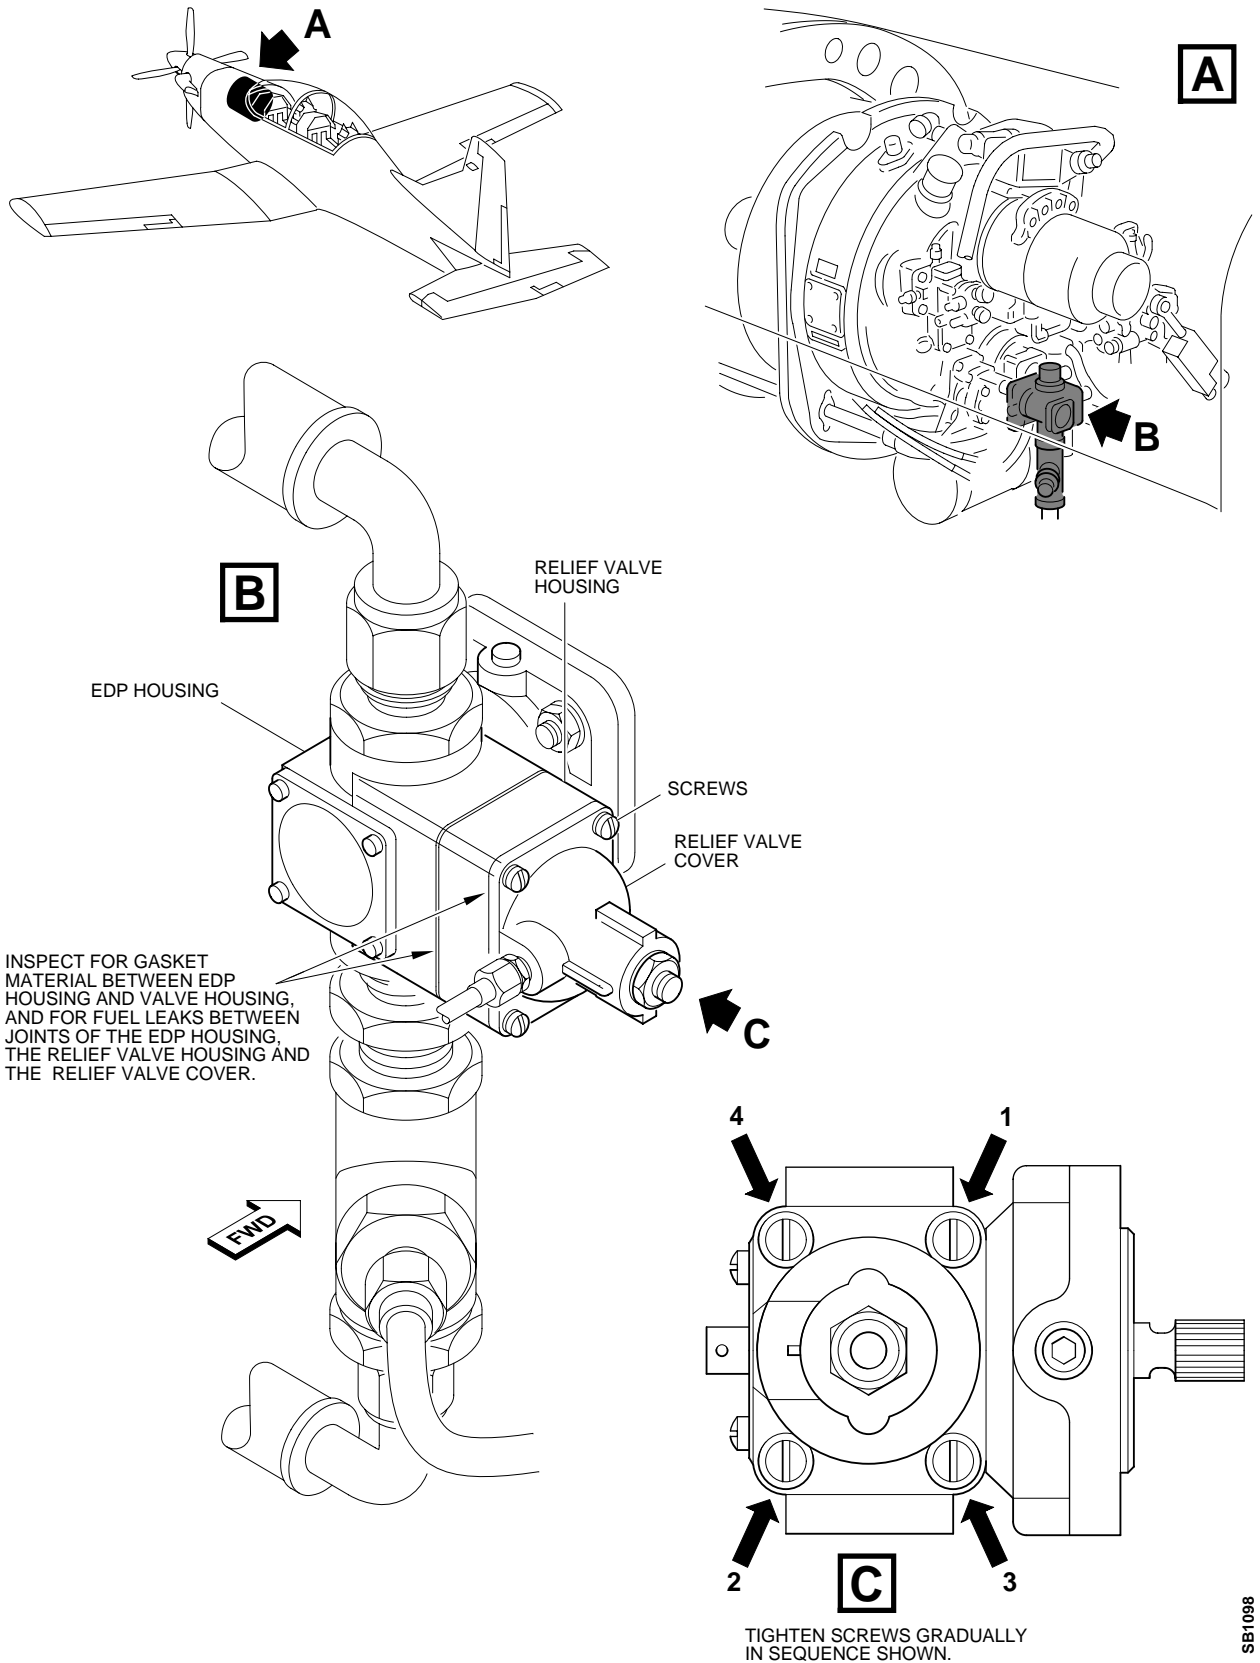
Torque Check and Fuel Leak Inspection of the EDP  
Figure 1

Fuel leakage through the gasket of the EDP relief valve.

It is possible the torque of the screws that attach the EDP relief-valve cover to the relief valve housing is not correct. It is also possible that the gasket between the EDP relief-valve housing and the EDP housing has been pushed out.

- (1) Visually inspect the joints between the EDP housing, relief valve housing and the relief valve cover for:

- Fuel leakage
- Gasket material pushed out

- (2) If the EDP shows signs of fuel leakage or the gasket between the EDP housing and the relief valve housing has been pushed out, replace the EDP (Ref. AMM, 28-20-10, Page Block 401).

- (3) Use a torque screwdriver to do a check of the torque value of the relief-valve-cover screws. Do the check clockwise only. The minimum torque must be 23 lbf in. (2,6 Nm).

- (5) If the relief-valve-cover screws are loose, or the torque found at Step (3) is less than 23 lbf in. (2,6 Nm), do as follows:

- (b) Torque the screws gradually to between 23 and 25 lbf in. (2,6 and 2,83 Nm). Do this in the sequence shown in Figure 1, Detail B.
