SERVICE BULLETIN

SERVICE BULLETIN NO: 28-006

FUEL - DISTRIBUTION FUEL BOOSTER PUMP - DAMAGE TO WIRES DURING INSTALLATION

PILATUS
PC-7 MK II
SERVICE BULLETIN

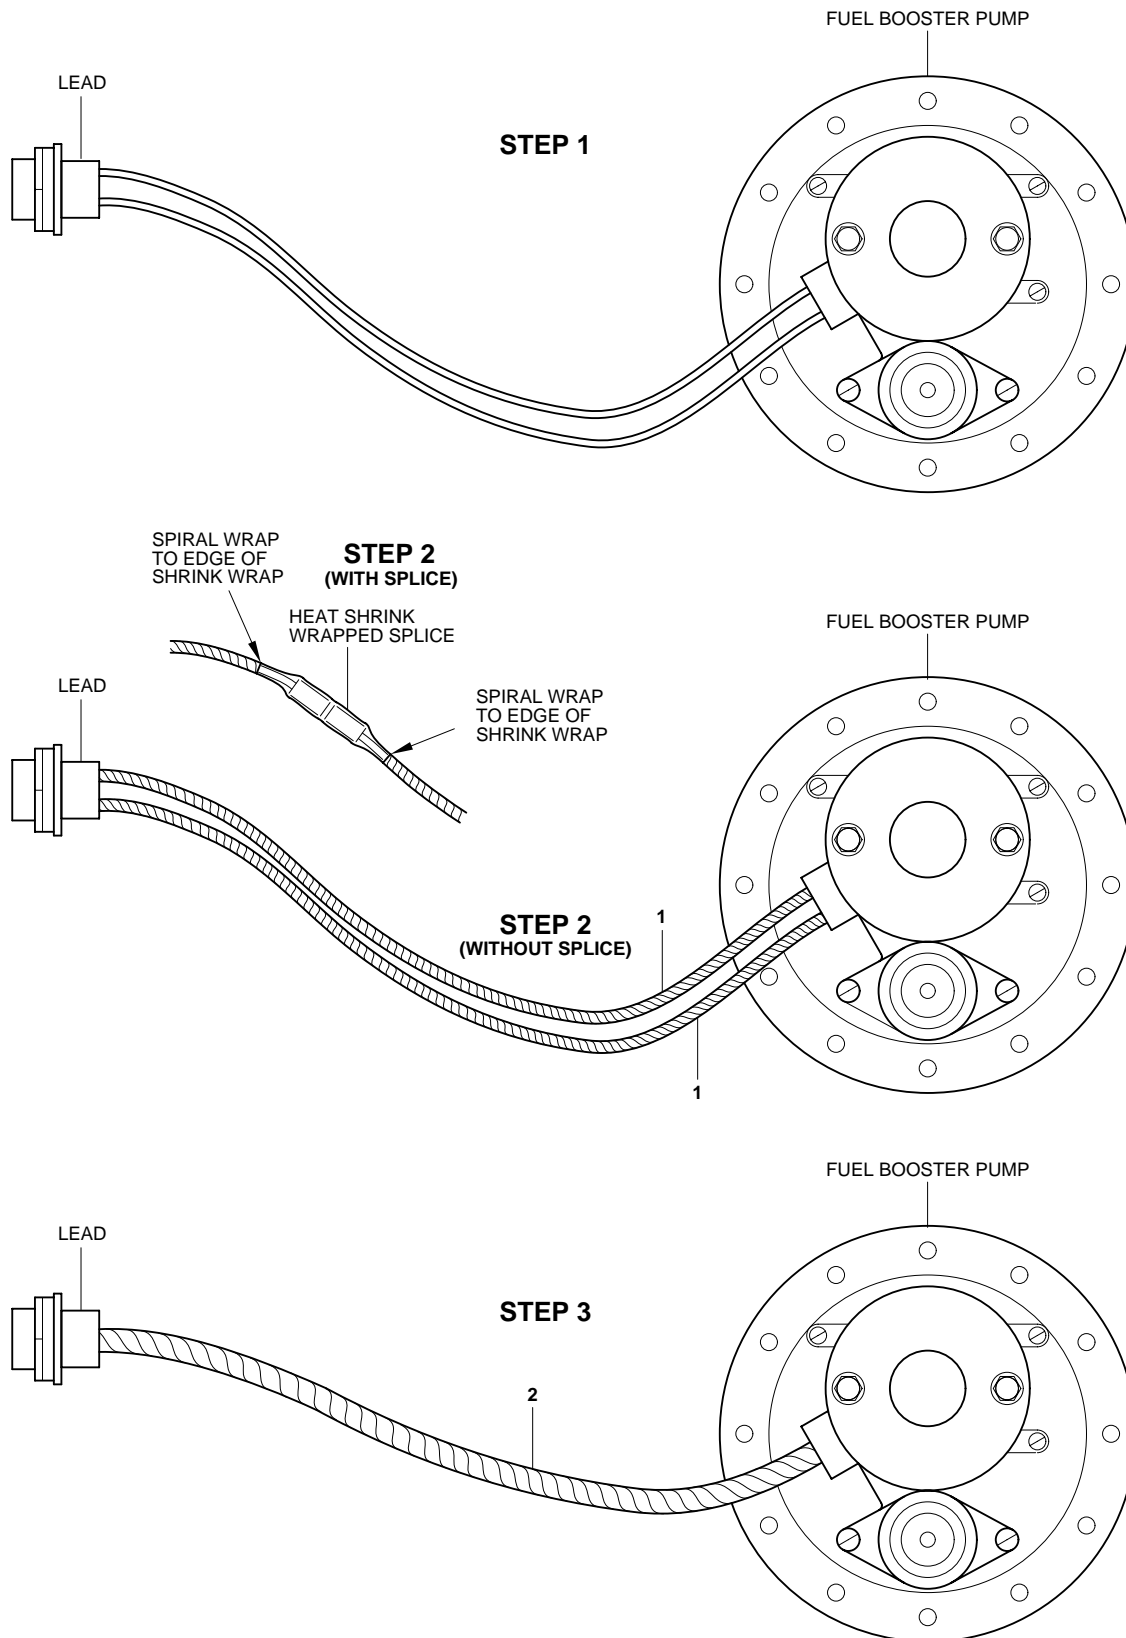
Lead Protection - Installation
Figure 1

It is possible the electrical power wires (leads) to the left and right fuel pumps are damaged. This damage could cause an electric arc from the leads in an air/fuel mixture which can make a dangerous condition.

The damage can occur to the leads during the installation of the pump. It is also possible that the leads could rub during the operation of the aircraft.

- (1) Unwind the fuel-pump lead (the black wire and the white wire) to isolate the wires. Hold the wires in this position.

- (2) Install the spiral wrap on each wire:
 - (a) For a wire with no splice. Wind spiral wrap (1) around the full length of the wire. Twist the spiral wrap (1) to make sure there are no gaps and cut the spiral wrap (1).
 - (b) For a wire with a splice. Wind spiral wrap (1) around the wire between the edge of the shrink wrap and the end of the wire. Twist the spiral wrap (1) to make sure there are no gaps and cut the spiral wrap (1). Do this for each side of the splice.
- (3) Release the black wire and the white wire.
- (4) Wind the spiral wrap (2) around the full length of the black wire and the white wire. Twist the spiral wrap (2) to make sure there are no gaps and cut the spiral wrap (2).

- (2) If there are no defects to the lead, install the lead protection
- (a) Unwind the fuel-pump lead (the black wire and the white wire) to isolate the wires. Hold the wires in this position.

- (3) Install the spiral wrap on each wire:
- (a) For a wire with no splice. Wind spiral wrap (1) around the full length of the wire. Twist the spiral wrap (1) to make sure there are no gaps and cut the spiral wrap (1).
- (b) For a wire with a splice. Wind spiral wrap (1) around the wire between the edge of the shrink wrap and the end of the wire. Twist the spiral wrap (1) to make sure there are no gaps and cut the spiral wrap (1). Do this for each side of the splice.
- (4) Release the black wire and the white wire.
- (5) Wind the spiral wrap (2) around the full length of the black wire and the white wire. Twist the spiral wrap (2) to make sure there are no gaps and cut the spiral wrap (2).
