# SERVICE BULLETIN

SERVICE BULLETIN NO: 55-004

## STABILIZERS - HORIZONTAL STABILIZER ELEVATOR - INSPECTION AND REPAIR TO PREVENT SKIN DISTORTION

PC-7 Mk II aircraft MSN 101 thru MSN 160 and MSN 601 thru MSN 604.

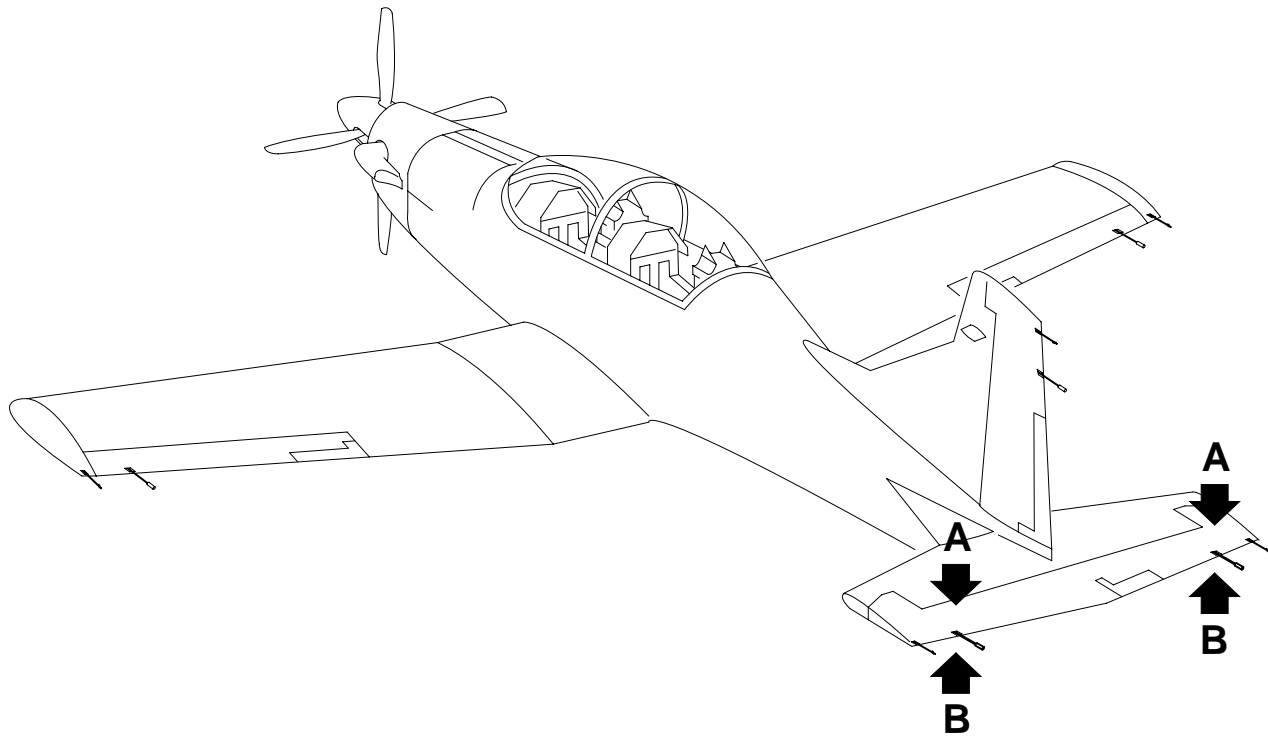
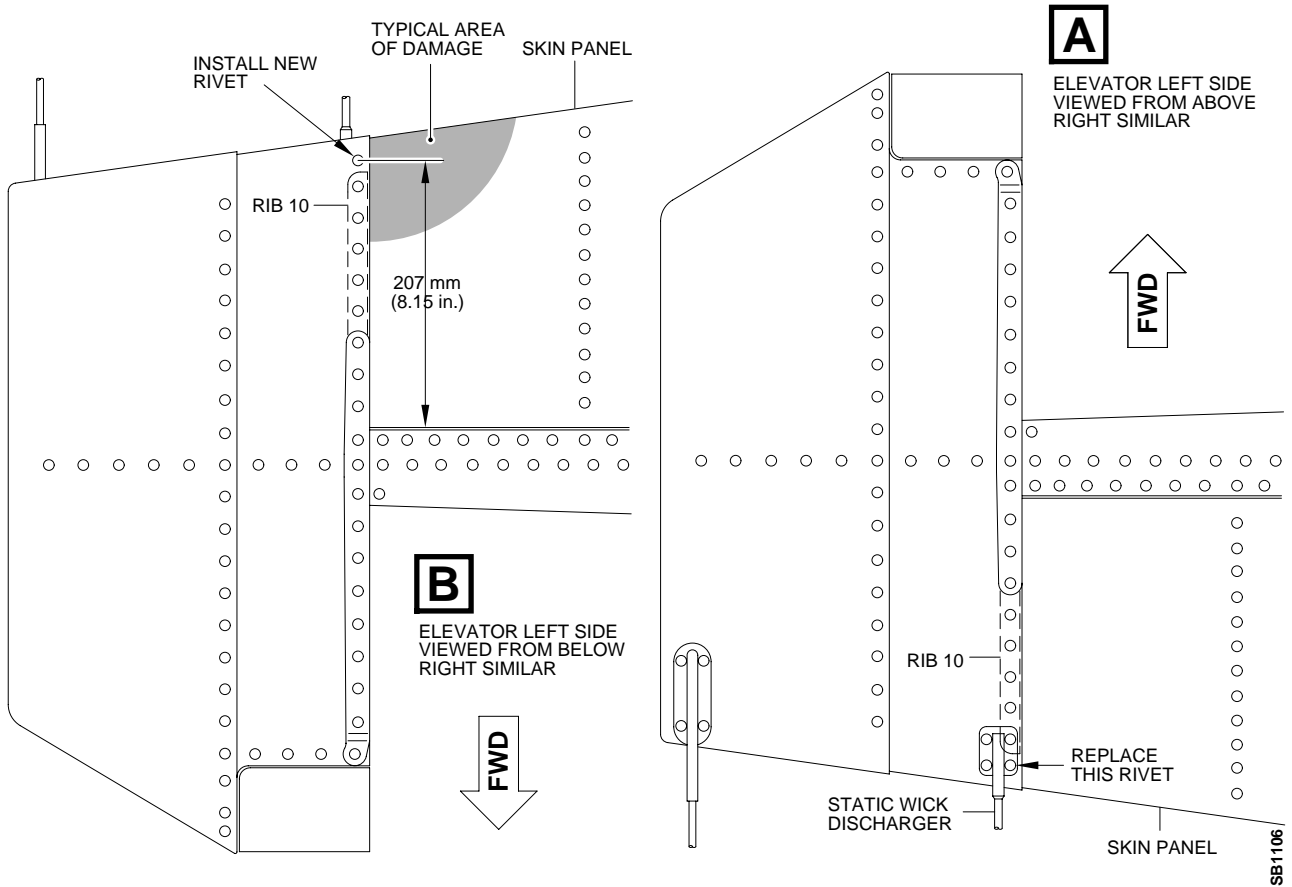
Elevator - Inspection and Repair  
Figure 1

It is possible for damage to occur in the bottom skin panels of the elevator during some flight conditions. The areas at risk of damage are adjacent to the trailing edges, immediately inboard of left and right rib 10.

There are no fasteners (rivets) to hold the skin panels in the areas between the last rivets at the rear ends of ribs 10 and the trailing edges of elevator. Thus, during unusually high aerodynamic loads, unwanted movement and separation of the skin from the internal structure can occur.

- (1) Do an inspection of the elevator for signs of buckling and crack damage in the bottom skin panels. Do this in the areas immediately inboard of the left and right ribs 10 and adjacent to the trailing edge.
- (2) Do an inspection of the elevator trailing edges for signs of distortion and crack damage.
- (3) Replace the elevator assembly if you find buckling, distortion or crack damage in the inspection areas (Ref. AMM, 27-30-01, Page Block 401). Send the unserviceable elevator to PILATUS for repair.

- (1) Make marks to show the new rivet locations on the bottom skin panels.
  - (a) Make a mark to show the centerline of the rivets which attach the bottom skin panel to the left rib 10. Make sure the centerline continues to the trailing edge.
  - (b) Make a mark to show an intersection of the rivet centerline at 207 mm (8.15 in.) from the front edge of the skin panel. The intersection of the marks shows the location of the rivet.
  - (c) Do Steps (a) and (b) again to show the new rivet location on the right side of the elevator.

- (3) Install the rivets in the bottom skin panels.
  - (a) Use a 2.5 mm (3/32 in.) and a 3.3 mm (1/8 in.(clearance)) diameter drills in sequence to make the rivet hole at the intersection of the marks on the left skin panel.
  - (b) De-burr the rivet hole.
