Service Bulletin No: 24-006
Modification No: Inspection**Ref No: 148**
ATA Chapter: 24**ELECTRICAL POWER - GENERAL**
INSPECTION OF THE WIRING LOOM FOR CHAFING NEAR THE REAR GPS MOUNTING RACK**1. Planning Information****A. Effectivity**

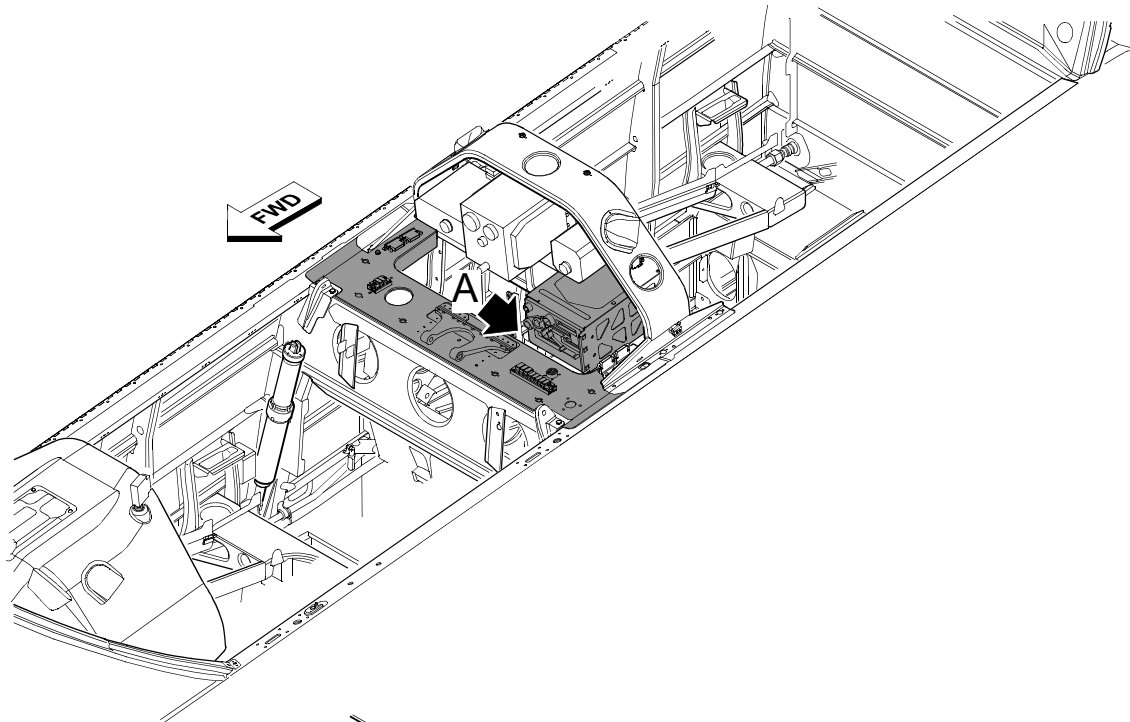
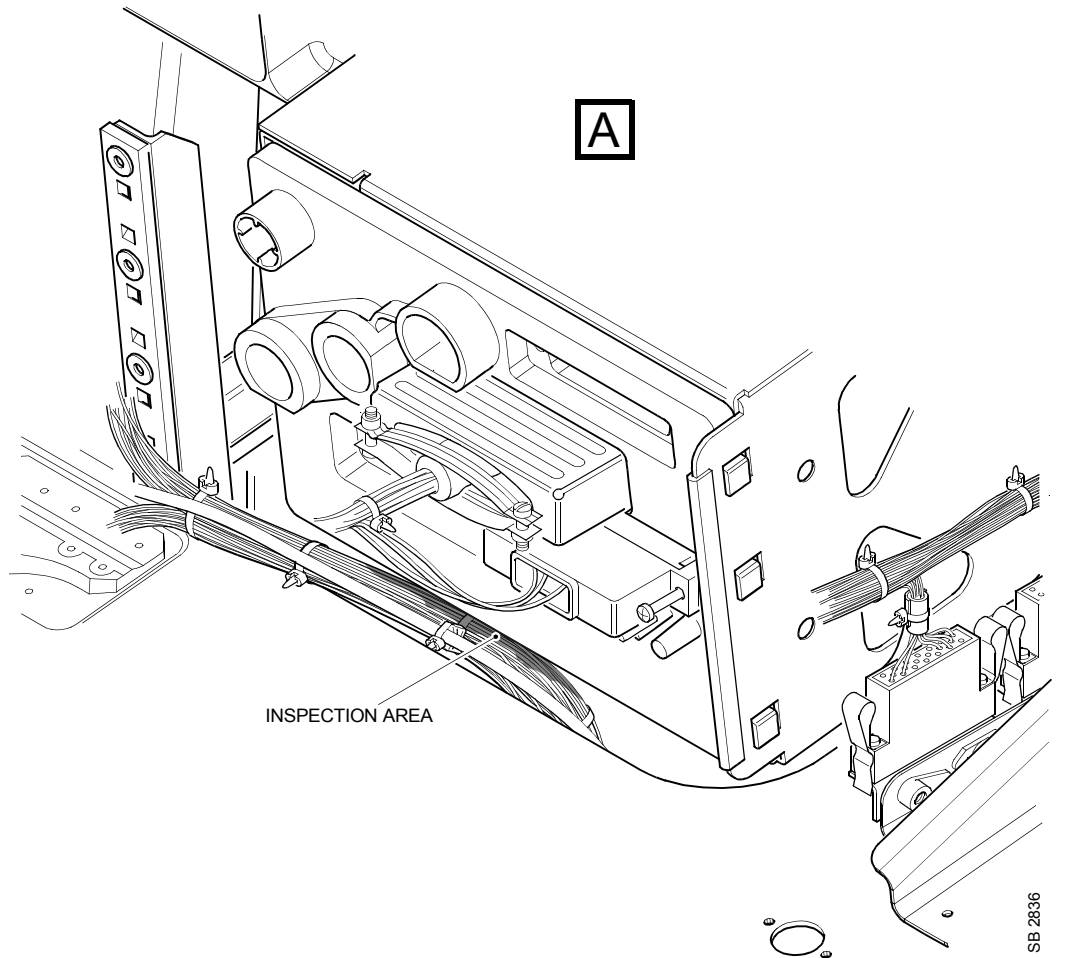
Wiring Loom/Rear GPS-500 Mounting-Rack Backplate - Inspection
Figure 1

An Operator has reported chafing of the wiring loom installed adjacent to the backplate of the rear GPS-500 mounting rack.

Investigation has shown the possibility that the wire loom could have been routed with minimal clearance to the backplate of the rear GPS-500 mounting rack. As a result of this, the wiring loom could chafe on the rear GPS-500 backplate causing damage to wire insulation.

- (1) Do a visual inspection of the wiring loom adjacent to the backplate of the rear GPS-500 mounting rack (Ref. Fig. 1 and 24-00-00, Page Block 201, Para. 3.A.).

- (2) If you find signs of chafing and you can see the bare wires under the insulation, do these steps:
 - (a) Repair or replace the wire(s). If necessary, contact Pilatus for more information.

- (b) In the area where the wiring loom is adjacent to the backplate, remove the cable ties that hold the wiring loom.
 - (c) Move the wiring loom, as much as possible, away from the backplate to get clearance between the wiring loom and the backplate.

- (d) Install the protection sleeve (P/N 917.96.92.155) (Ref. 24-00-00, Page Block 201, Para. 3.B.).
 - (e) Install the cable ties (Material No. P09-005 and/or P09-008 and/or P09-014), as necessary, to hold the wiring loom.

- (3) If you find signs of chafing but you cannot see bare wires under the insulation, do these steps:
 - (a) In the area where the wiring loom is adjacent to the backplate, remove the cable ties that hold the wiring loom.

- (b) Move the wiring loom, as much as possible, away from the backplate to get clearance between the wiring loom and the backplate.
 - (c) Install the protection sleeve (P/N 917.96.92.155) (Ref. 24-00-00, Page Block 201, Para. 3.B.).

- (d) Install the cable ties (Material No. P09-005 and/or P09-008 and/or P09-014), as necessary, to hold the wiring loom.
- (4) Report your findings to Pilatus.
