Service Bulletin No: 52-006

**CANOPY - GENERAL
INSPECTION OF THE CANOPY HINGE SCREWS FOR SECURITY OF INSTALLATION****1. Planning Information****A. Effectivity**

Aircraft MSNs 675 thru 764.

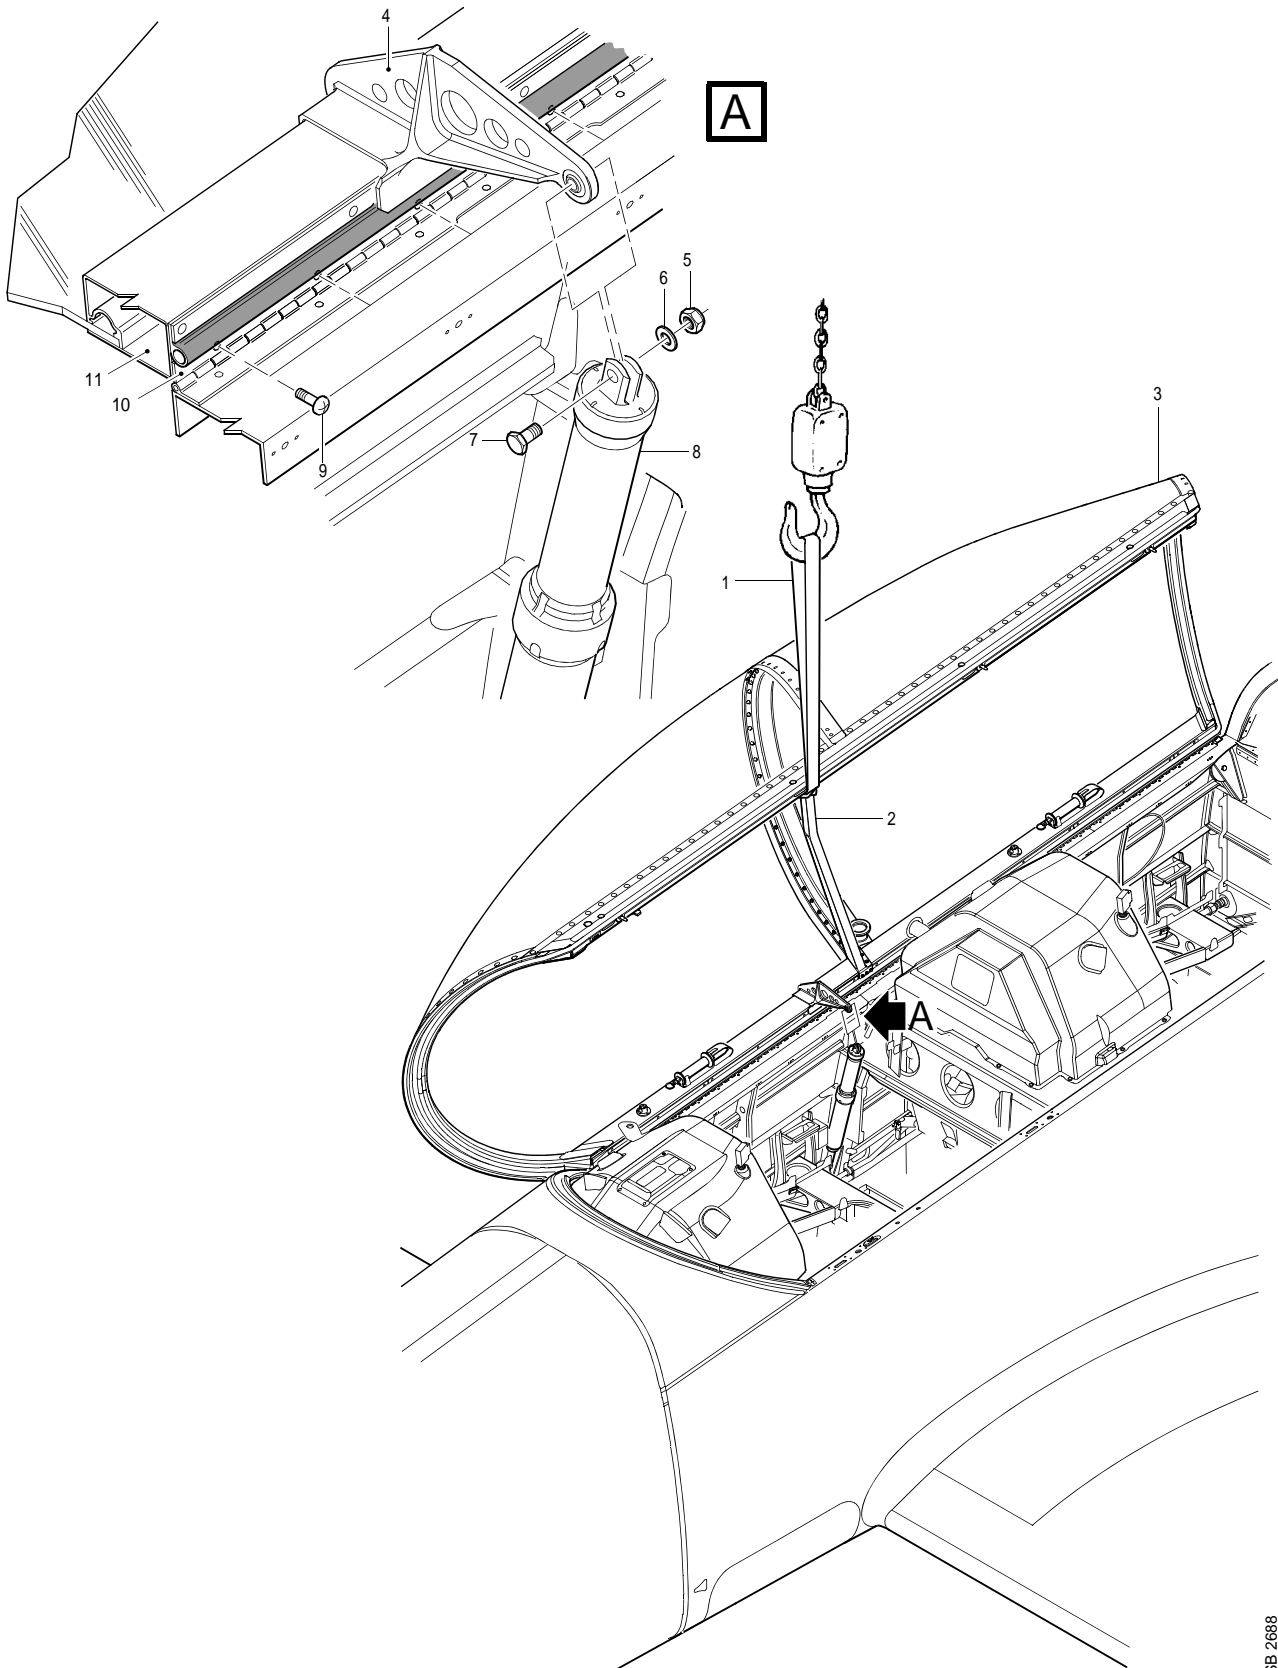
Inspection
Figure 1

An operator found that some of the screws that attach the canopy to the canopy hinge had become loose.

- (1) Fully open the canopy (3).
- (2) Attach the lifting sling (1) to the left side of the canopy cross member (2).
- (3) Attach the lifting sling (1) to the hoist and support the weight of the canopy (3).
- (4) Remove the nut (5), the washer (6) and bolt (7) which attach the damper strut (8) to the canopy operating lever (4).
- (5) Move the canopy damper (8) clear of the work area.

CAUTION: DO THE PROCEDURE FOR ALL THE SCREWS (9) INSTALLED THROUGH THE CANOPY HINGE (10) BUT LOOSEN/REMOVE ONLY ONE SCREW AT A TIME.

- (6) Loosen one screw (9) at a time, two turns, then continue to loosen for a third turn.
- (7) Make sure that, on the third turn, you can still feel the resistance of the self-locking threads of the rivnut.
- (8) Continue to loosen the screw (9). After the third turn you should feel a small but obvious reduction in the force required to turn the screw.

- (9) If you feel the reduction in force as described in Step (8), fully tighten the screw (9).
- (10) If you cannot feel the reduction in force as described in Step (8), do the steps that follow:
 - (a) Remove the screw (9).
 - (b) Use solvent (Material No. P01-008) and a lint-free cleaning cloth (Material No. P02-041) to clean the:
 - Threads of the removed screw (9)
 - Threads of the rivnut in the canopy beam (11)
 - (c) Let the solvent dry.
 - (d) Apply adhesive (Material No. P08-017) to the threads of the screw (9) and install it. Make sure you fully tighten the screw (9).

(11) Install the canopy damper (8) to the canopy operating lever (4) with the bolt (7), the washer (6) and the nut (5).
