Service Bulletin No: 53-019

ATA Chapter: 53

FUSELAGE - MAIN FRAMES**DO A CHECK OF THE MATERIAL SPECIFICATION OF THE FRAME 11 FITTINGS AND, IF NECESSARY, DO A CHECK FOR CRACKS****1. Planning Information****A. Effectivity**

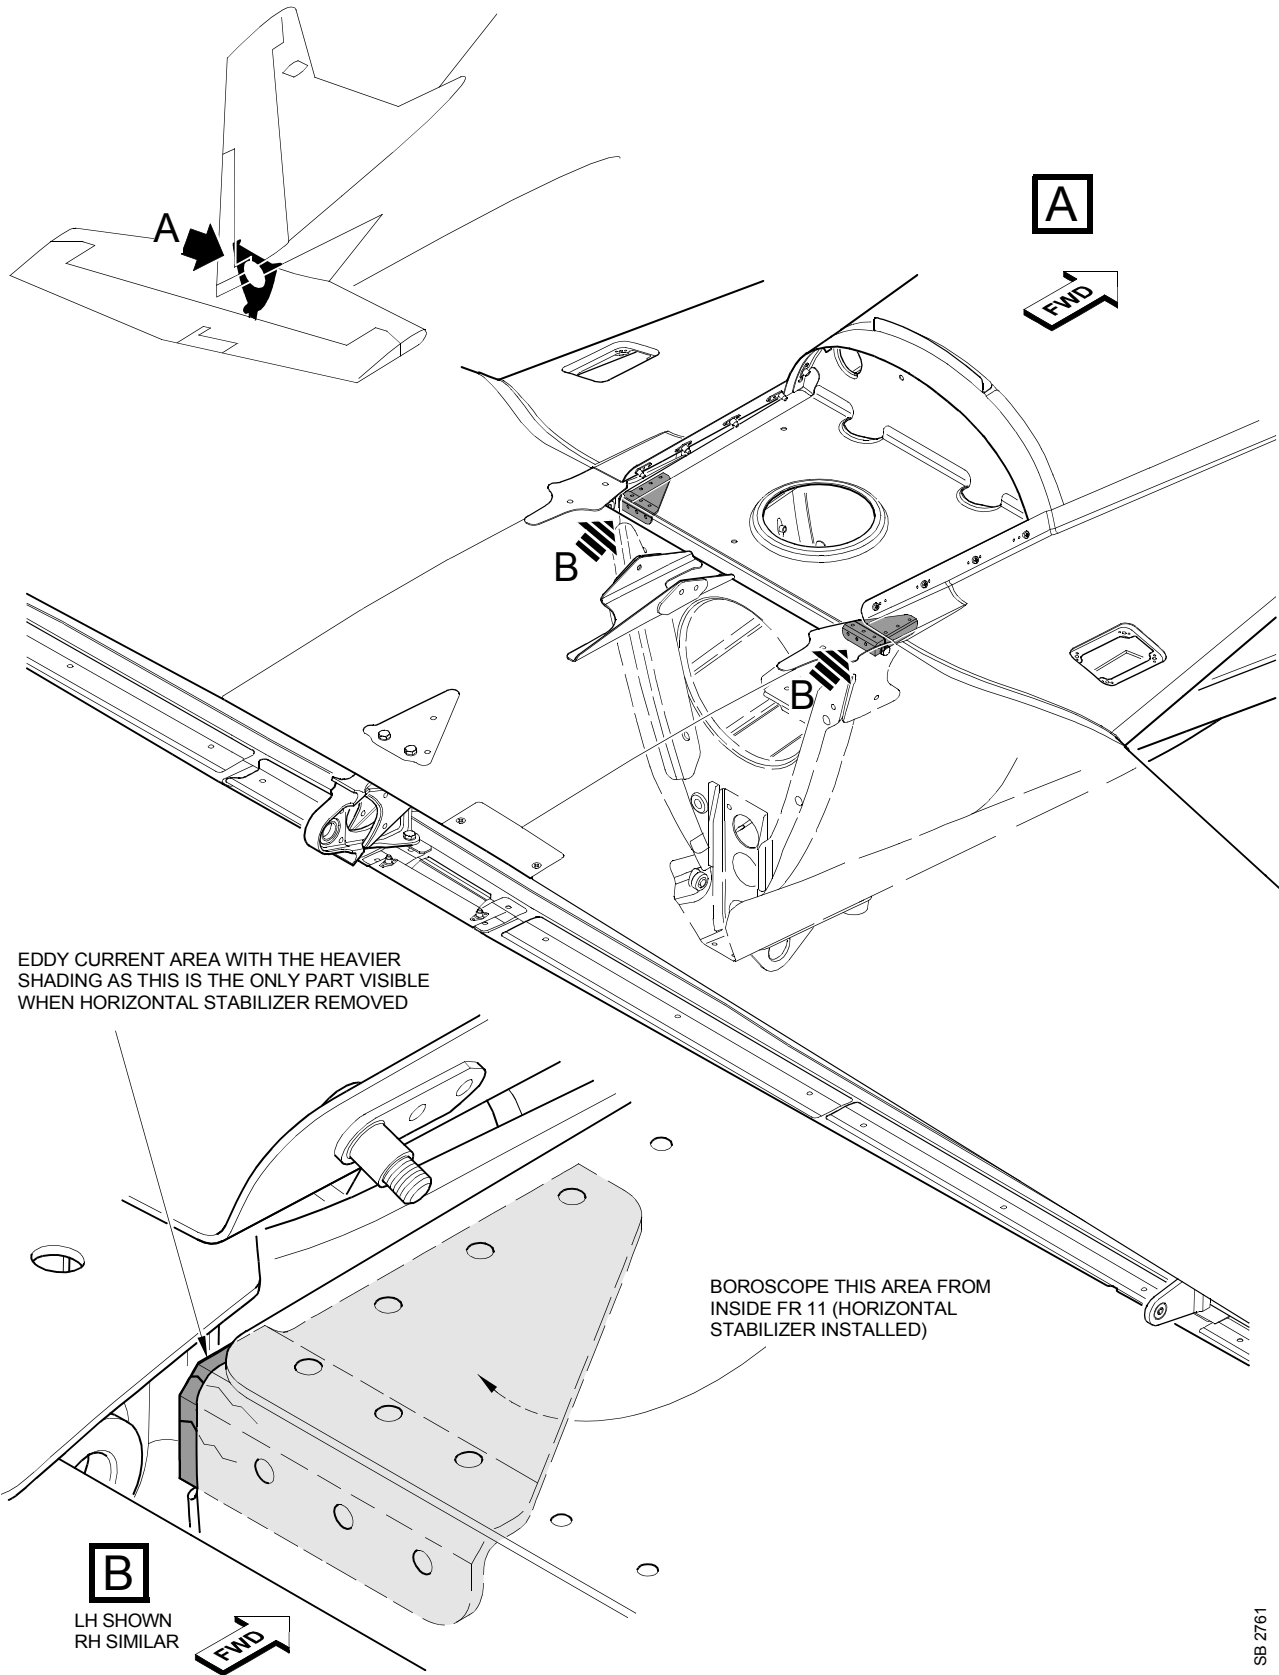
Fittings - Crack Inspection (If Necessary)
Figure 3

An operator reported Stress Corrosion Cracking (SCC) on the FR 11 left fitting P/N 112.35.07.489 and right fitting P/N 112.35.07.490 (known hereafter as "fittings").

Initially the material specification of the parts was AA2024-T351.

(1) Obey the manufacturer's instructions and use a borescope to examine the fitting from inside FR11 (looking AFT) for cracks (Ref. Fig. 3).

- (2) If you find cracks, you must replace the fitting before the next flight (Ref. Service Bulletin 53-020). Make a copy of the Inspection Report Form (Ref. Fig. 4).
- (3) If you do not find cracks in the area examined in Step 3.C.(1):
 - (a) Remove the horizontal stabilizer (Ref. AMM, 55-10-00, Page Block 401).
