PILATUS AIRCRAFT LTD. STANS, SWITZERLAND

PC-7 MKII

Service Bulletin No: 21-009 Ref No: 128

AIR CONDITIONING - DISTRIBUTION INSPECT, AND IF NECESSARY, REPLACE THE AIR CONDITIONING HOSES IN THE DE-FOG SYSTEM

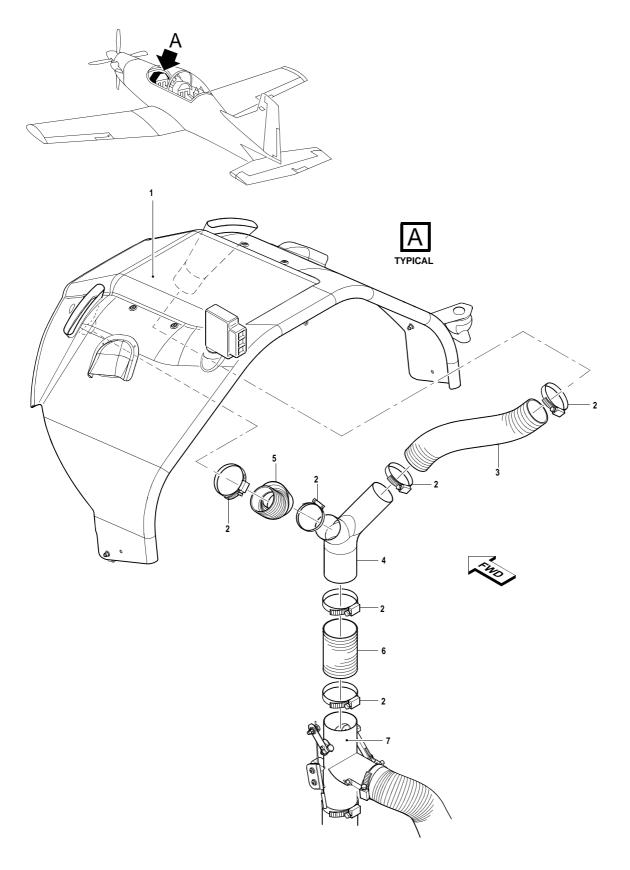
Replacement of the ECS Hoses Figure 1

Some of the ECS air hoses have experienced delamination problems. This type of hose (type 984) was installed in new production and offered as replacement for in-service hoses. If a hose installed in the de-fog system collapses, it can impair the forward vision from the cockpit.

- (1) Do an inspection of the ECS hoses, items (3), (5) and (6).
- (2) If the hoses are dark grey in color, they are type 984 and must be replaced.
- (3) Replace the ECS hoses:

- (a) Remove the ECS hoses:
 - 1 Remove the front coaming (1) (Ref. AMM, 34-13-03, Page Block 401).
 - 2 Loosen the clamps (2) that attach:
 - The air hose (3) to the air distributor (4)
 - The air hose (5) to the air distributor (4)
 - The air hose (6) to the air distributor (4) and the air distributor assembly (7).

- 5 Remove and keep the clamps (2) from:
 - The air hose (3)
 - The air hose (5)
 - The air hose (6).
- 6 Discard:
 - The air hose (3)
 - The air hose (5)
 - The air hose (6).
- (b) Install the new hoses:
 - 1 Put the clamps (2) on:
 - The new air hose (5) (P/N 917.96.83.051)
 - The air hose (3) (P/N 917.96.83.052)
 - The air hose (6) (P/N 917.96.83.054).
 - 2 Put these hoses in position:
 - The air hose (5) (P/N 917.96.83.051)
 - The air hose (3) (P/N 917.96.83.052)
 - The air hose (6) (P/N 917.96.83.054).
 - <u>3</u> Put the clamps (2) in the correct position on:
 - The air hose (5) (P/N 917.96.83.051)
 - The air hose (3) (P/N 917.96.83.052)
 - The air hose (6) (P/N 917.96.83.054)
