Service Bulletin No: 51-001

ATA Chapter: 51

AIRCRAFT STRUCTURE - GENERAL**DO A CHECK OF THE MATERIAL SPECIFICATION USED DURING MANUFACTURE AND, IF NECESSARY, DO A CHECK FOR CRACKS OR REPLACE THE PART****1. Planning Information****A. Effectivity**

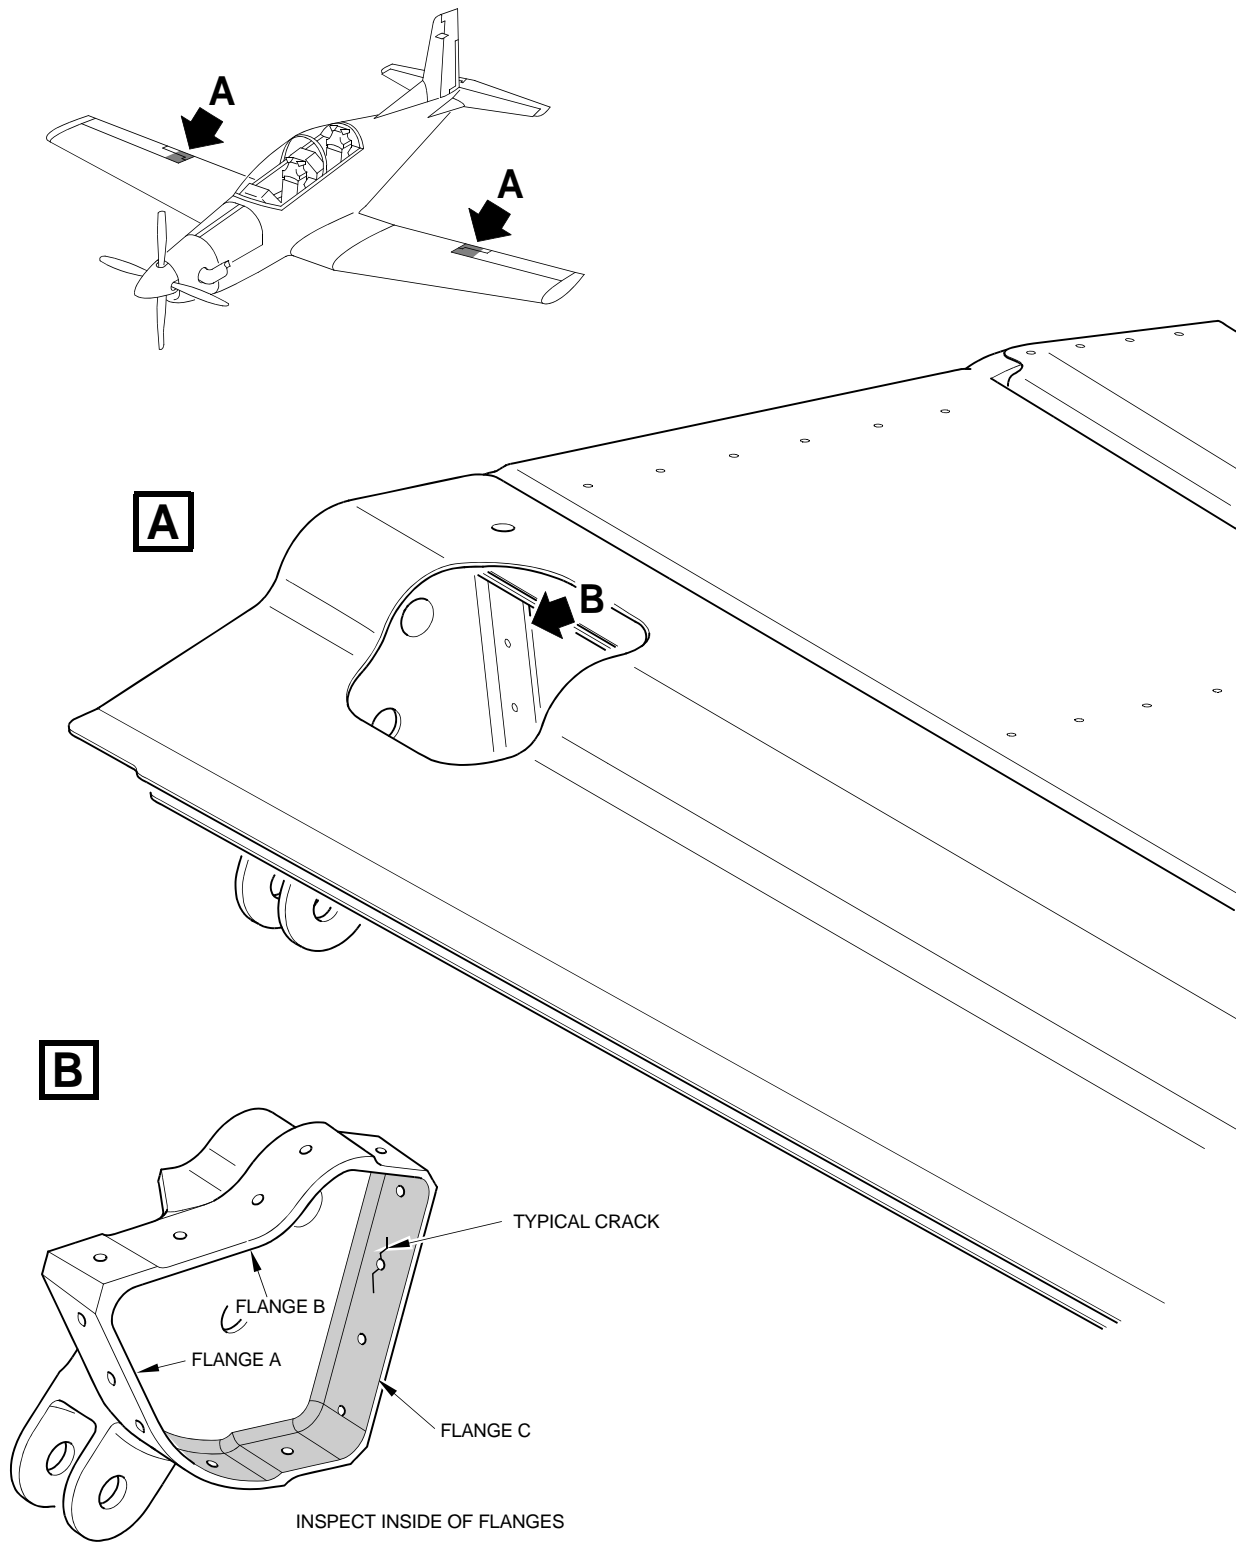
Nose Rib 1 - Inspection (If Necessary)
Figure 3

- (d) Do an inspection for cracks (Ref. Fig. 3):
- NOTE:** Step 3.B.(1)(d) is only applicable to aileron nose ribs made from AA2024-T351.
- NOTE:** Only personnel that are qualified and authorized by their designated Airworthiness Authorities are allowed to do this test.

- NOTE:** It is not necessary to remove the layers of surface protection to do the inspection.
- 2 Use a bright light source and a mirror to examine the inspection areas of the left-aileron nose-rib 1 for cracks.

- 3 If you find cracks:
- a You must contact Pilatus Customer Support before next flight. The address is:
- PILATUS AIRCRAFT LTD.,
Customer Technical Support (MCC),
P.O. Box 992
6371 Stans, Switzerland

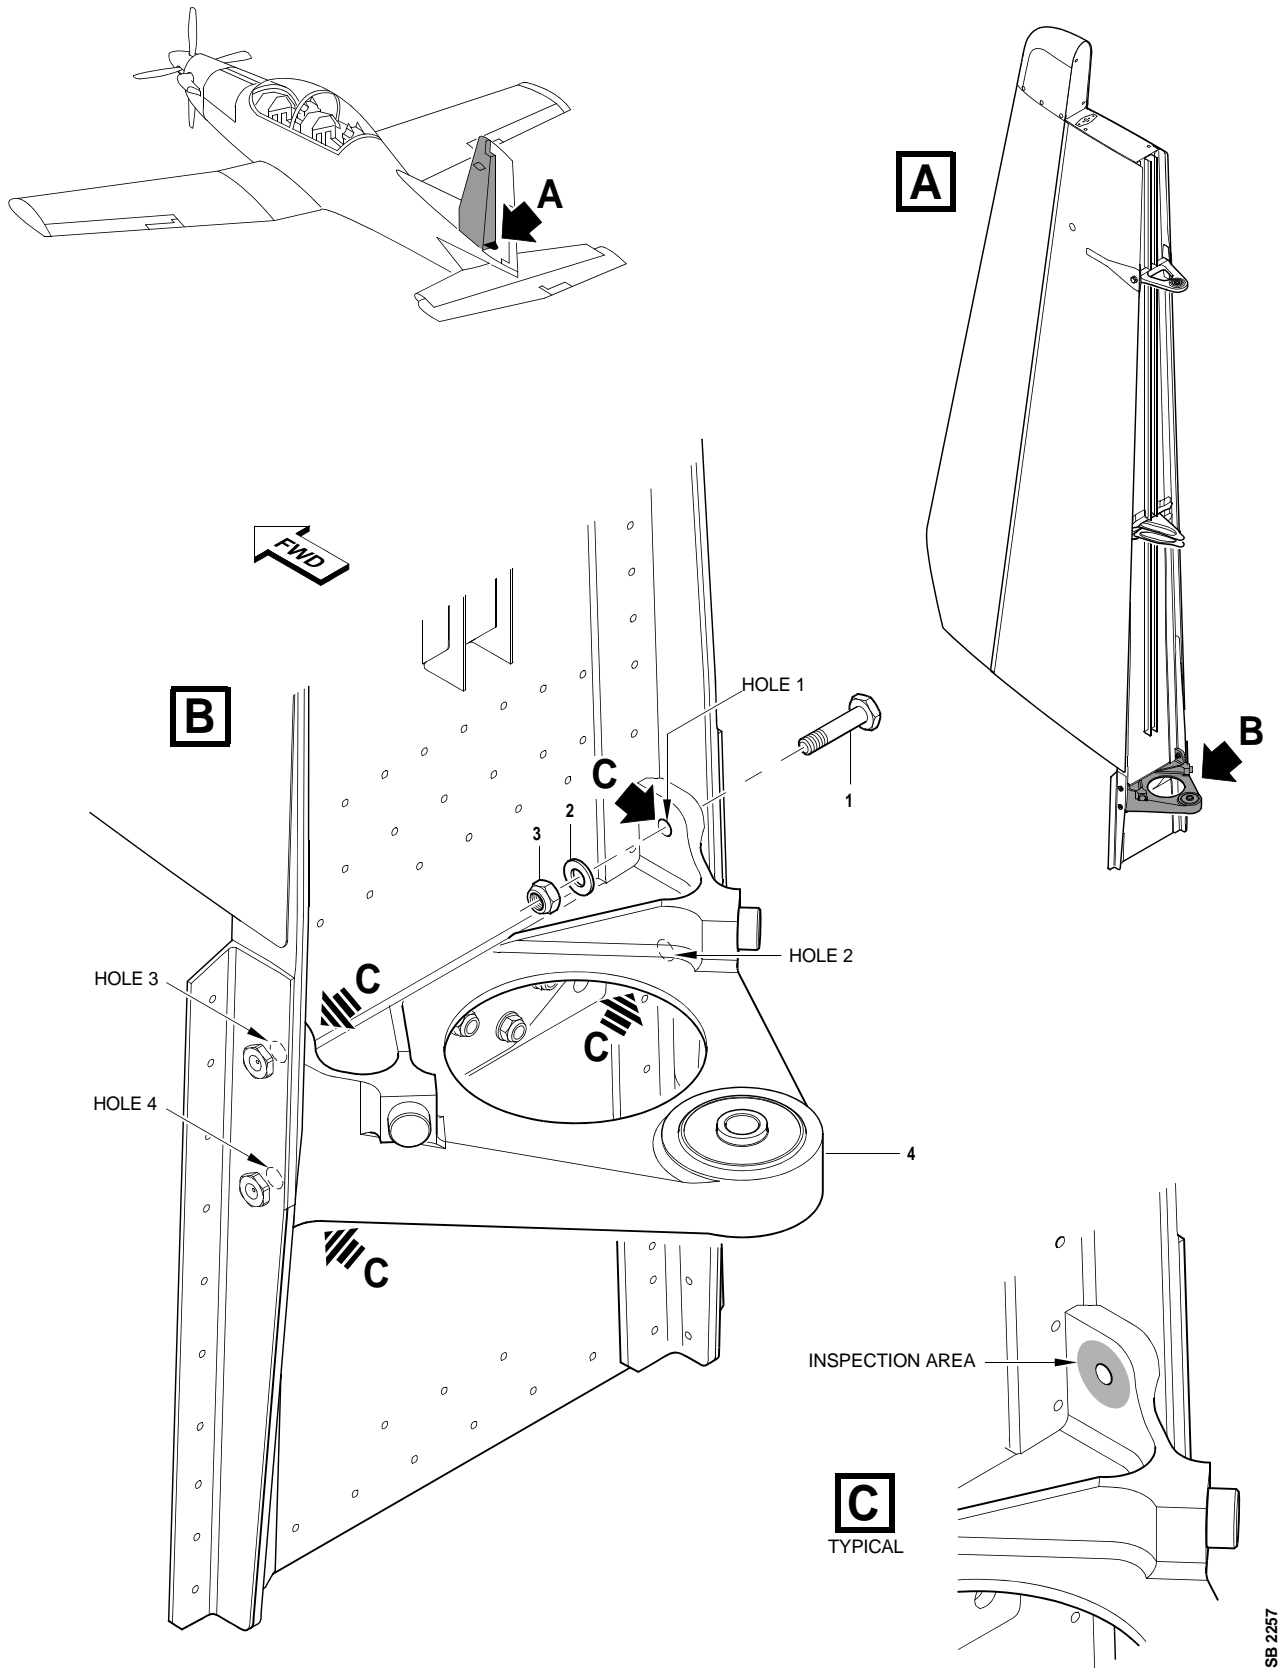
Lower Rudder Bracket - Inspection (If Necessary)
Figure 5

- (d) Do an eddy-current Non-Destructive-Inspection (NDI) for cracks (Ref. Fig. 5):

- 8 If you find cracks:

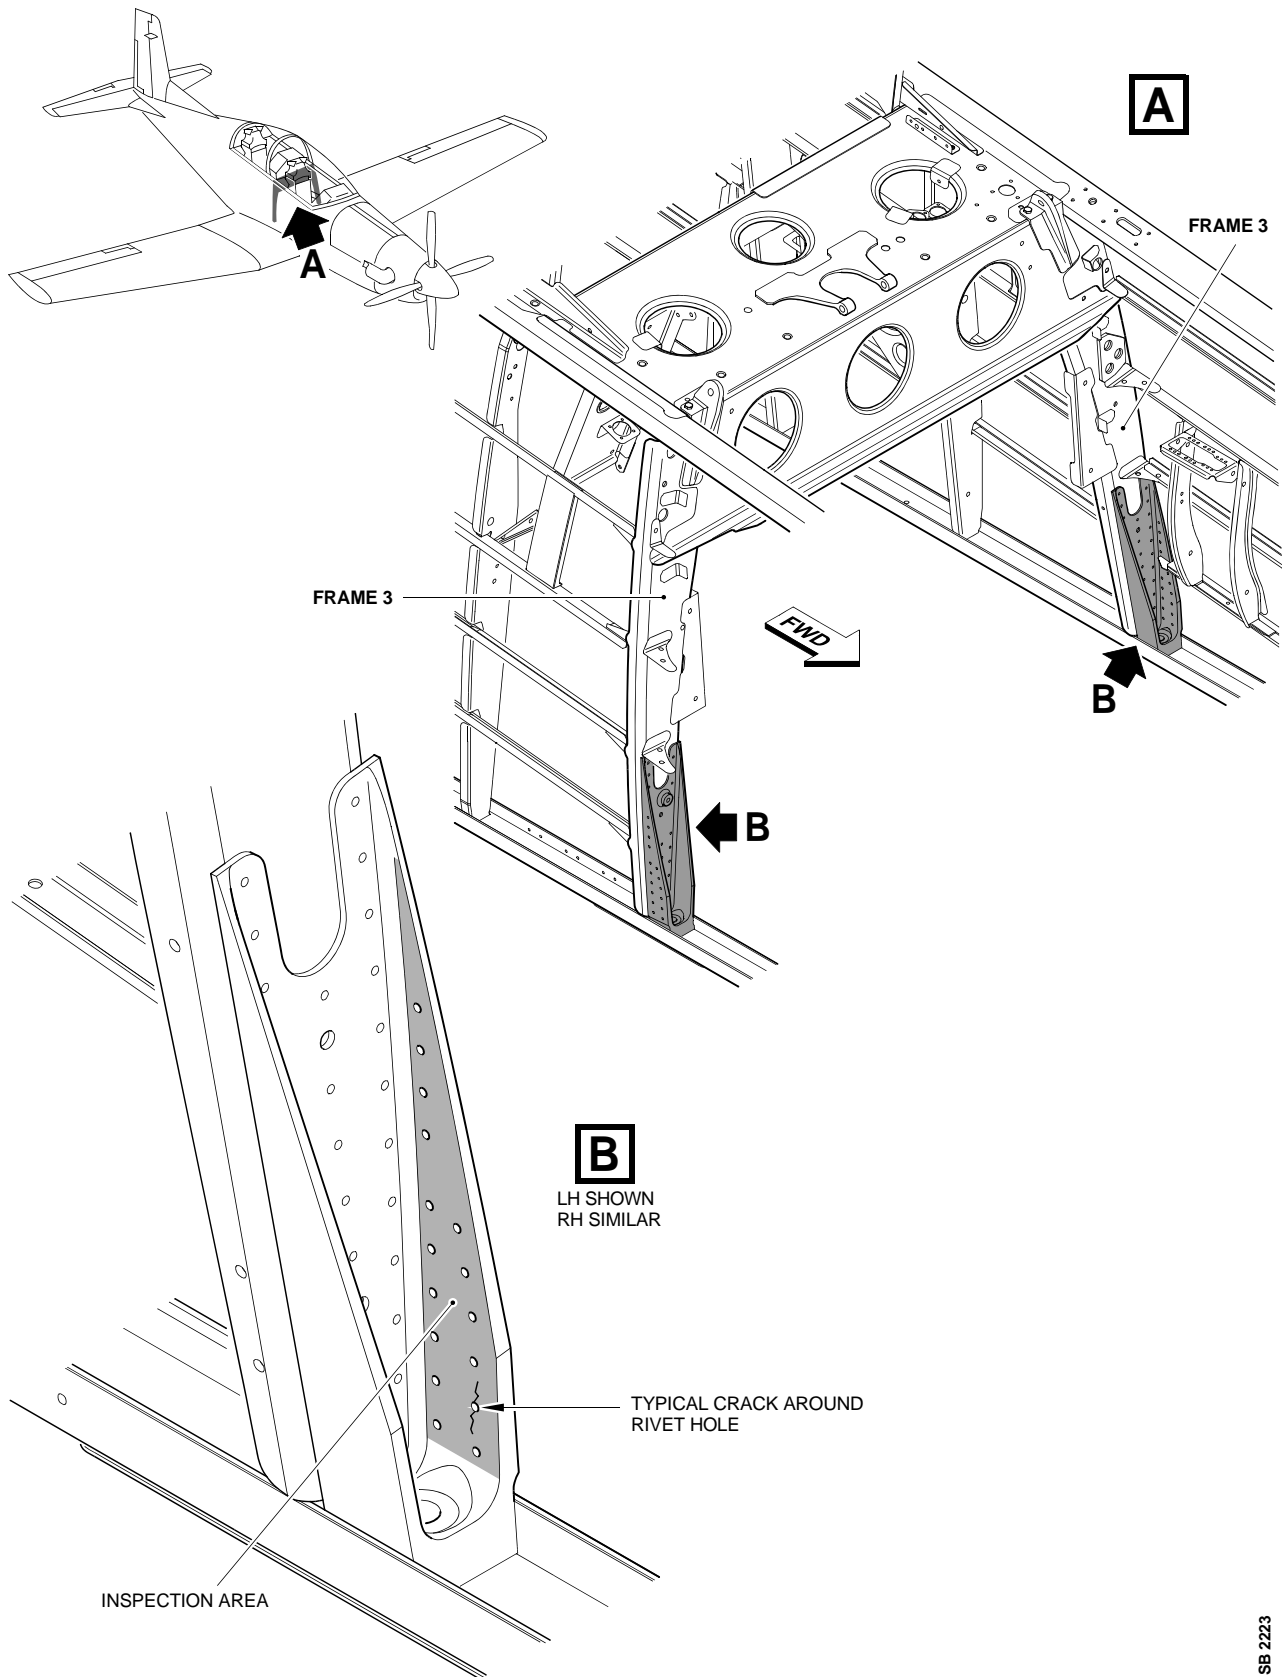
Frame 3 Pick-Up Brackets - Inspection (If Necessary)
Figure 7

(e) Do an inspection for cracks (Ref. Fig. 7):

2 Obey the manufacturer's instructions and use a boroscope to examine the inspection areas of the left frame 3 pick-up bracket for cracks.

3 If you find cracks:

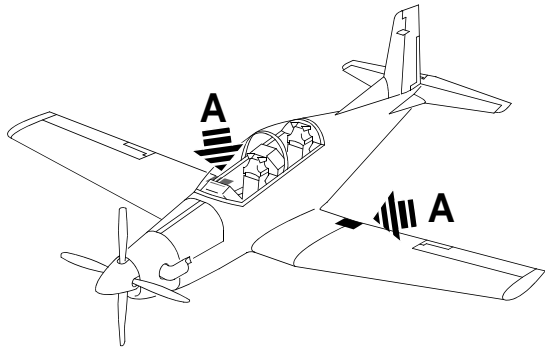
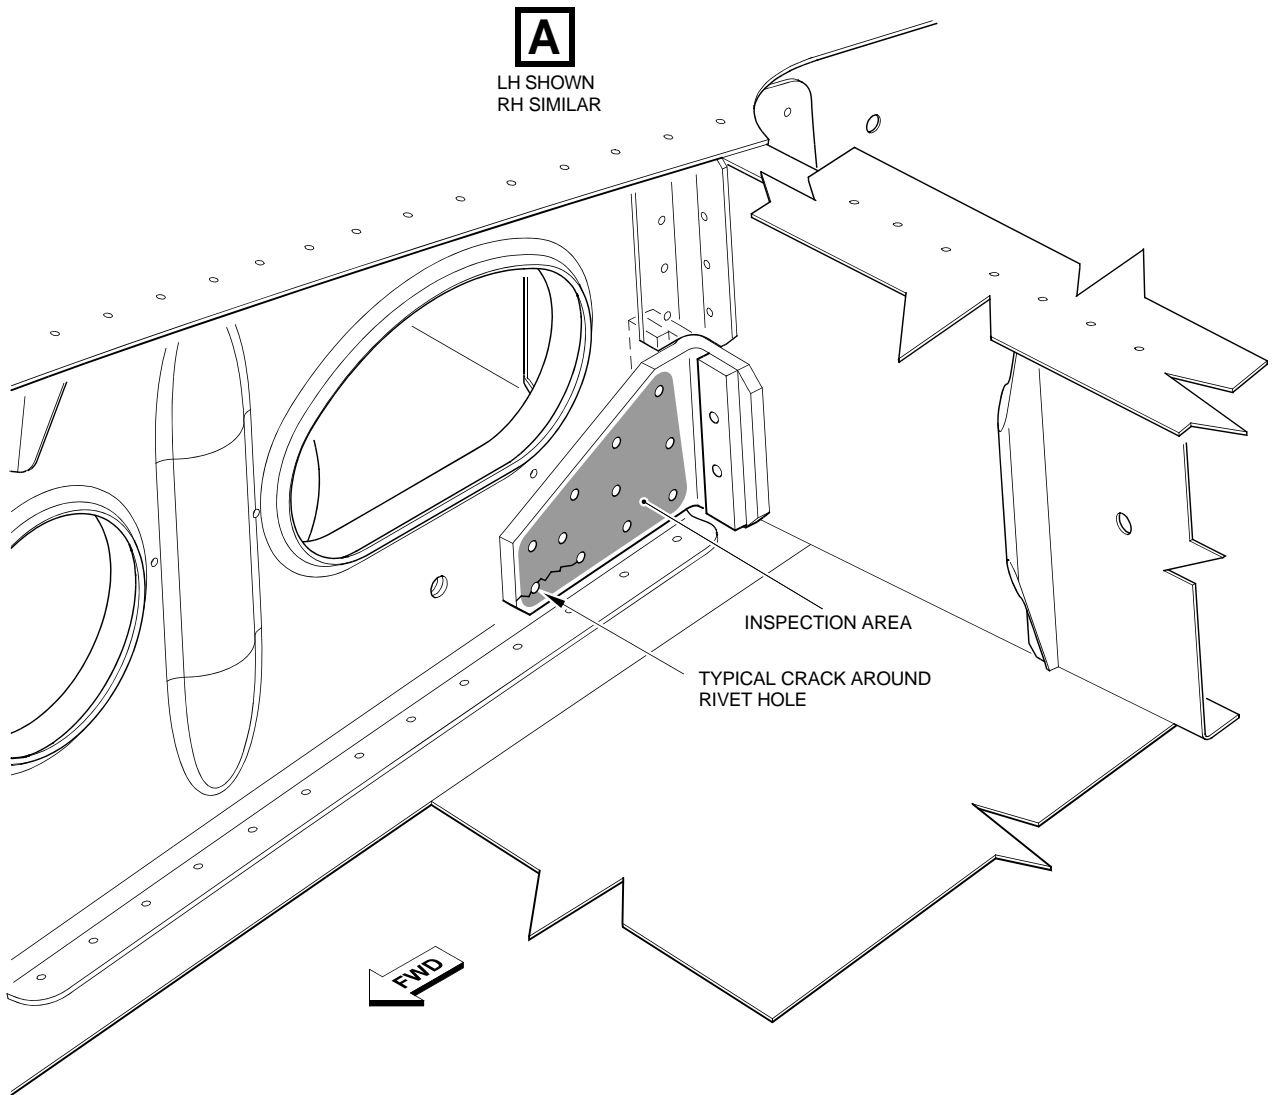
Left and Right Flap Bearing Support-Bracket - Inspection (If Necessary)
Figure 9

(d) Do an inspection for cracks (Ref. Fig. 9):

2 Obey the manufacturer's instructions and use a boroscope to examine the inspection areas of the left flap bearing support-bracket for cracks.

3 If you find cracks:

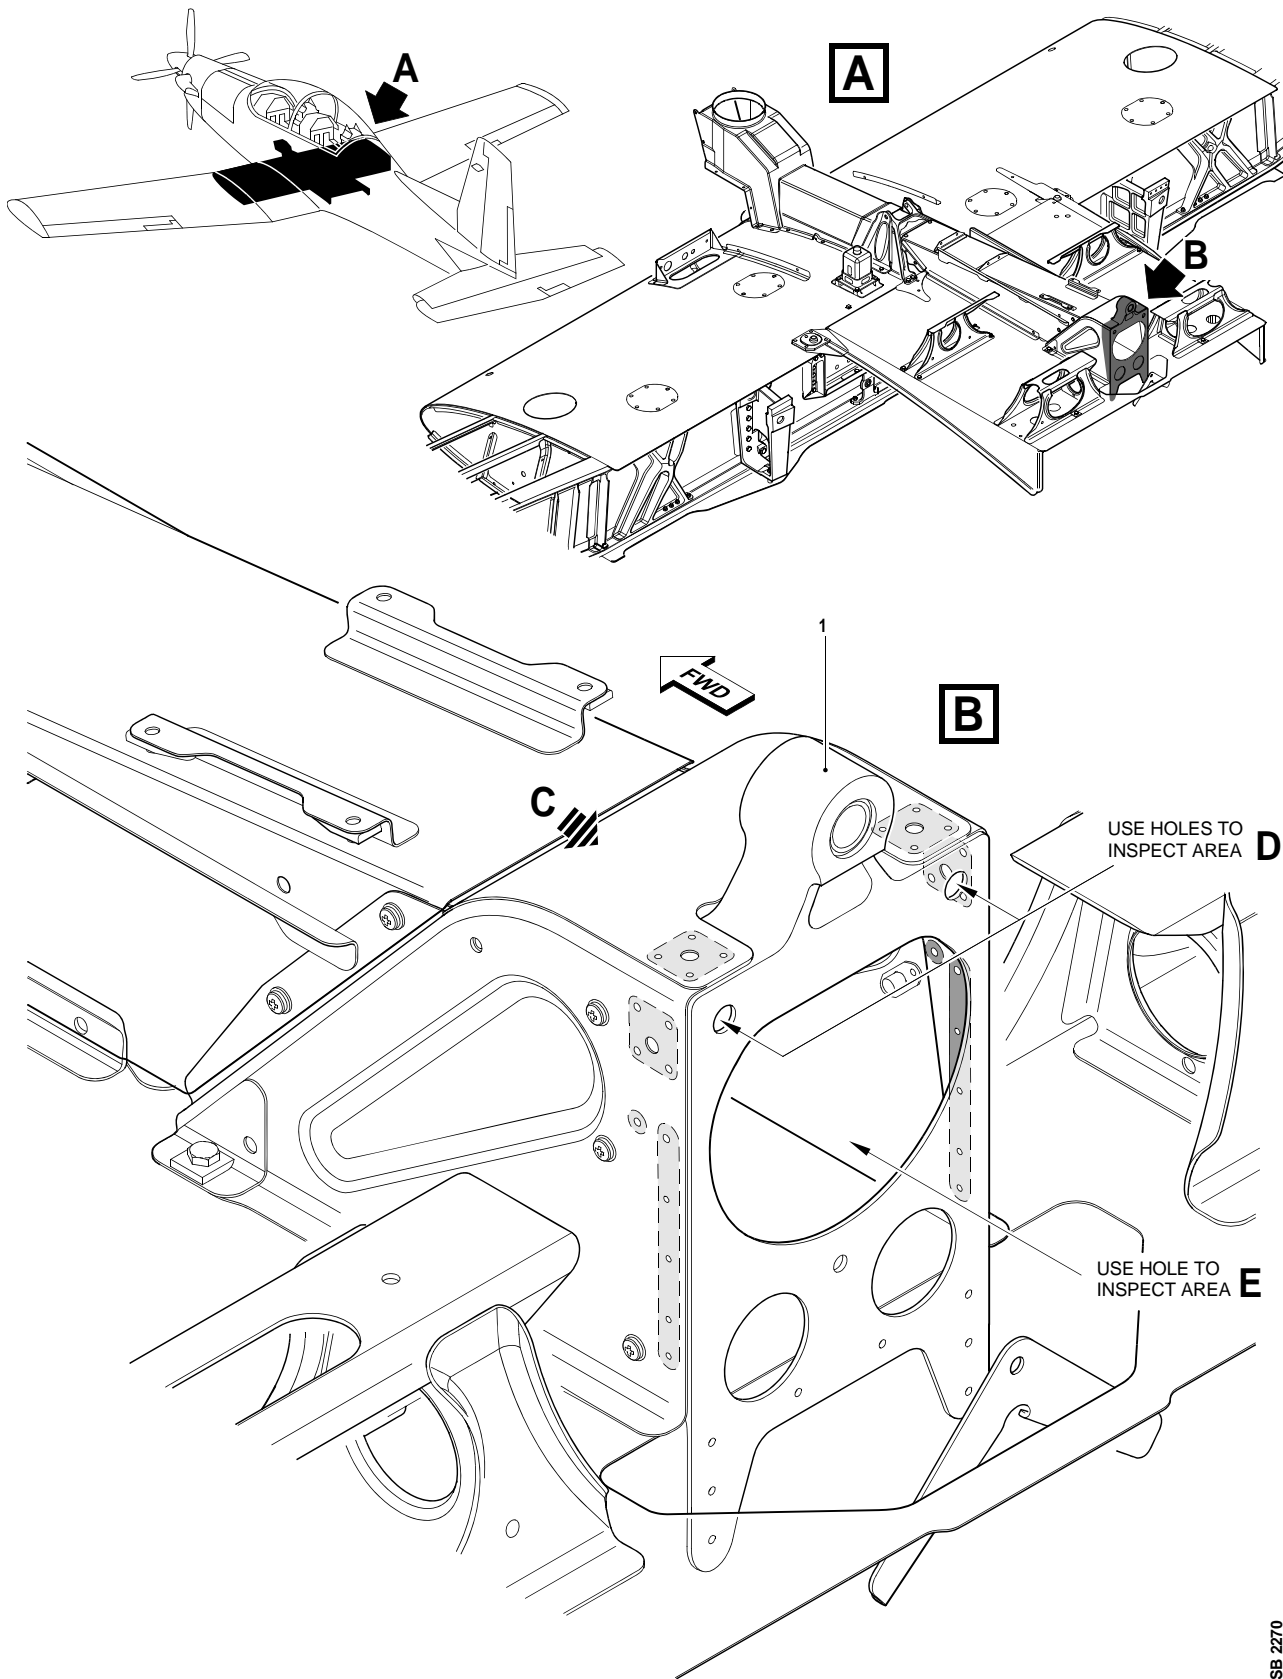
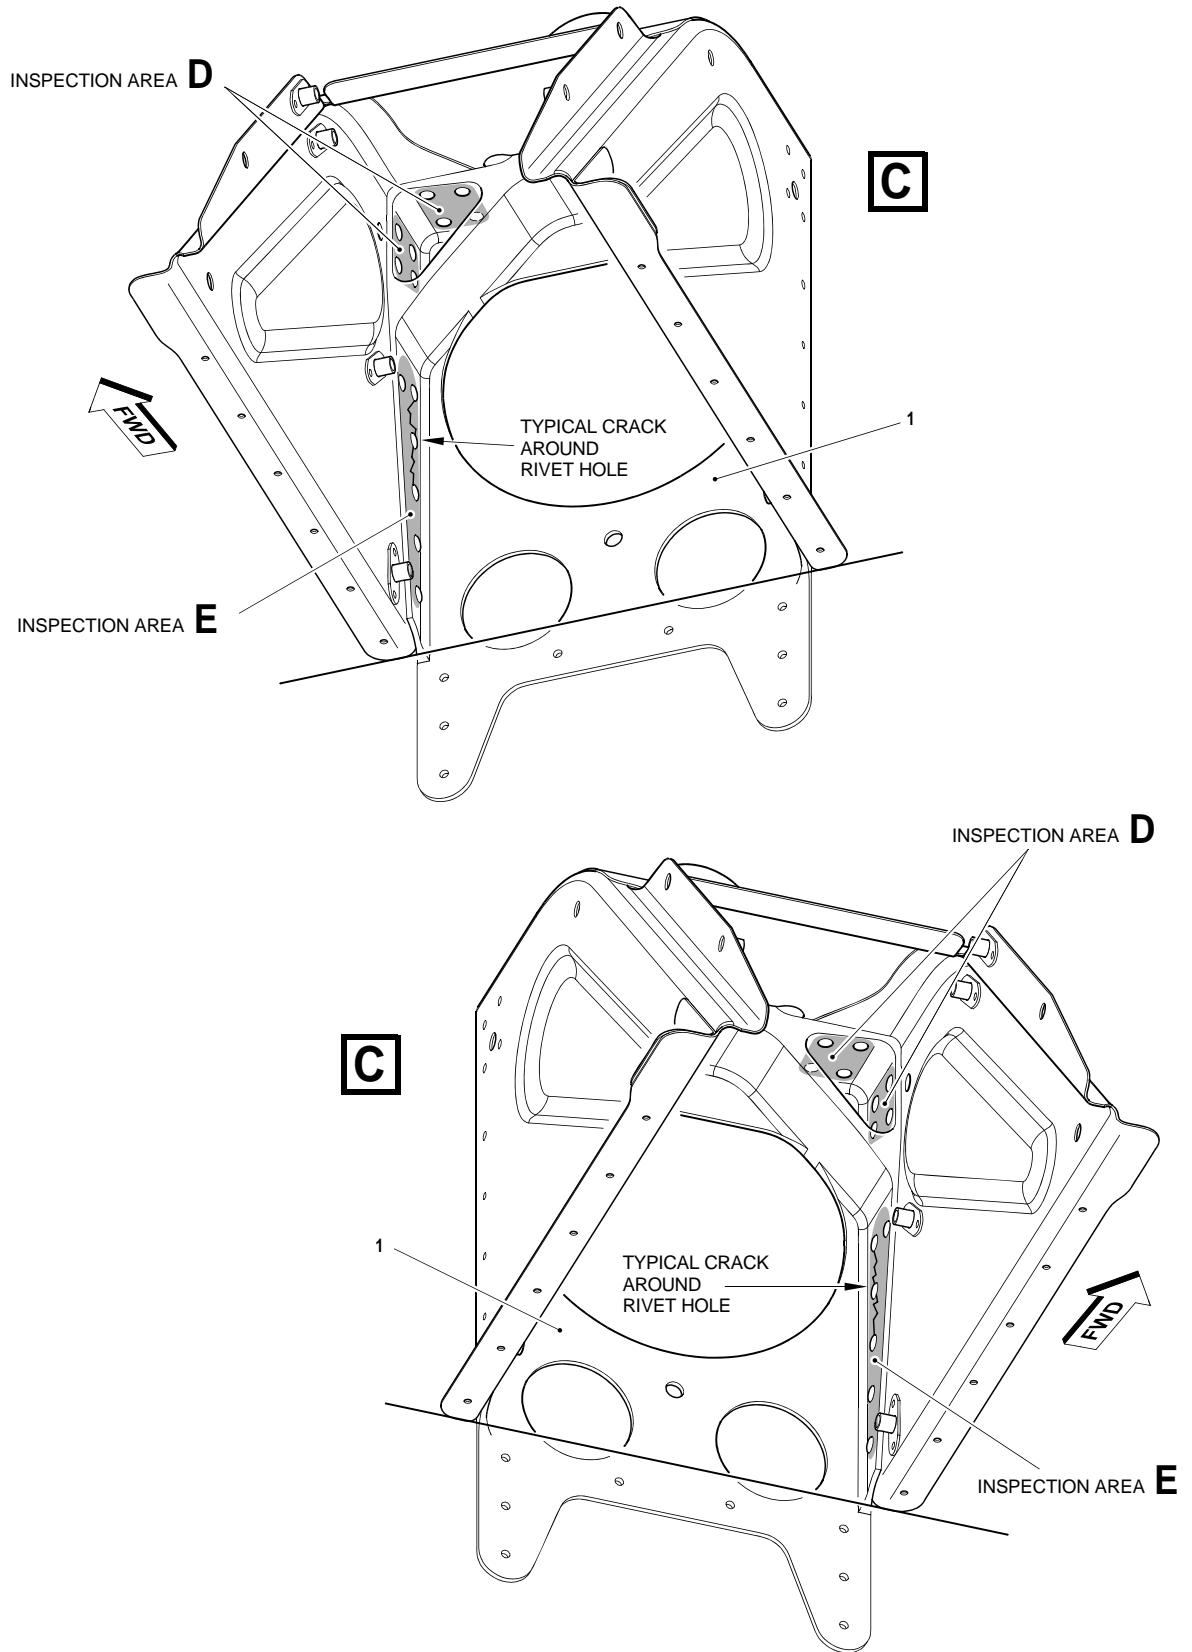
Rear Control-Column Support-Bearing Bracket - Inspection (If Necessary)
Figure 11, Sheet 1 of 2

(d) Do an Inspection for cracks (Ref. Fig. 11):

2 Obey the manufacturer's instructions and use a boroscope to examine the inspection areas of the rear control-column support-bearing bracket (1) for cracks.

3 If you find cracks:

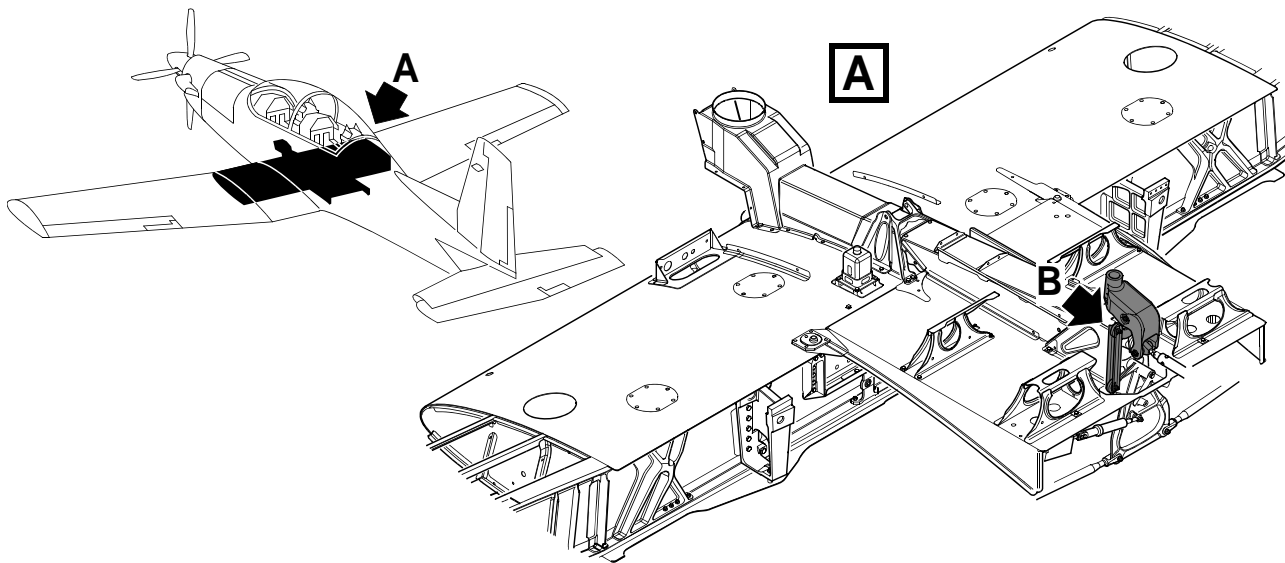
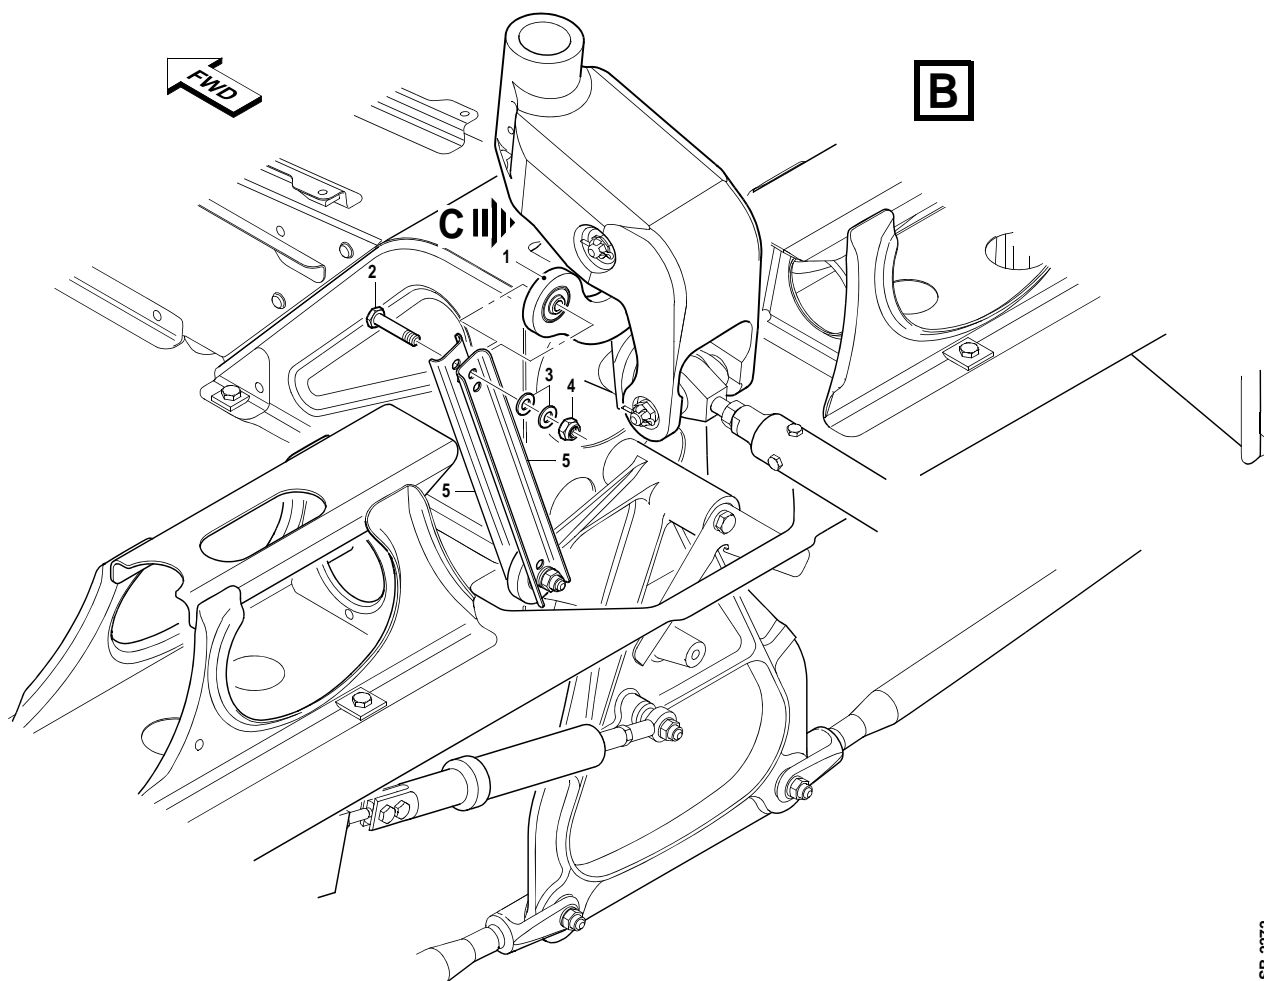
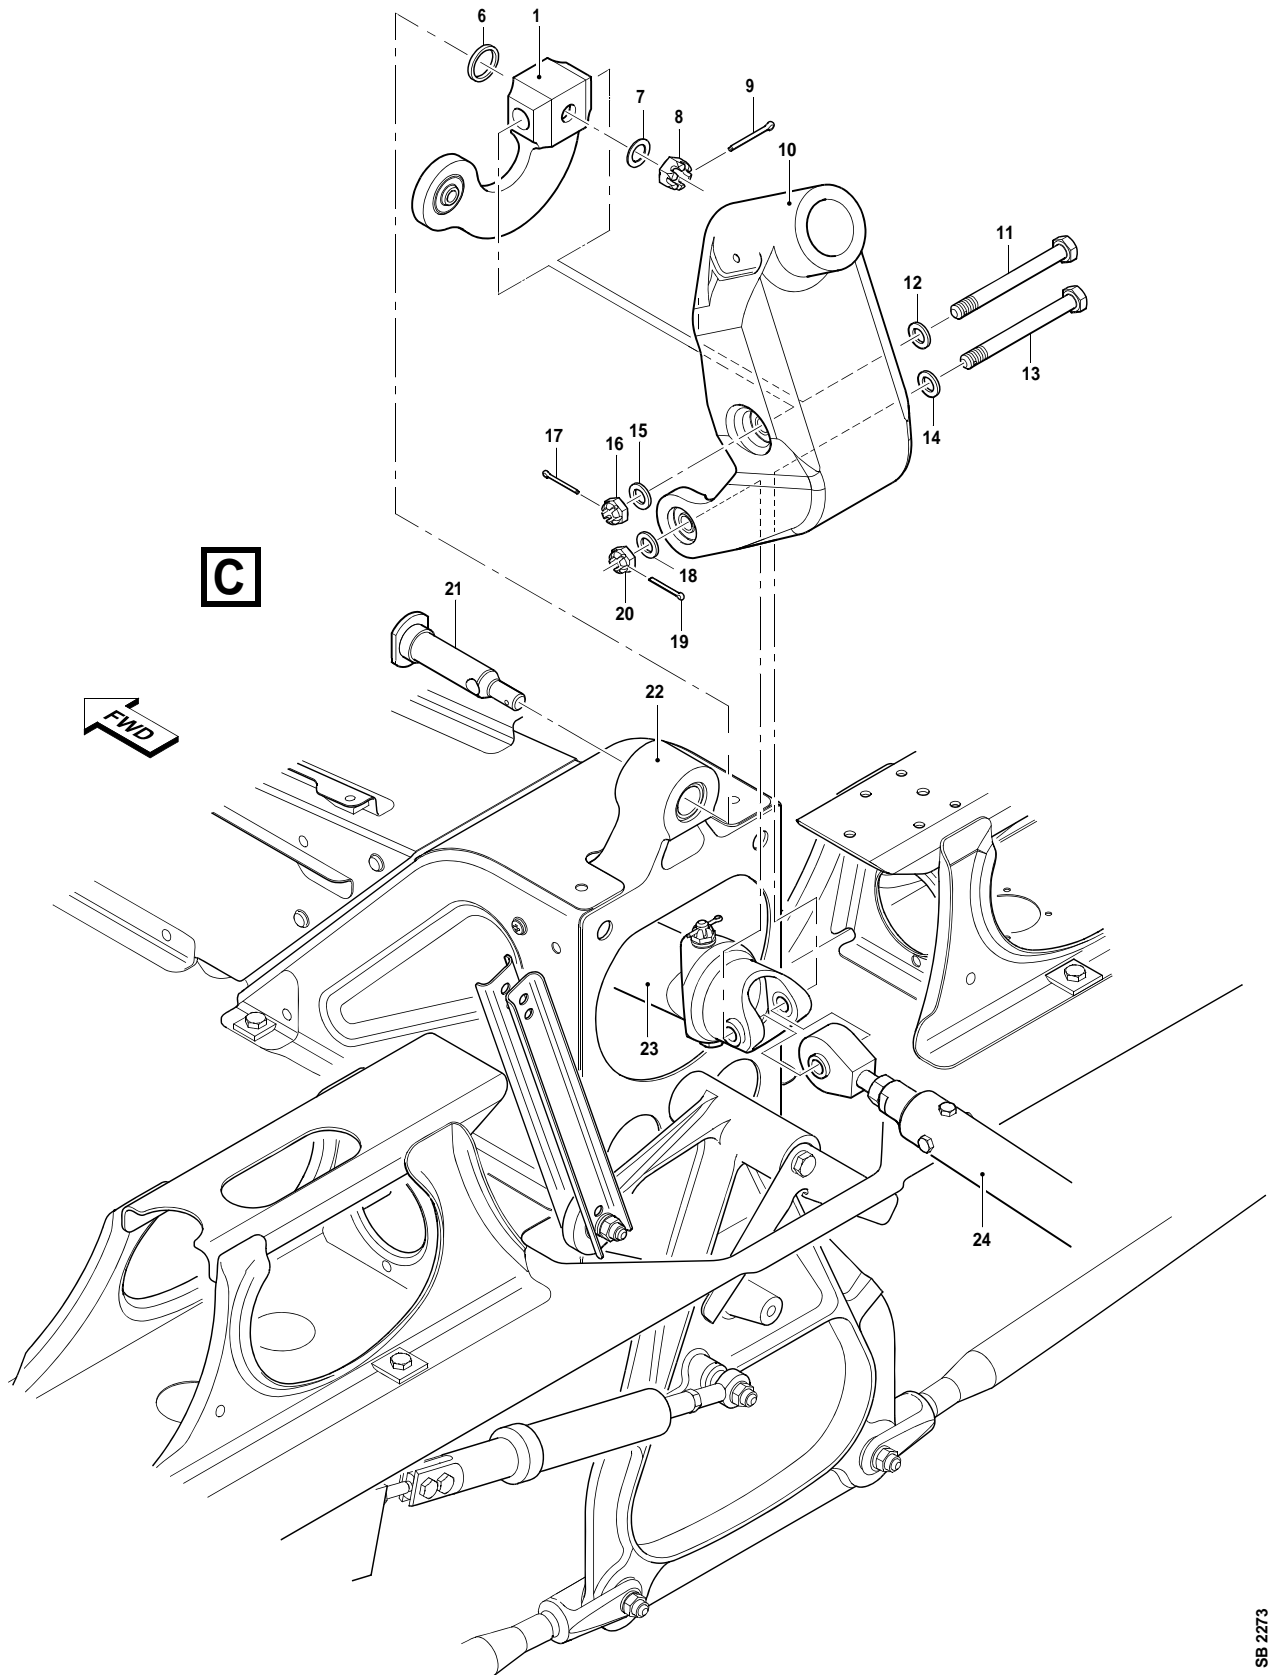
Inspection / Replacement of the Lever on the Rear Control Column
Figure 13, Sheet 1 of 2

(6) Inspection and, if Necessary, Replacement of the Lever on the Rear Control-Column (Ref. Fig. 13)

(d) Replace the lever (Ref. Fig. 13):

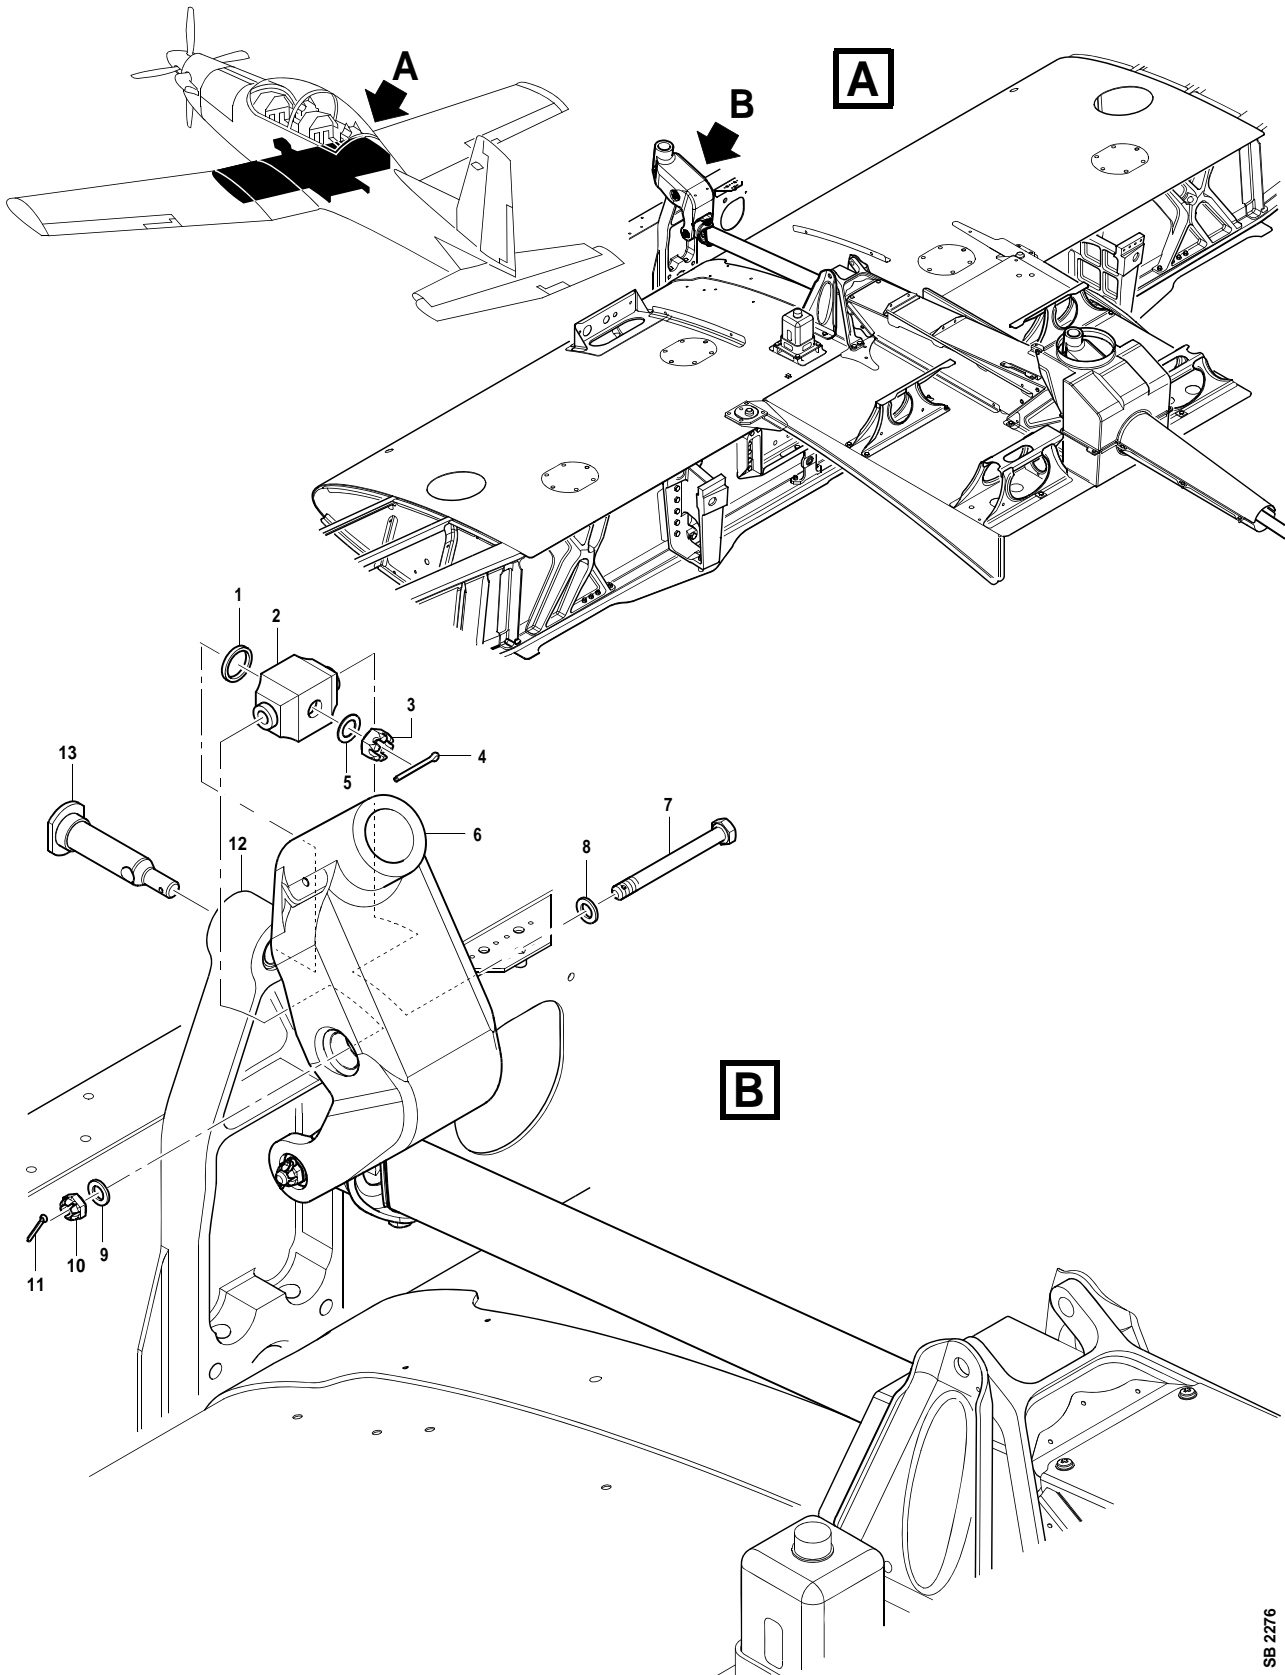
Replacement of the Bearing on the Forward Control Column
Figure 14

(7) Inspection and, if Necessary, Replacement of the Bearing in the Forward Control-Column (Ref. Fig. 14)

(d) Replace the bearing assembly (Ref. Fig. 14):

- 14 Install the bolt (7), the washer (8) (if removed), the washer (9) and the nut (10).
- 15 Torque the nut (10) to between 7 and 8 Nm (60 and 70 lb in).

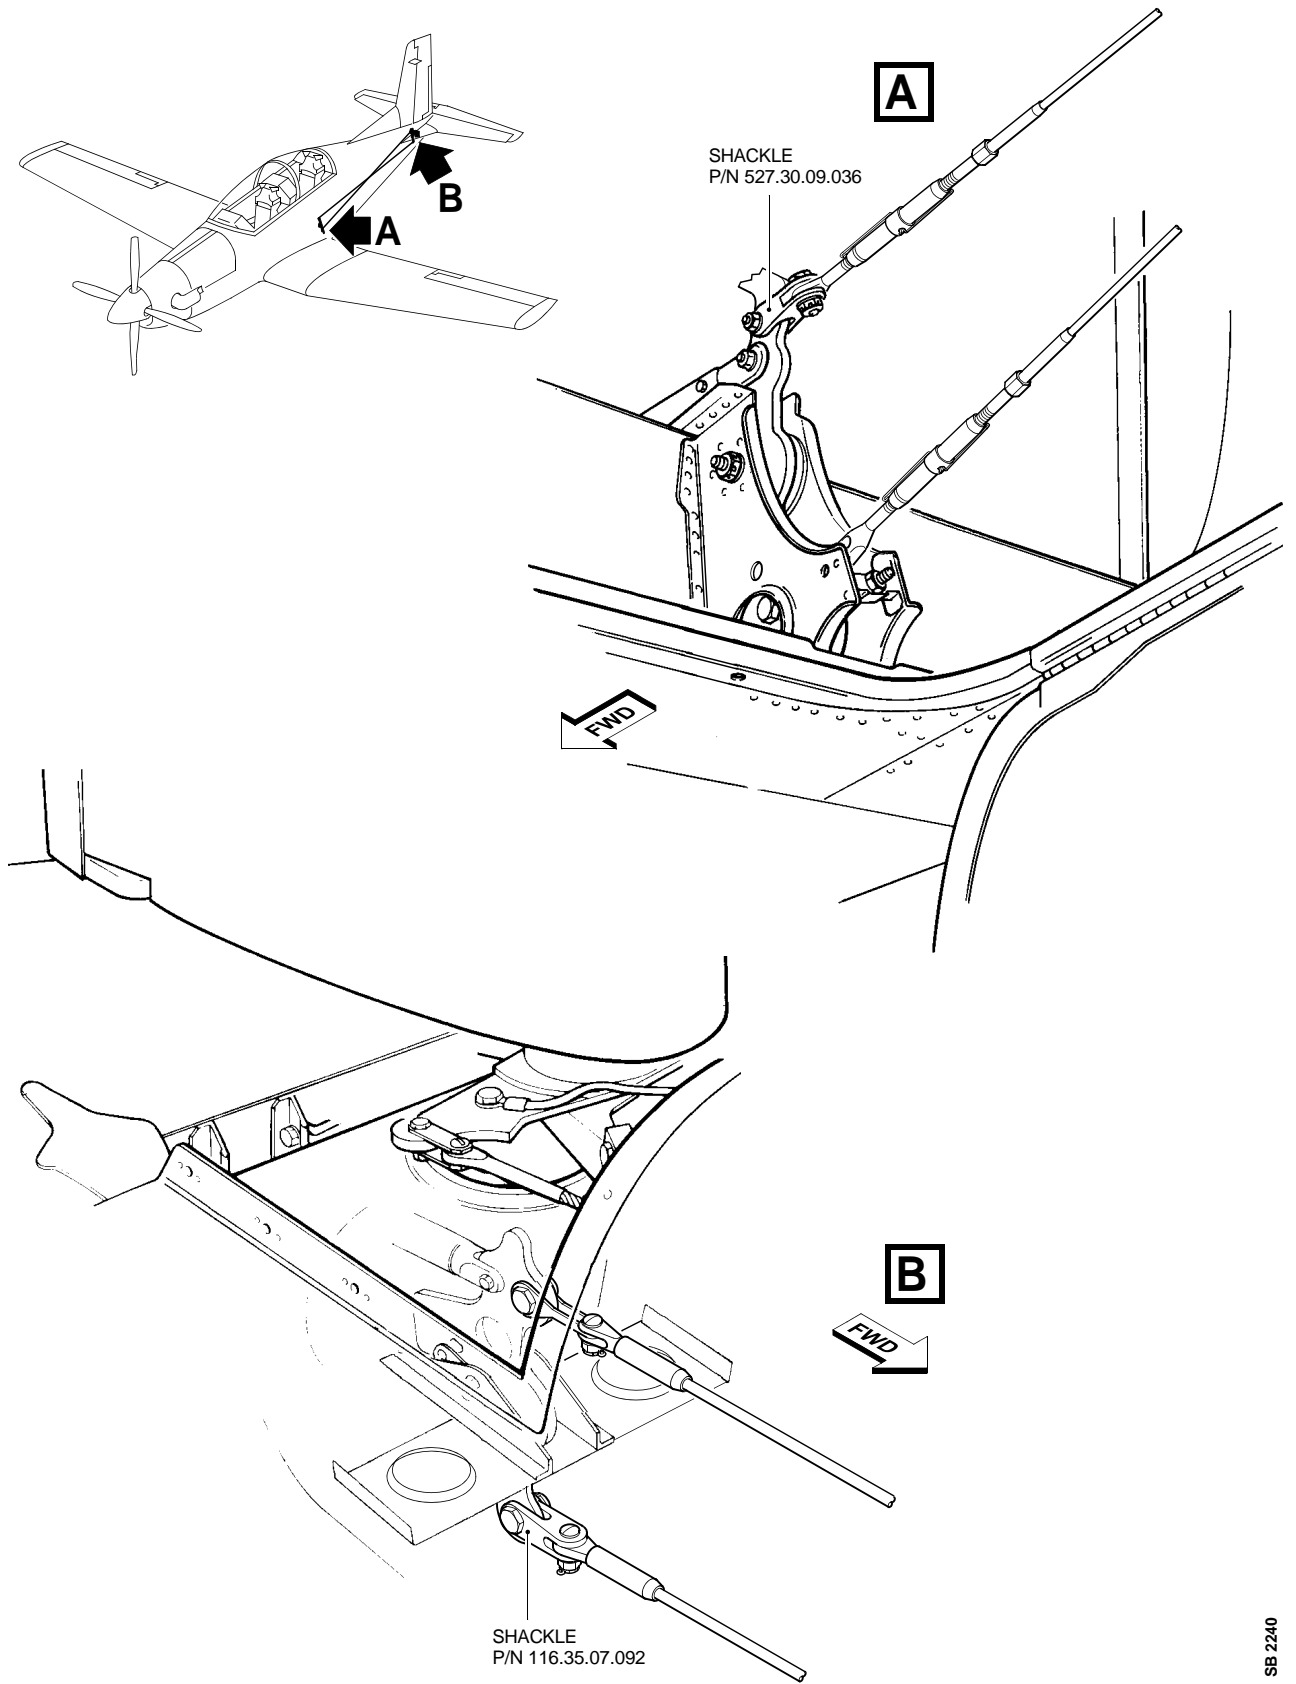
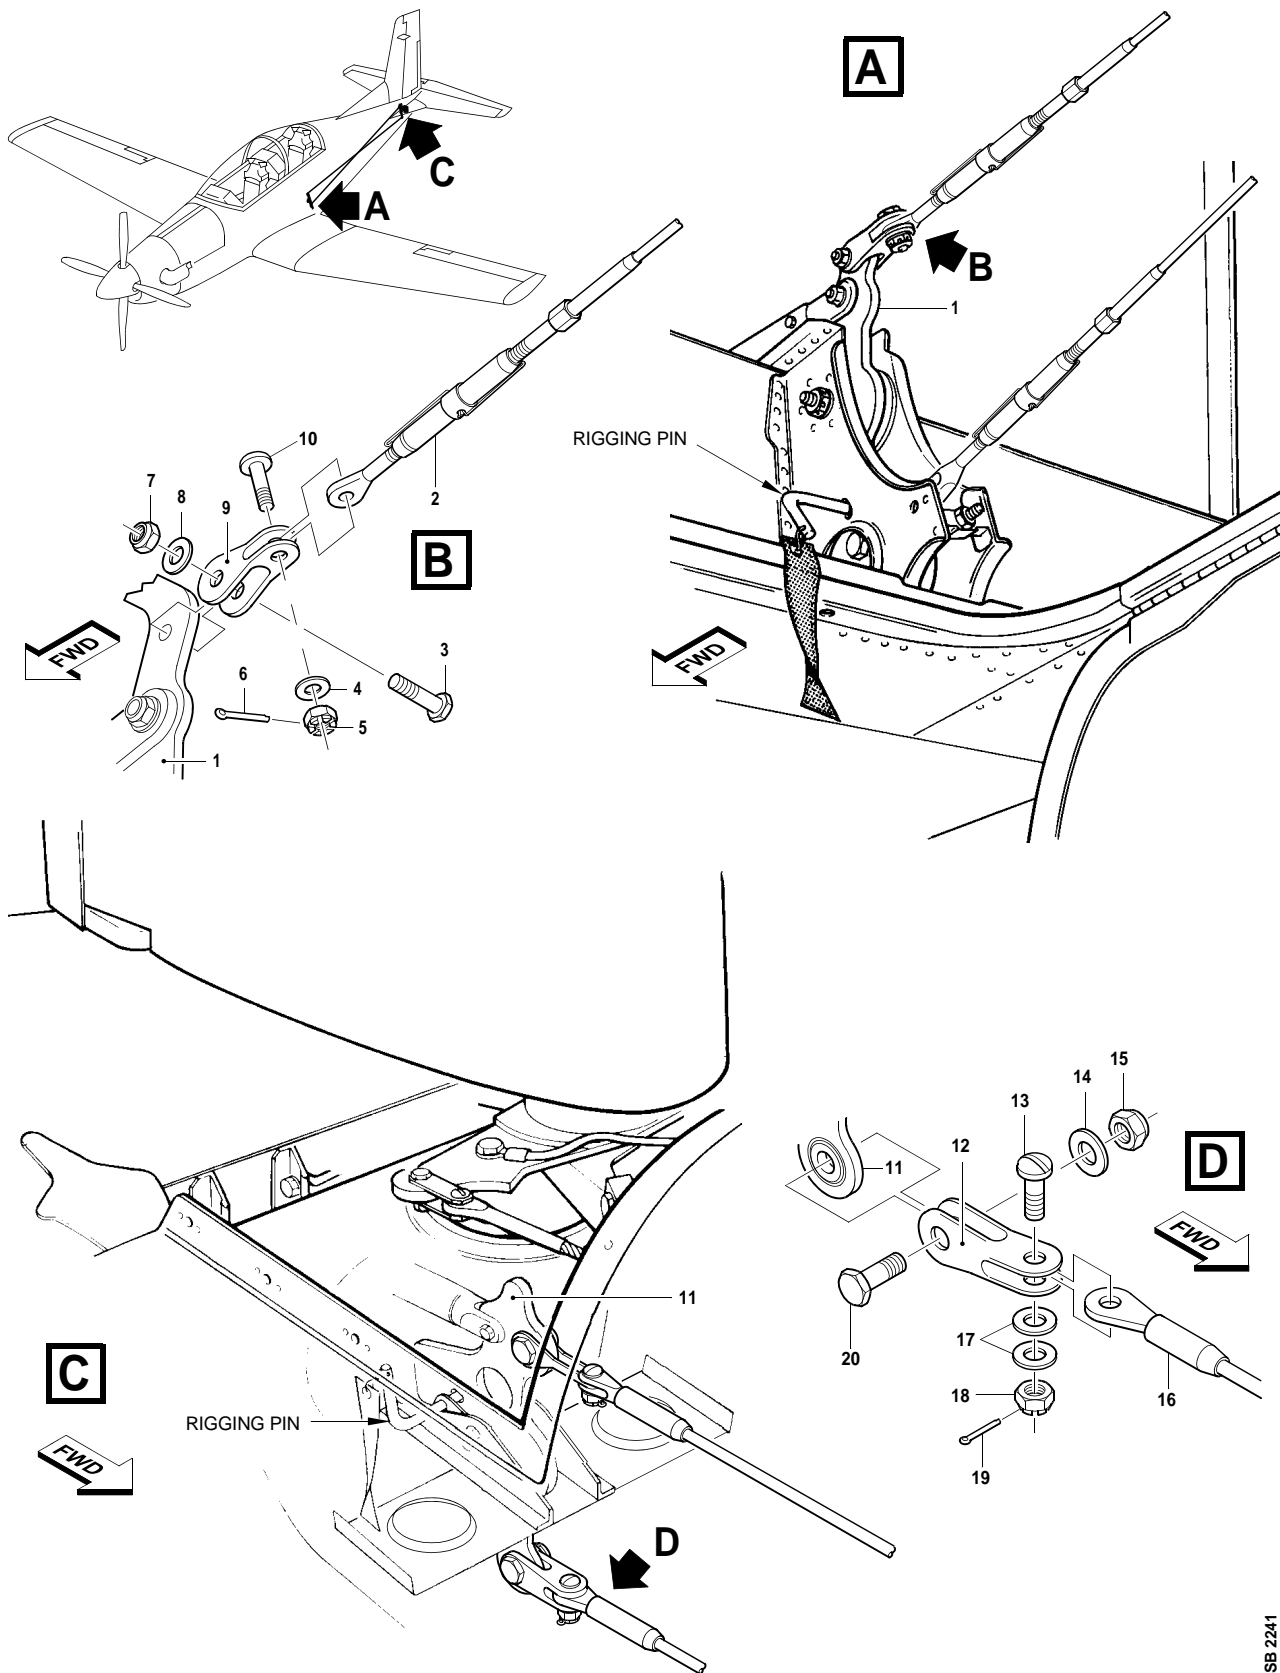
Inspection and, if necessary, Replacement of the Shackles on the Elevator Control Cable
Figure 15

(8) Inspection and, if necessary, Replacement of the Shackles on the Elevator Control Cable (Ref. Fig. 15 and Fig. 16)

- 17 If the shackle (P/N 116.35.07.092) is made from AA2124-T851, continue this Service Bulletin from Step 3.B.(8)(f)15.
- (f) Replace the shackle (P/N 116.35.07.092) (Ref. Fig. 15 and Fig. 16):

- 11 Put the new shackle (12) (P/N 527.30.09.231) in position between the lever (11) and the control cable (16).
