Service Bulletin No: 51-001

ATA Chapter: 51

AIRCRAFT STRUCTURE - GENERAL**DO A CHECK OF THE MATERIAL SPECIFICATION USED DURING MANUFACTURE AND, IF NECESSARY, DO A CHECK FOR CRACKS OR REPLACE THE PART****1. Planning Information****A. Effectivity**

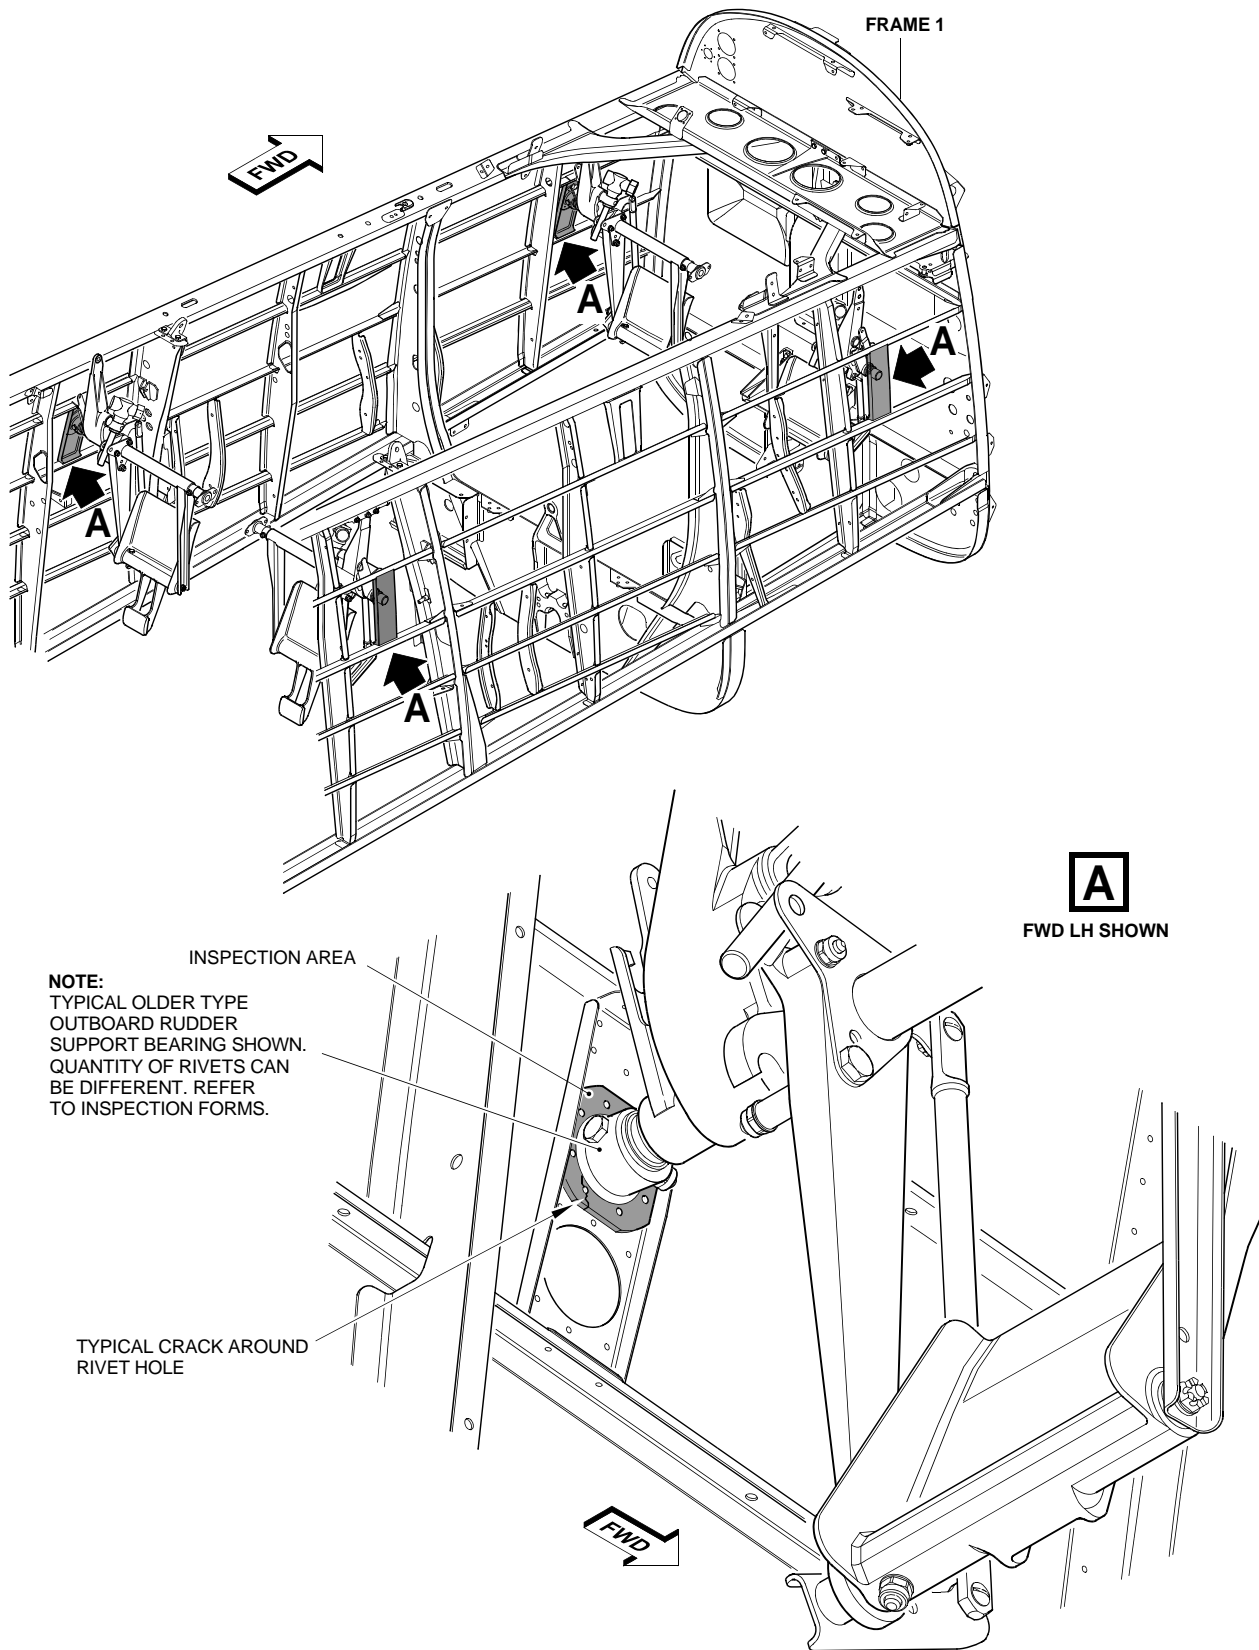
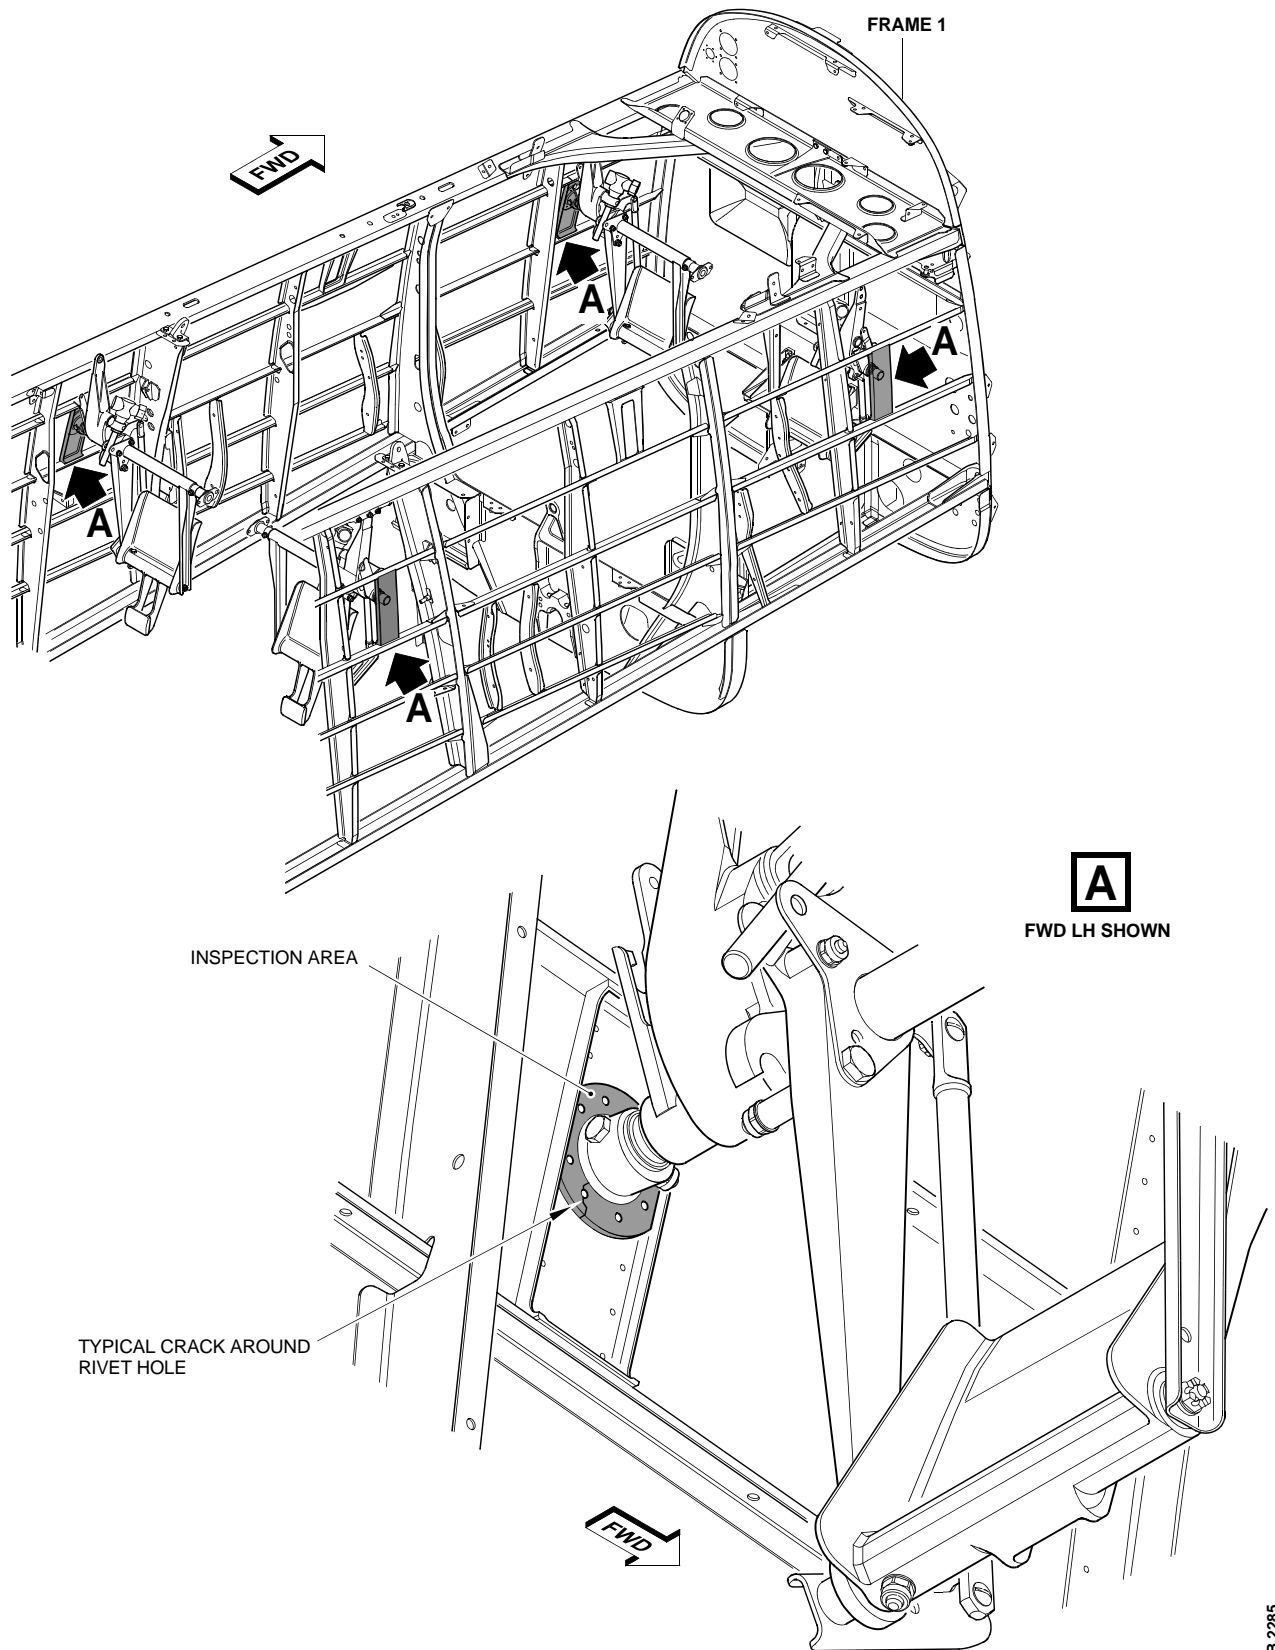
Front and Rear Rudder-Pedal Outboard-Bearings (P/N 553.20.09.062) - Inspection (If Necessary)
Figure 17, Sheet 1 of 2

- (f) Do an inspection for cracks of the outboard bearings (Ref. Fig. 17):

- 3 Obey the manufacturer's instructions and use a boroscope to examine the inspection areas of the outboard bearings (P/N 553.20.09.062 or P/N 553.20.09.235) for cracks.

- 4 If you find cracks:

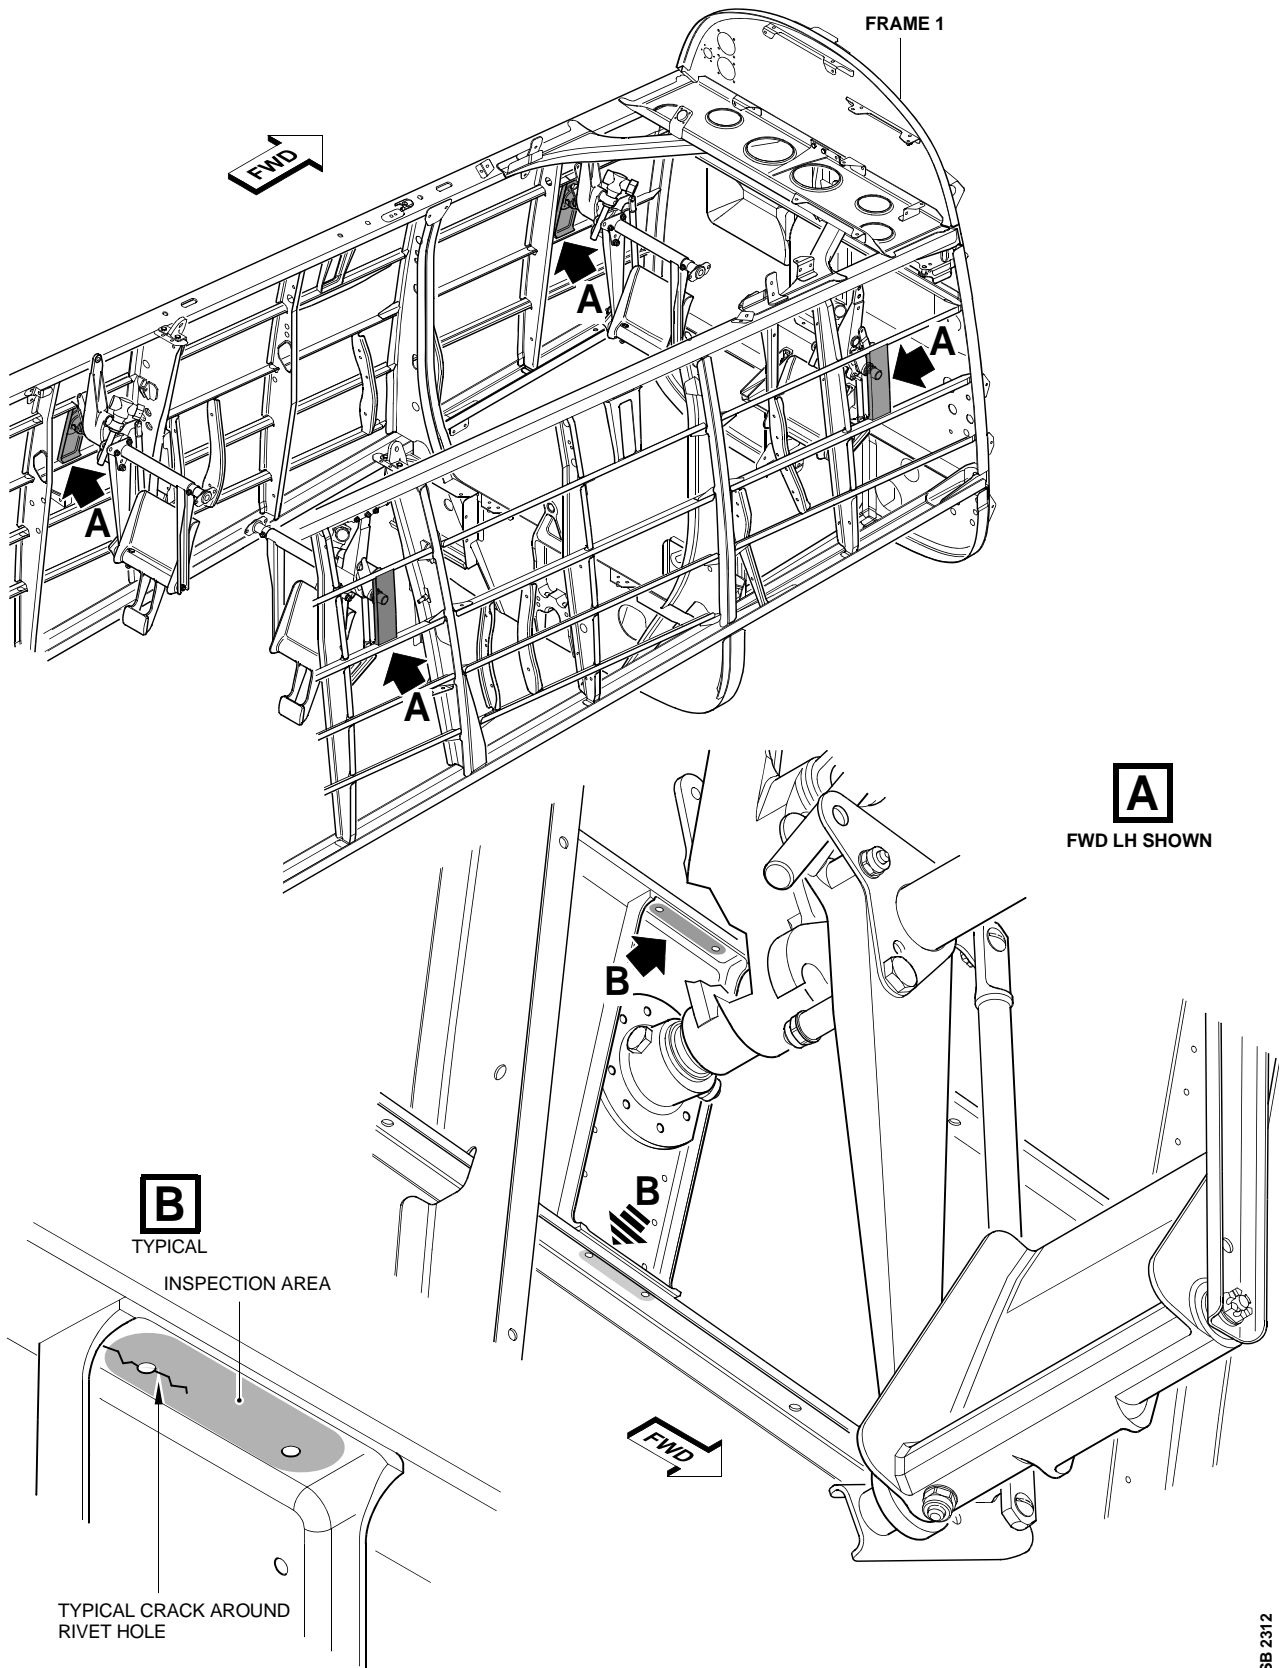
Front and Rear Rudder-Pedal Outboard-Bearing-Support Plates (P/N 553.20.09.229) - Inspection
Figure 19

(i) Do an inspection for cracks of the support plates (Ref. Fig. 19):

3 Obey the manufacturer's instructions and use a boroscope to examine the inspection areas of the support plates (P/N 553.20.09.229) for cracks.

4 If you find cracks:
