# SERVICE BULLETIN

SERVICE BULLETIN NO: 30-001

## ICE AND RAIN PROTECTION - PITOT-STATIC AND AOA ANTI-ICE SYSTEM STATIC-PORT HEATER WIRES - INSPECTION

All PC-7 MkII aircraft, up to and including MSN 684.

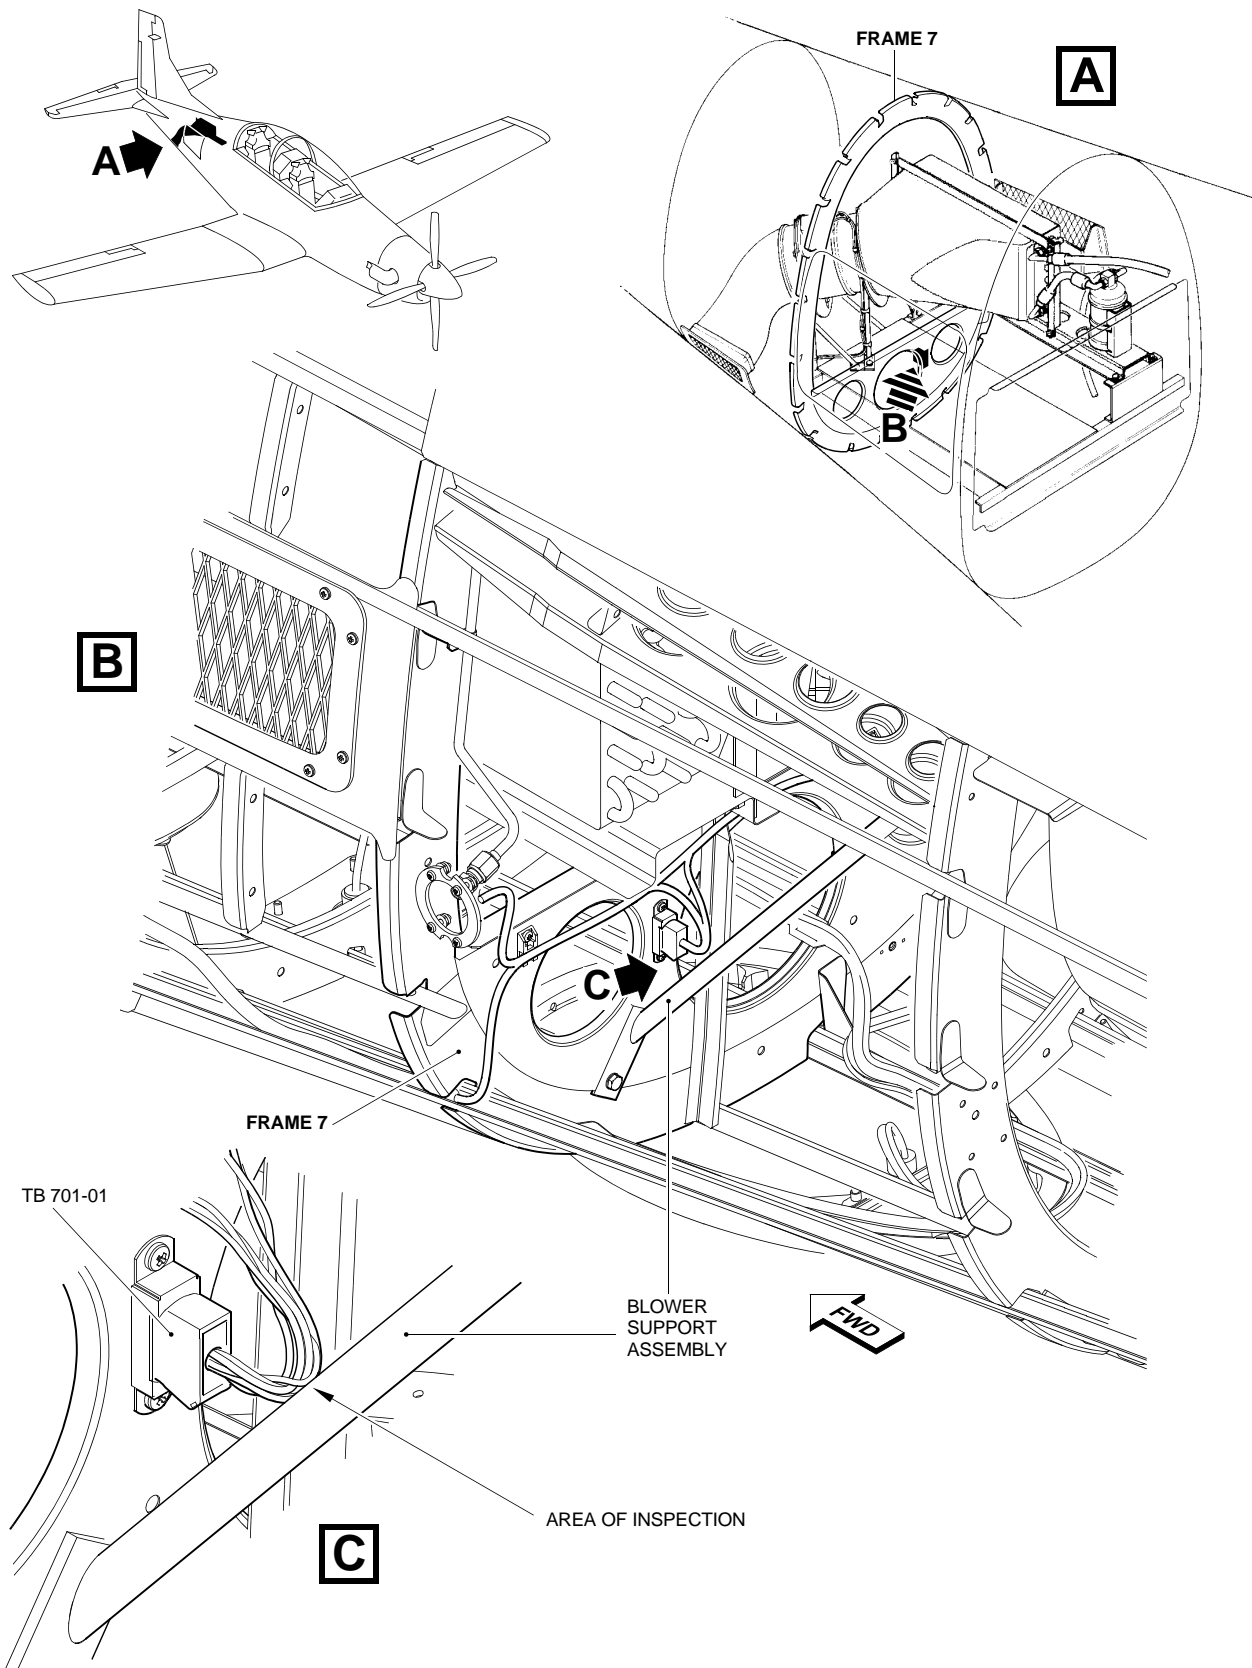
Inspection  
Figure 1

Chafing of electrical wires against a support strut for the condenser fan.

- (1) Examine the wires connected to TB701-01 to see if they can touch the support-strut for the condenser blower motor:

(ii) If you find signs of melting, burning or the insulation is worn so that you can see the metal wire inside, you must replace the wire(s). Obey the safety precautions given in AMM 24-00-00, Page Block 201.

(iii) Apply glass-fiber tape (Material No. P09-020) around the support-strut where the wires can touch.

(iv) If possible, attach the wires to the support-strut with cable ties (Material No. P09-008) to prevent movement. Do not do this if it puts strain on the wires.
